Preliminary Inspection Report for South Carolina Regulated Dams and Impoundment Structures Regulations R.72-1 through R.72-9

A. Dam Number: D 2085 & Hazard Class 2 B. Name of Dam: Anthony Lake Dam
C. Inspection Date (11/14/2012) & Time: 1330 D. Date of Last Inspection: (07/10/2007)
E. Location-County/City: Taylors / Greenville F. EQC Regional Office: Greenville
G. Inspector's Name: John Cobb
H. Owner's Name: Richard Penoyer
I. Contact Person (if different from above):
J. Dam Owner's or Contact Person's Phone Numbers: Home () Office () Other ()
K. Dam Owner's or Contact Person's mailing address:
Address 1 1013 Camp Creek Rd
Address 2 (optional)
City Taylors State SC Zip Code 29187

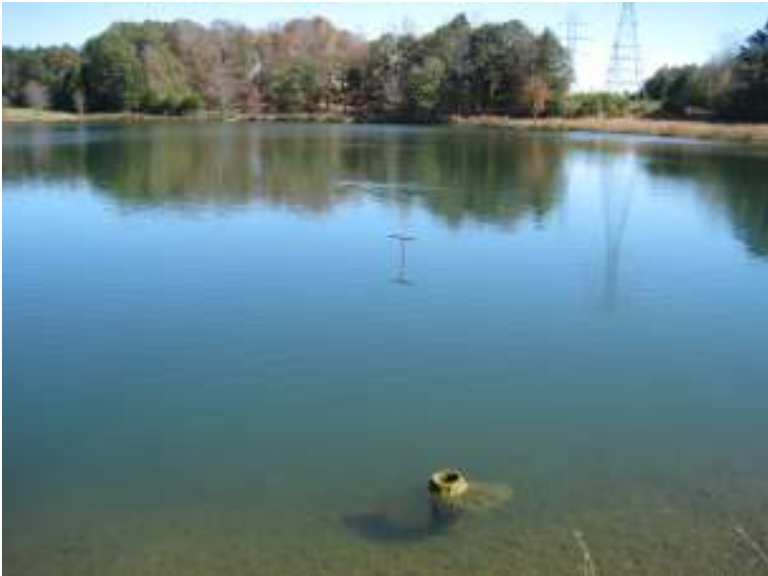
The trash rack has fallen off of the drainpipe. It can be seen to the left of the pipe in the above picture.

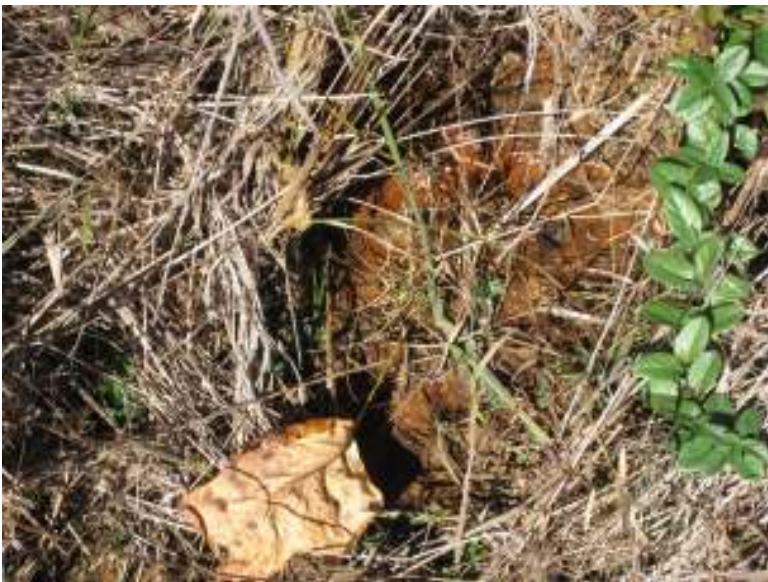
This picture is of an area of concern that shows seepage on the down stream slope of the dam.

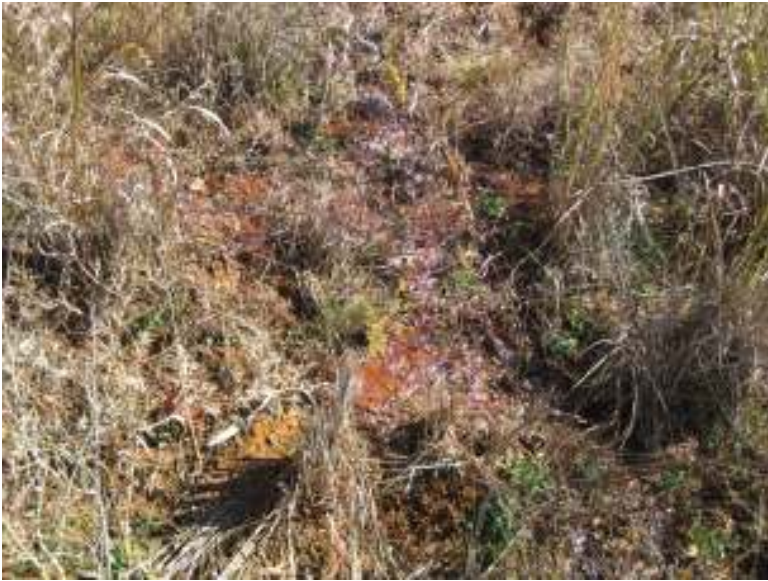
This picture is of an additional area of seepage on the down stream slope of the dam.

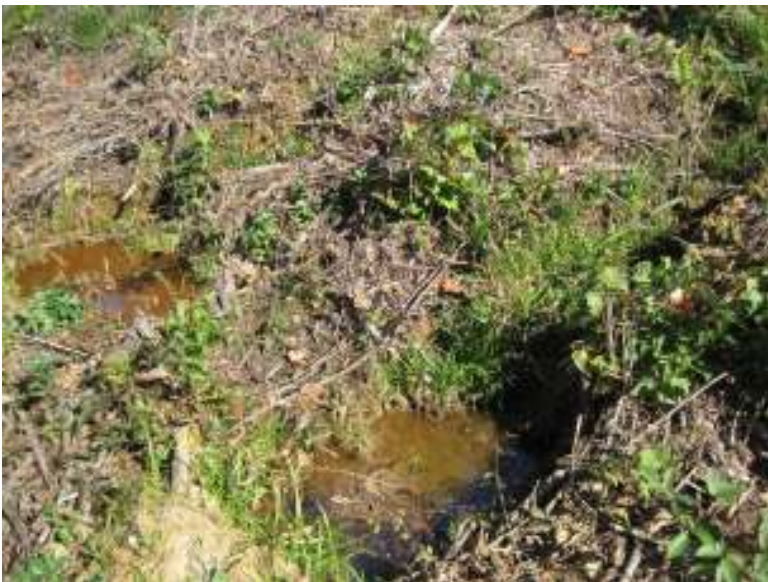
This picture shows yet another area of seepage on the down stream slope of the dam.

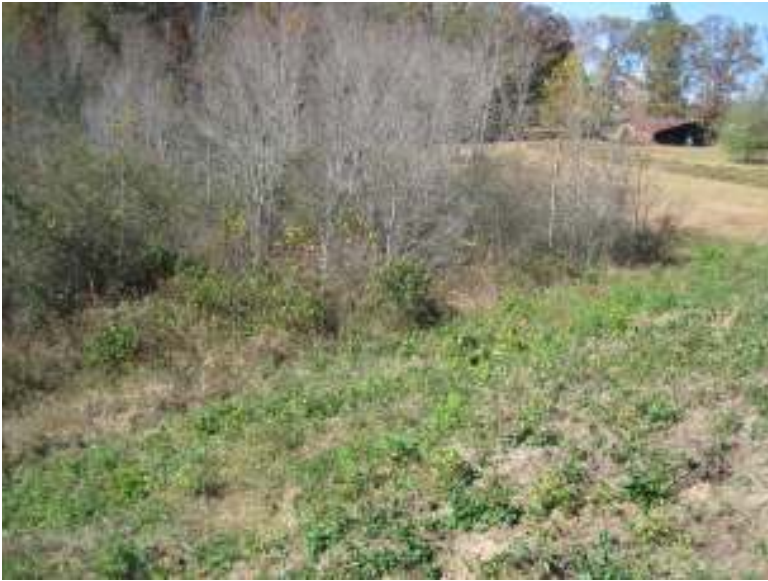
Small saplings that need to be removed around the outlet pipe.

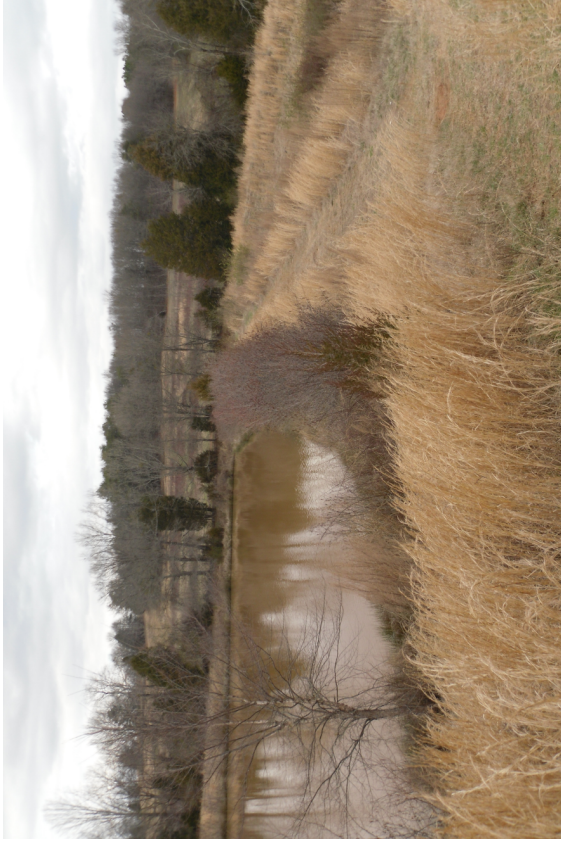
1: Thick vegetation on the upstream and downstream slopes of the dam

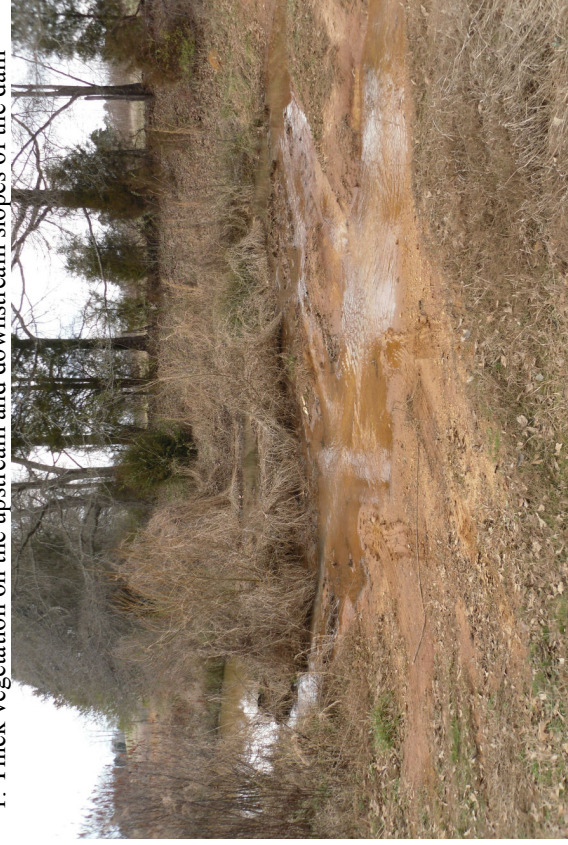
2: Emergency spillway conveying flow

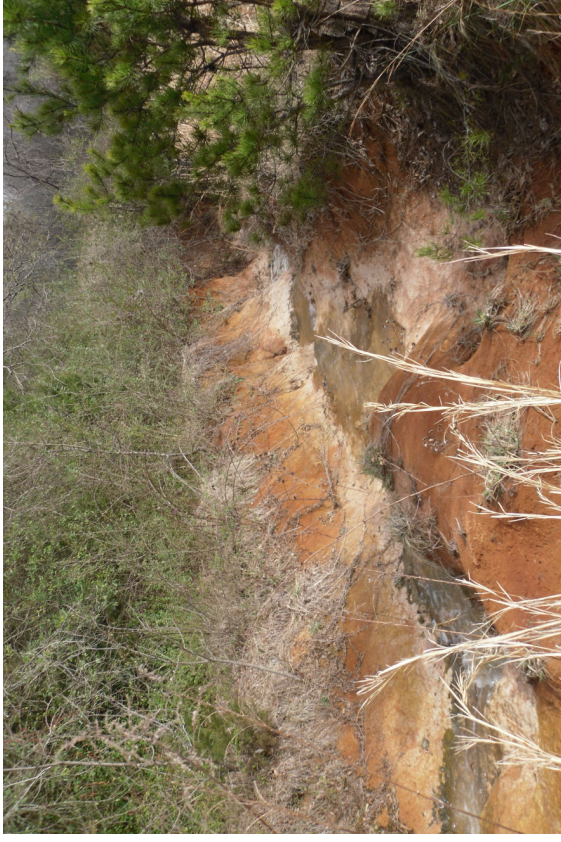
3: Significant erosion observed in the emergency spillway

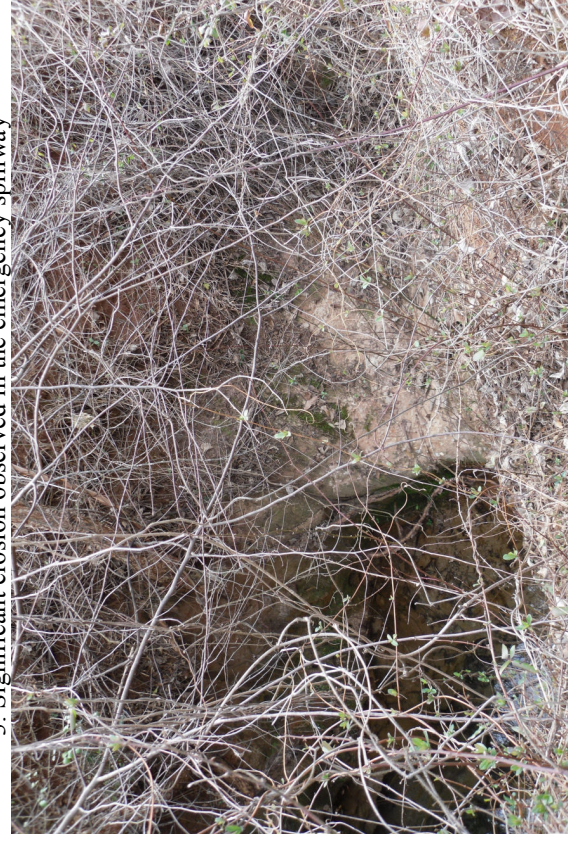
4: Large gully/ area of erosion between outlet pipe and emergency spillway

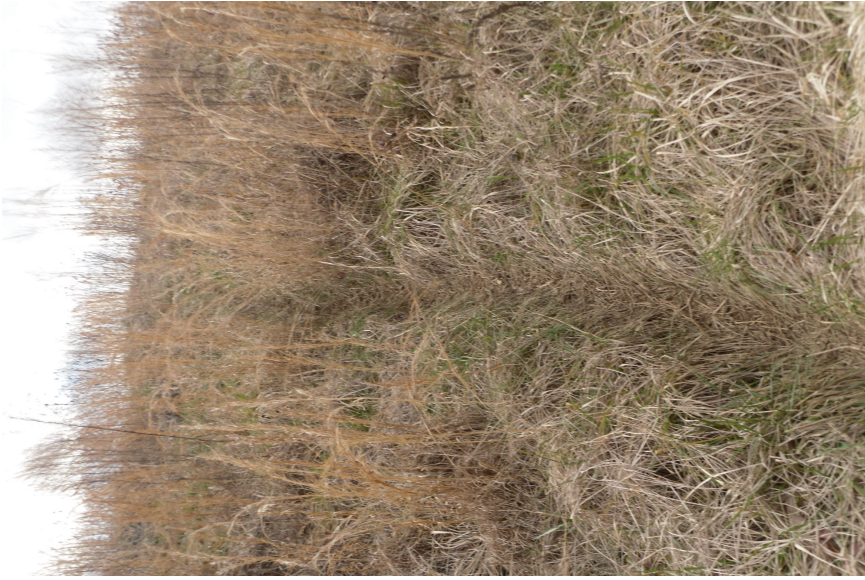
5: Animal trails on the downstream slope

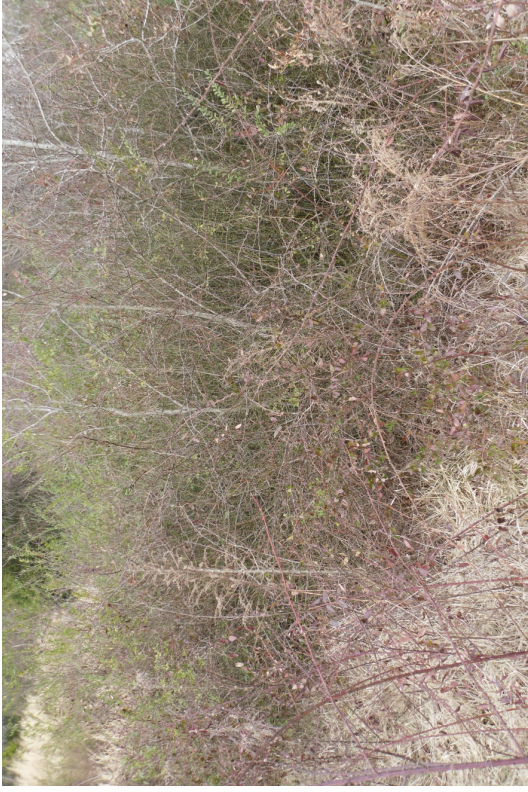
6: Thick vegetation prevented access to outlet pipe

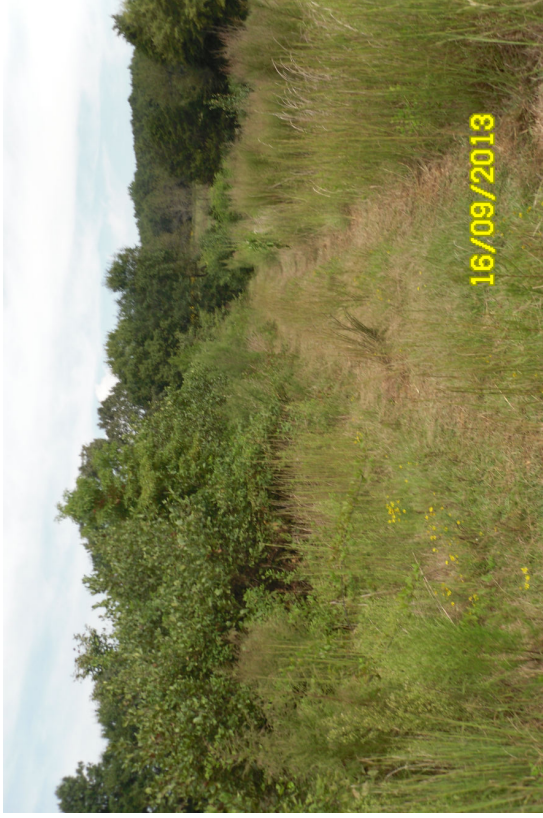
1: Thick vegetation on the upstream and downstream slopes of the dam

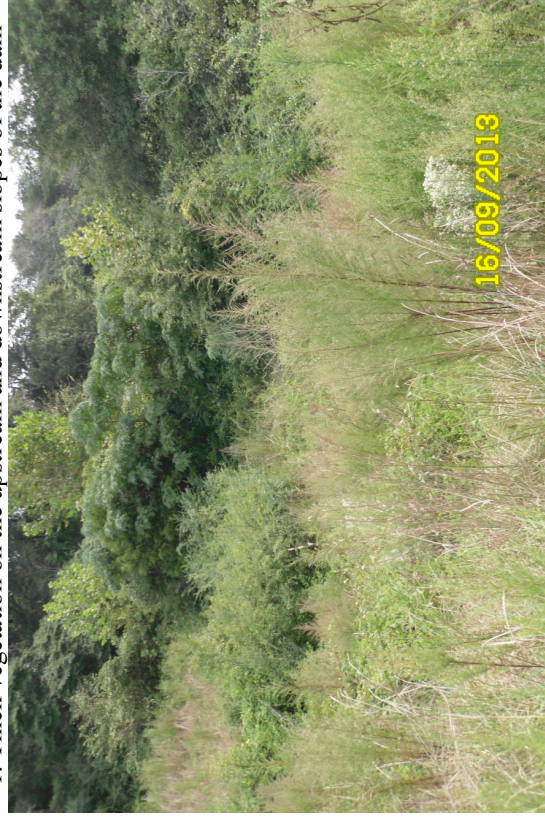
2: Thick vegetation around the outlet pipe

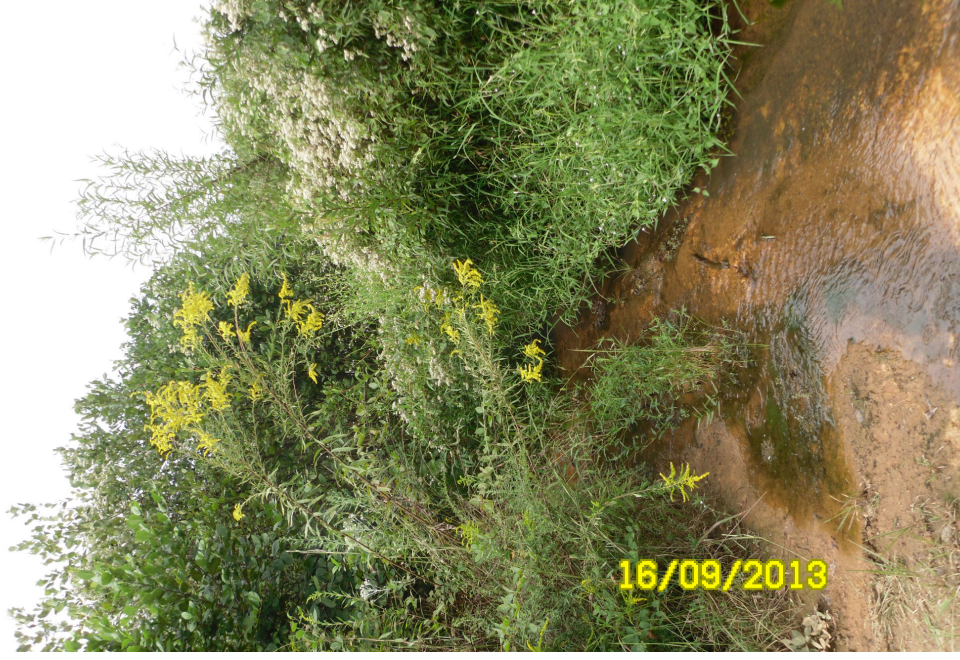
3: Emergency spillway conveying flow

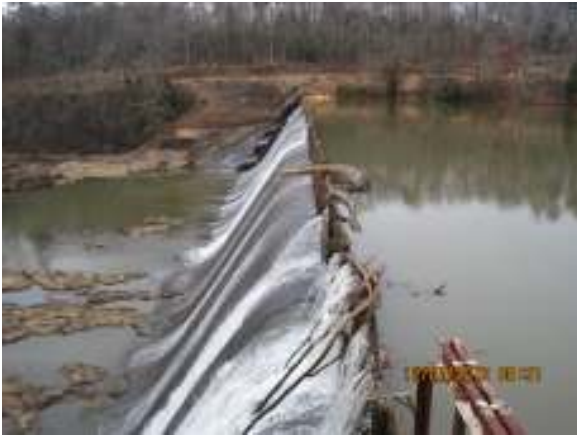
crest of dam and debris on flashboards

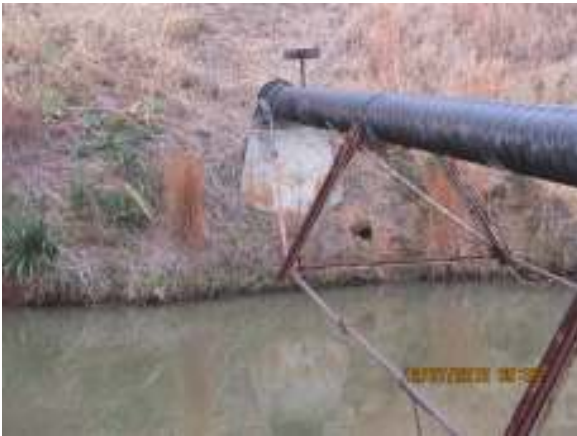
animal activity in channel

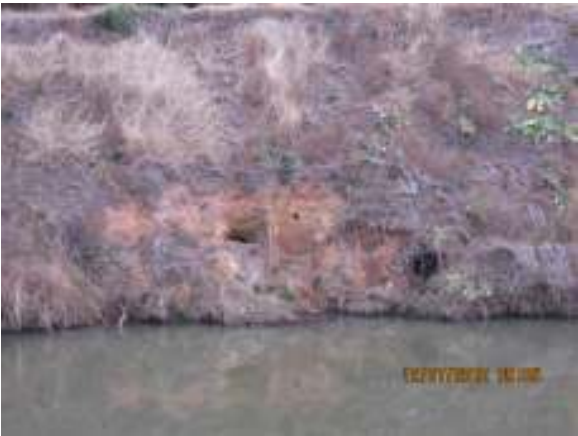
animal activity in channel

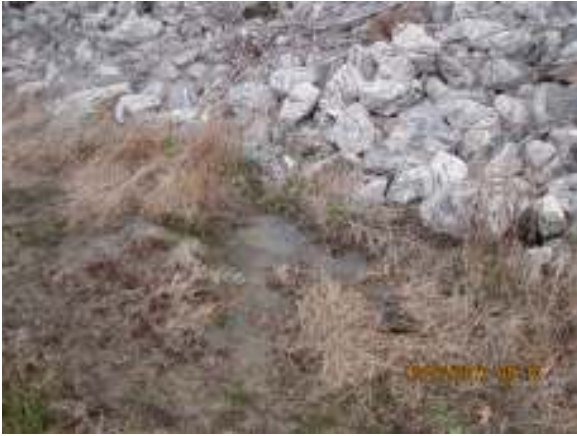
seepage at toe of channel

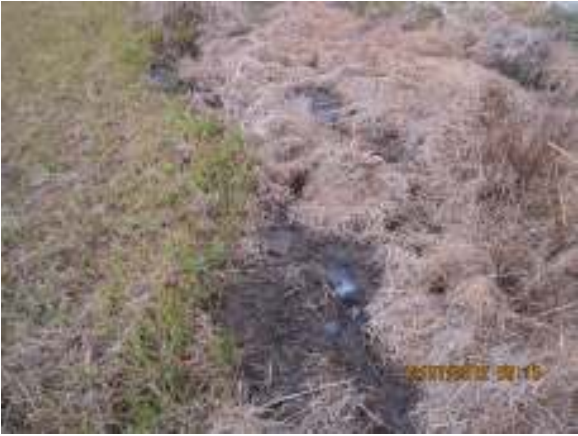
seepage at toe of channel

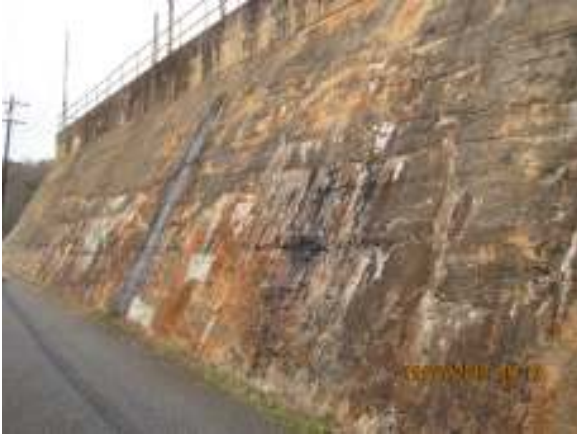
seepage at concrete structure

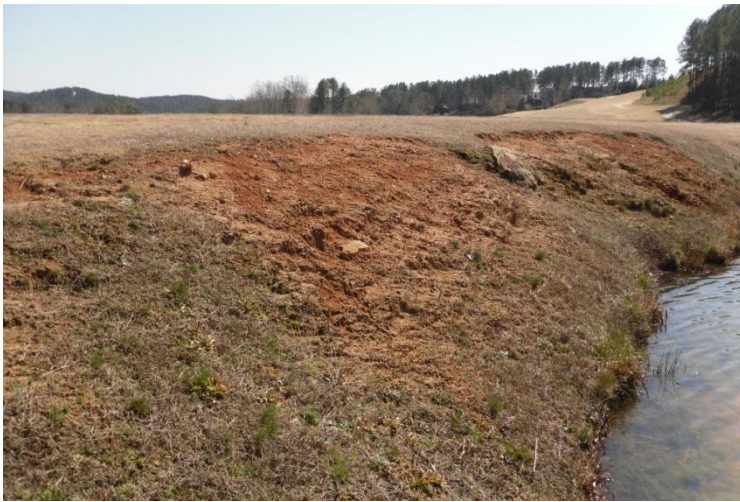
Upstream slope- needing to be stabilized

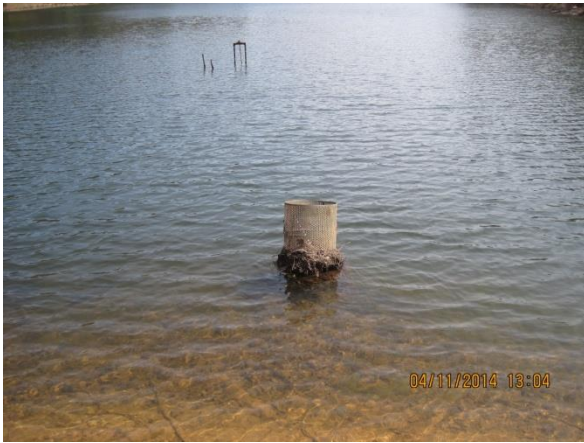
Trash rack w/ debris

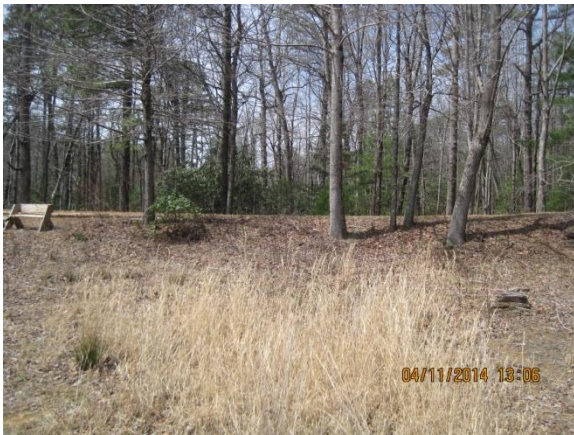
Trees on dam

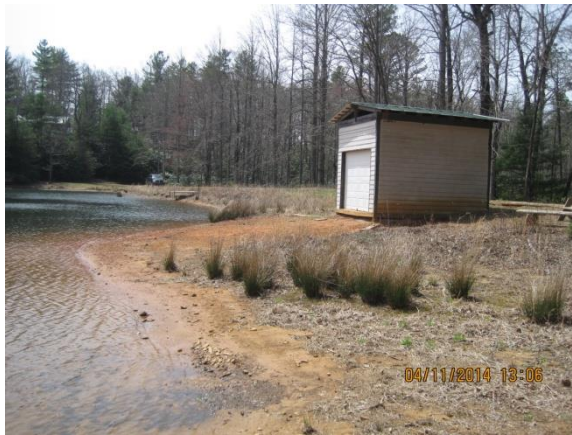
Boat shed constructed on dam

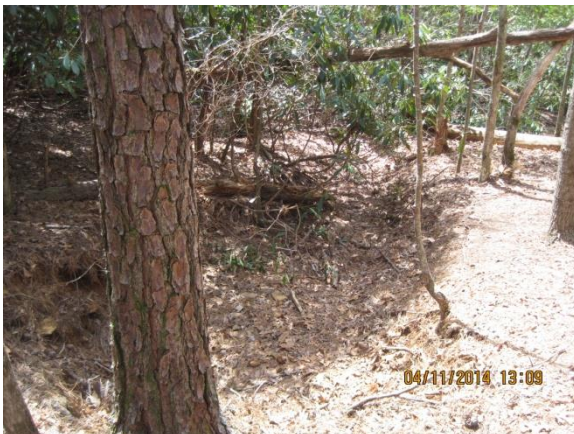
Channel being formed by emergency spillway

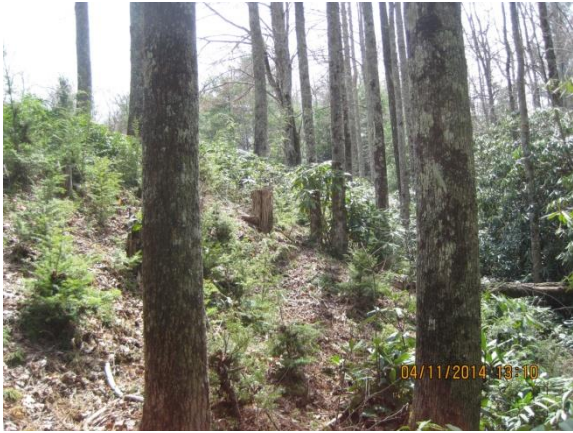
Large trees on dam

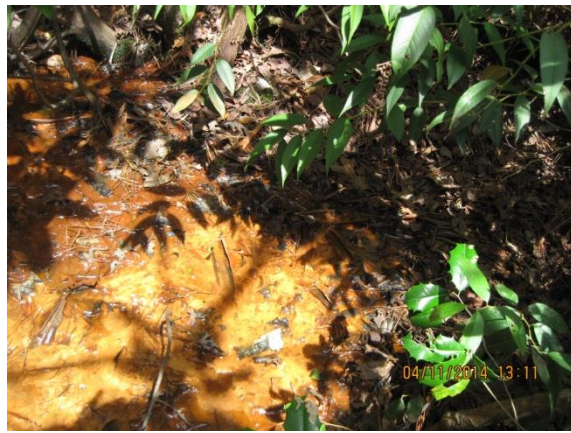
Seepage area

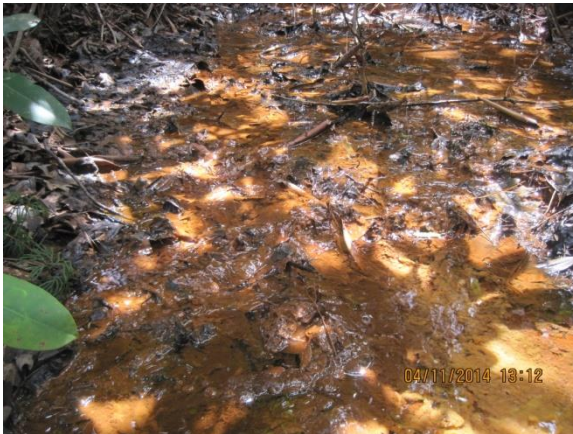
Seepage area

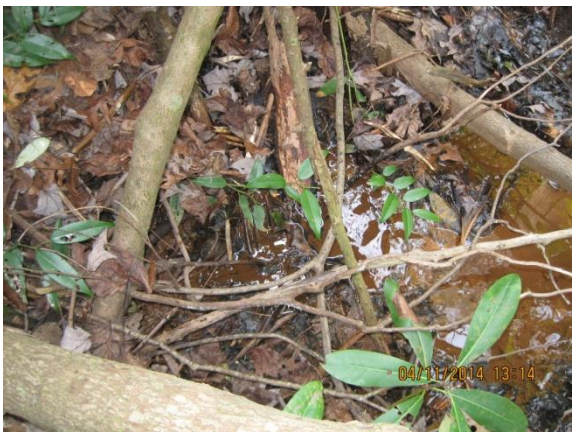
Seepage area

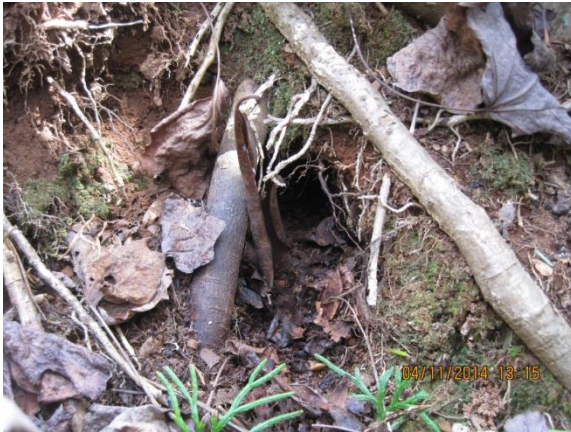
Burrow

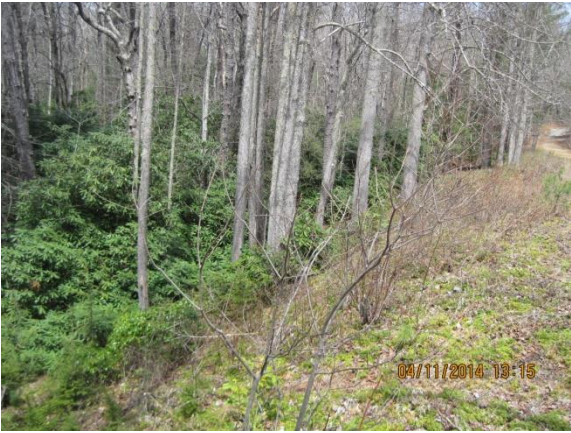
Trees and thick underbrush on dam

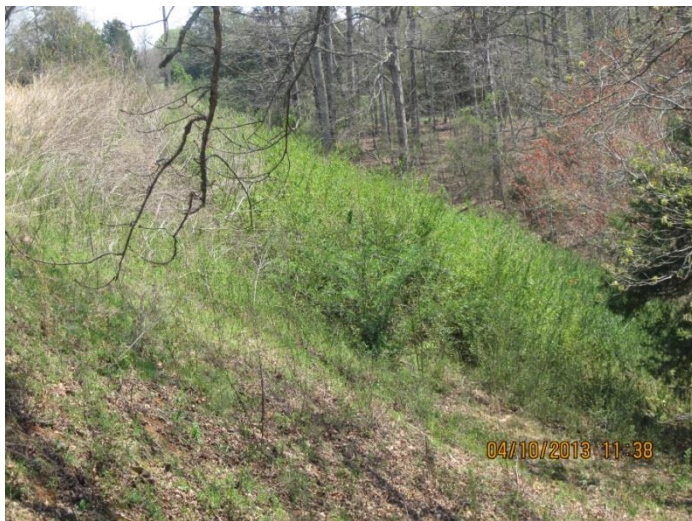
Downstream slope of dam- thick vegetation

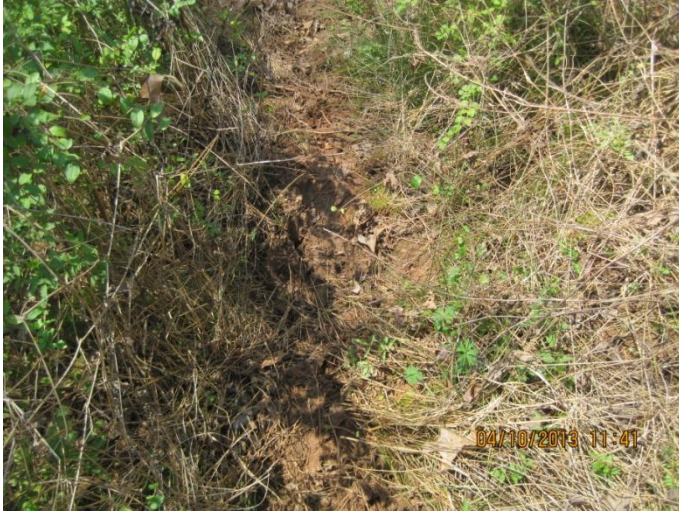
Animal trail on downstream slope of dam

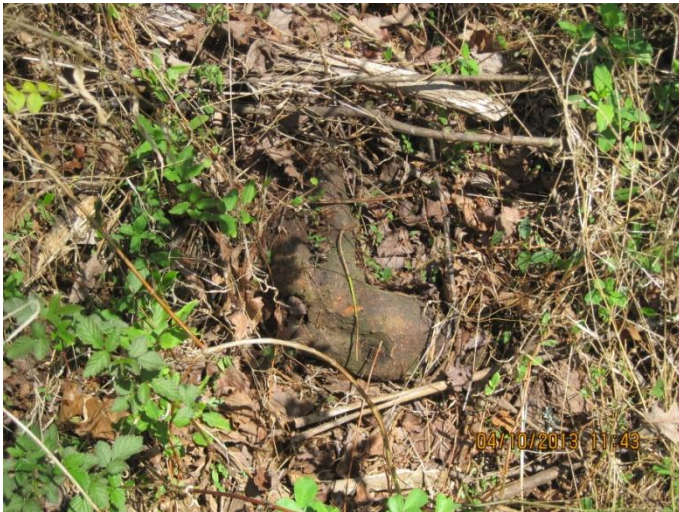
Roots on toe of dam

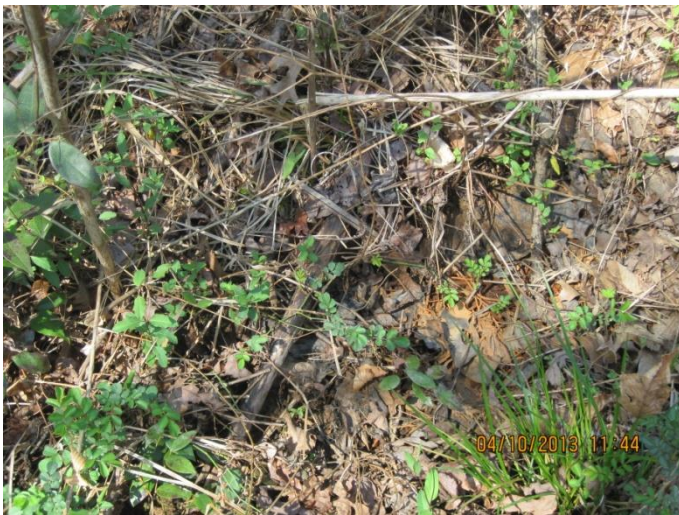
Seepage area at the toe of the dam

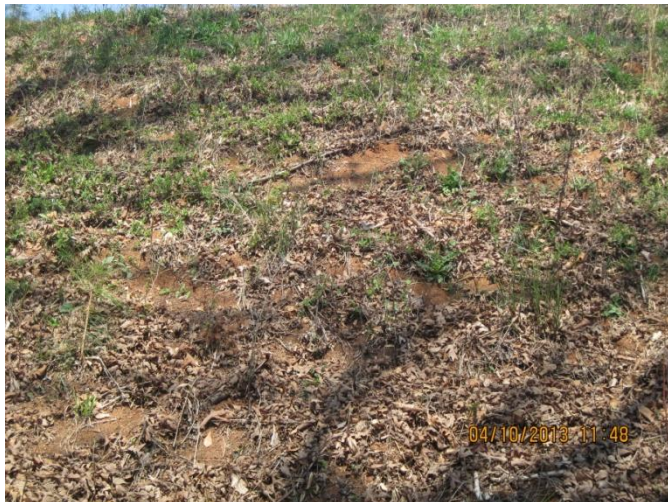
Sloughed area on downstream slope of dam

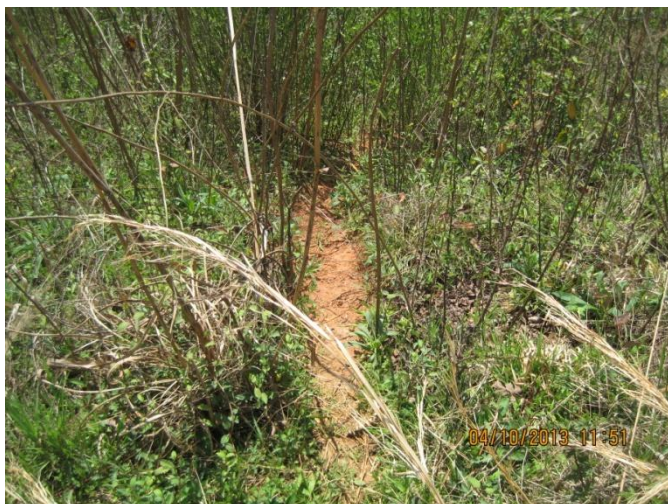
Animal trail on downstream slope of dam

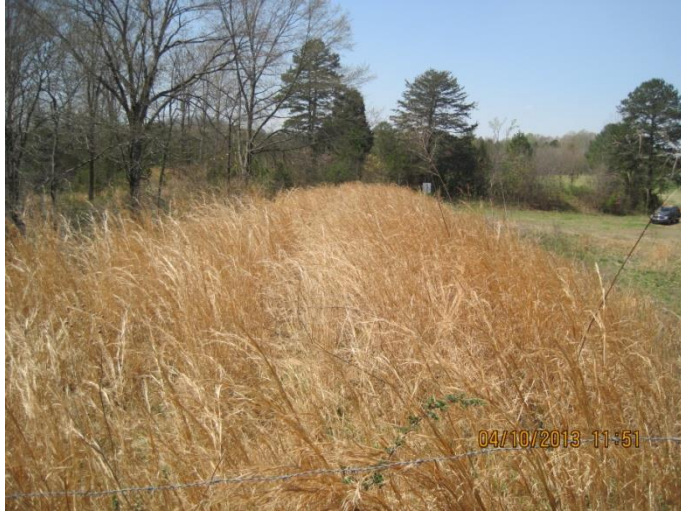
Crest of dam w/ vegetation needing to be cut

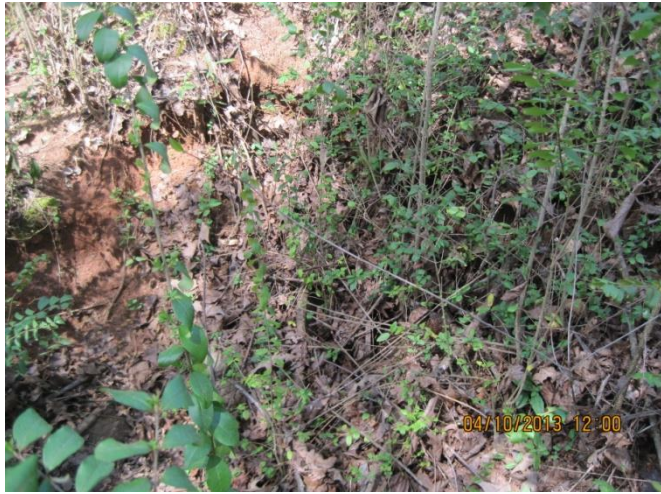
Possible animal activity/burrow

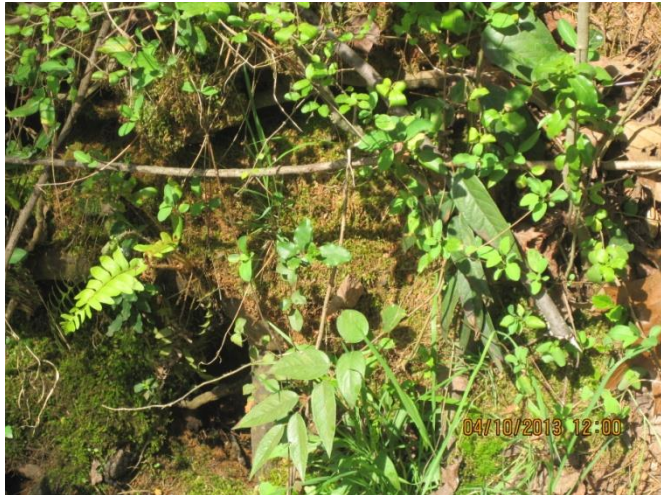
Roots at toe of dam

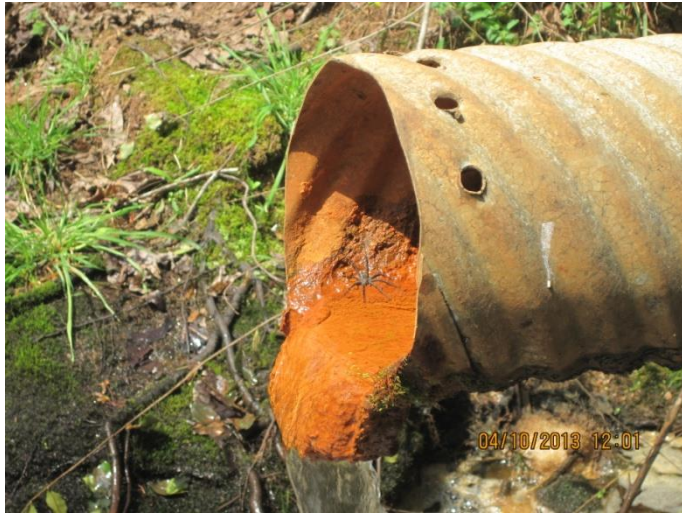
Toe drain with Iron bacteria
