## Twelve Mile Creek Watershed: Assessment of Regulated Dams

April 1, 2016

**PROJECT NAME:** High Level Hydrologic and Hydraulic Overview Model Report for  
Three Regulated Dams on 12 Mile Creek Watershed

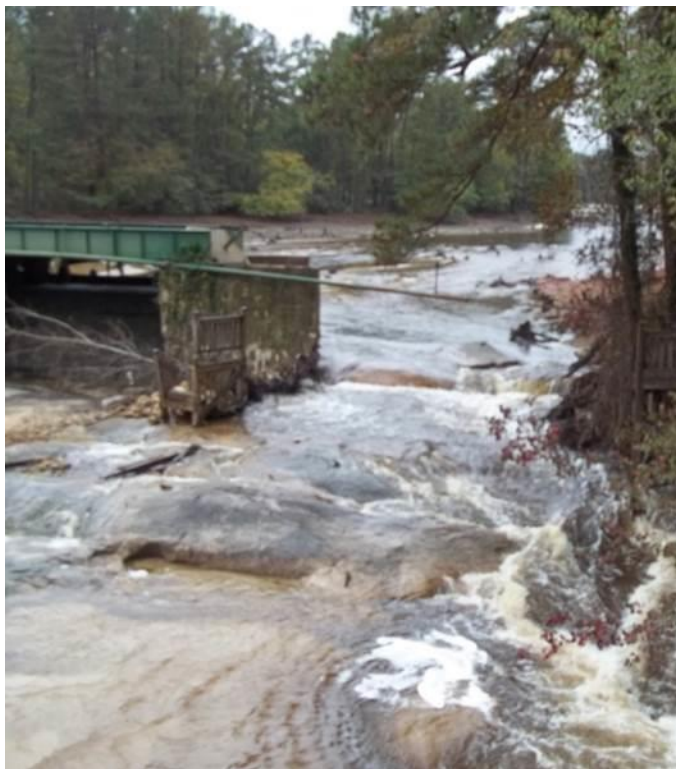
Photo of Gibson's Pond Dam Breach

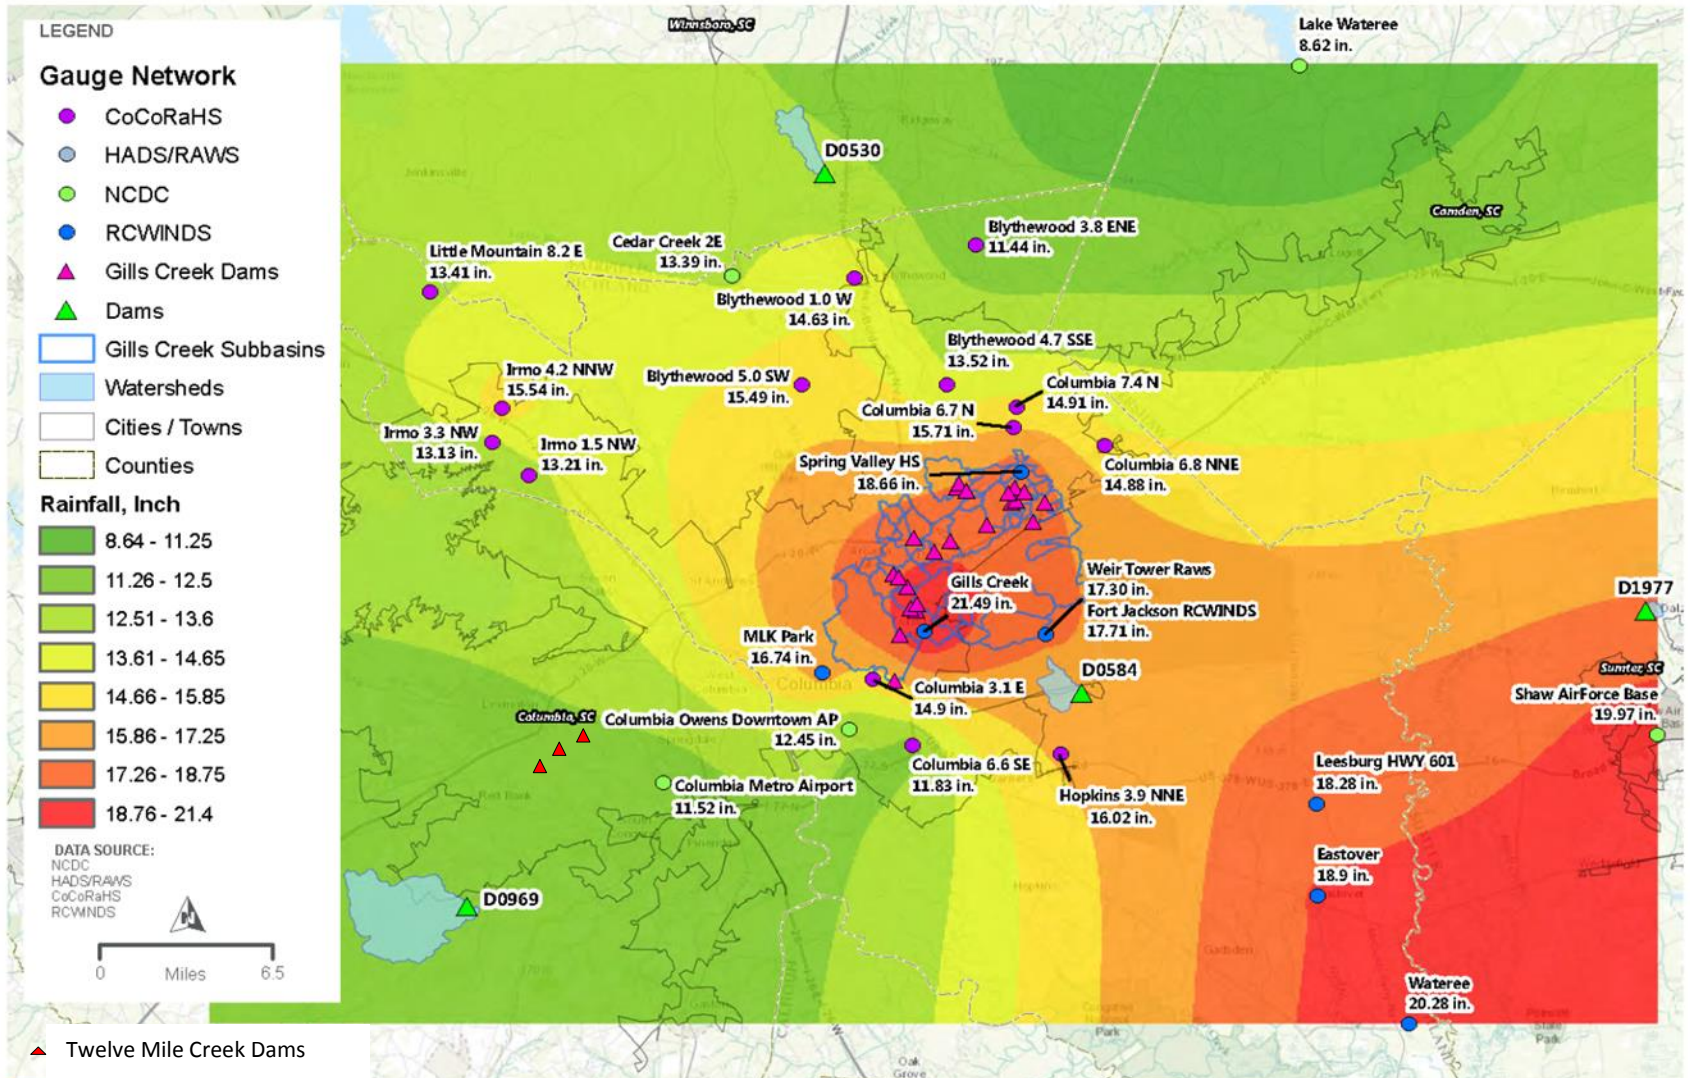
Figure 1. October 2-6 Rainfall Totals

The October 2015 storm event resulted in a total accumulation of approximately 11.6 inches of precipitation between October 2 and 5 as estimated by the NOAA radar (FEMA White Paper). These precipitation amounts exceed the 24-hr 500-year event of 11.2 inches (NOAA Atlas 14, 2006). It is important to note that the distribution of precipitation frequency at the time of establishment of design criteria changes with additional hydrologic record (e.g., the statistical 100-year precipitation event determined in 1970, based on available precipitation records, would be expected to be different compared to the current 100-year precipitation event based on frequency analysis of the additional 45 years of record through 2015).

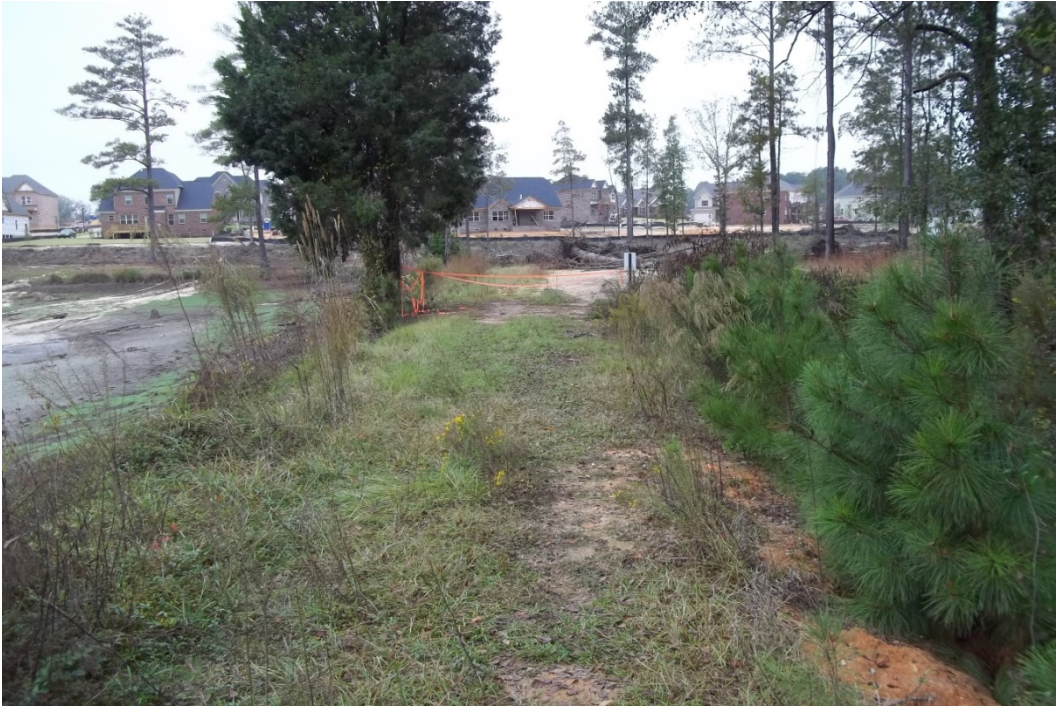
Photo 1: Left abutment on top of dam.

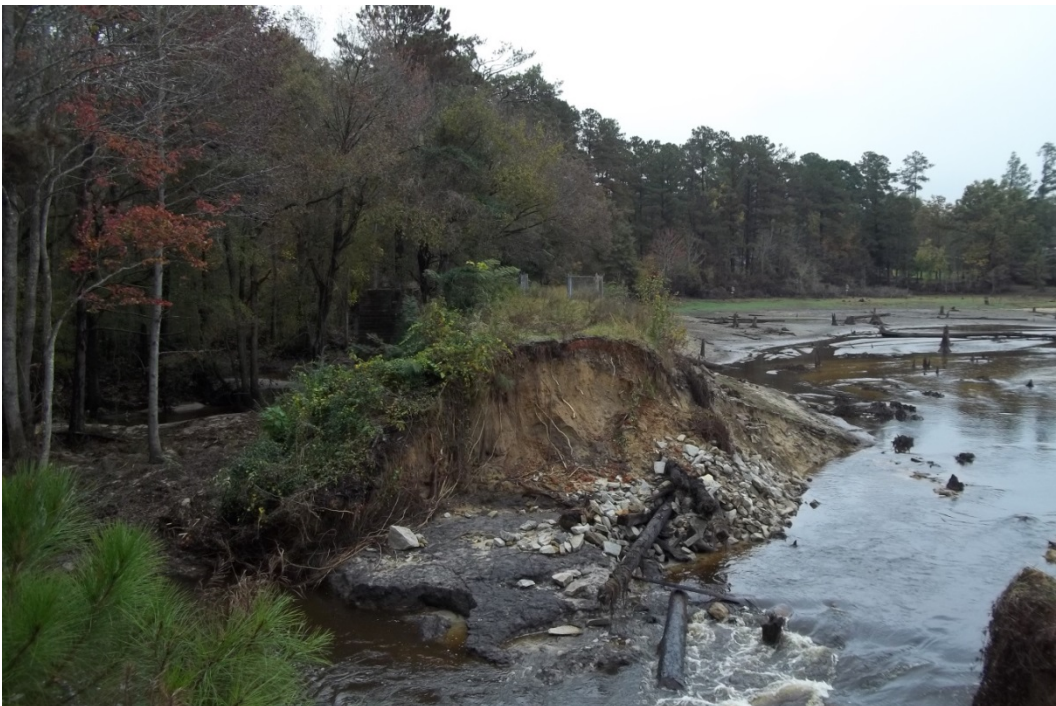
Photo 2: View is of center embankment at breach.

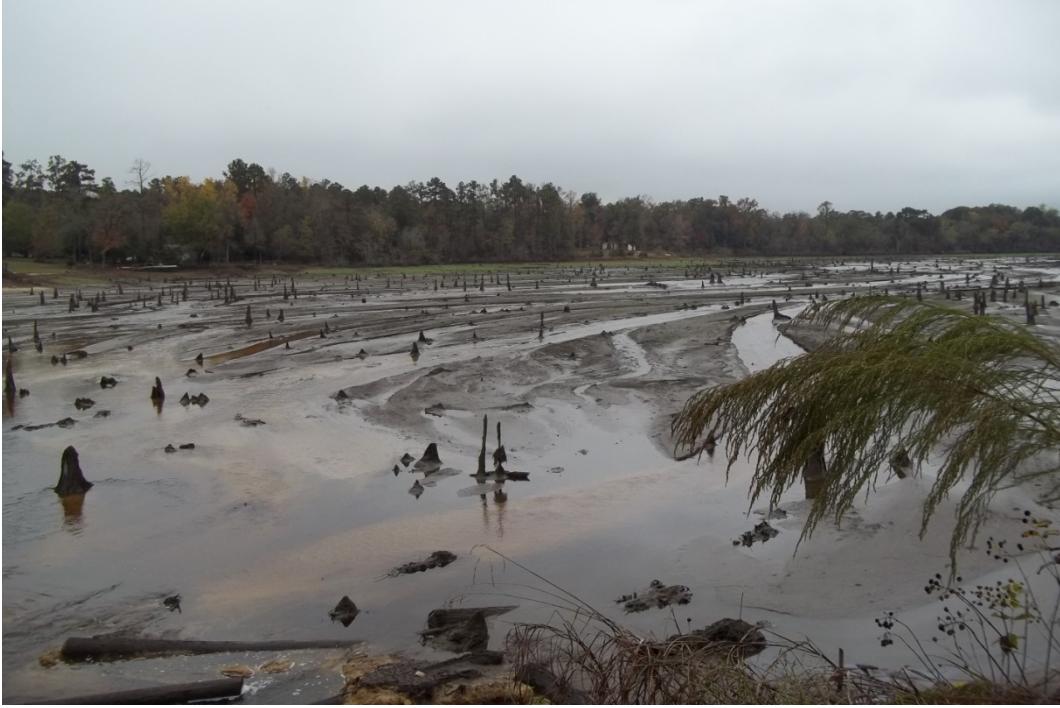
Photo 3: Looking upstream from top of dam.

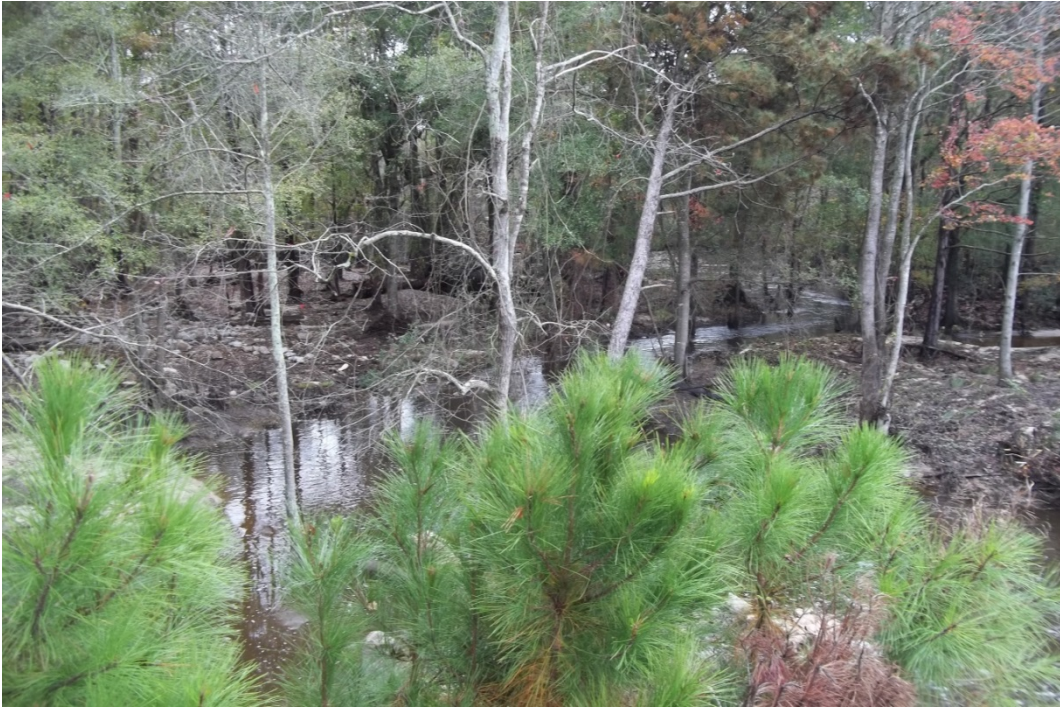
Photo 4: Looking downstream from top of dam.

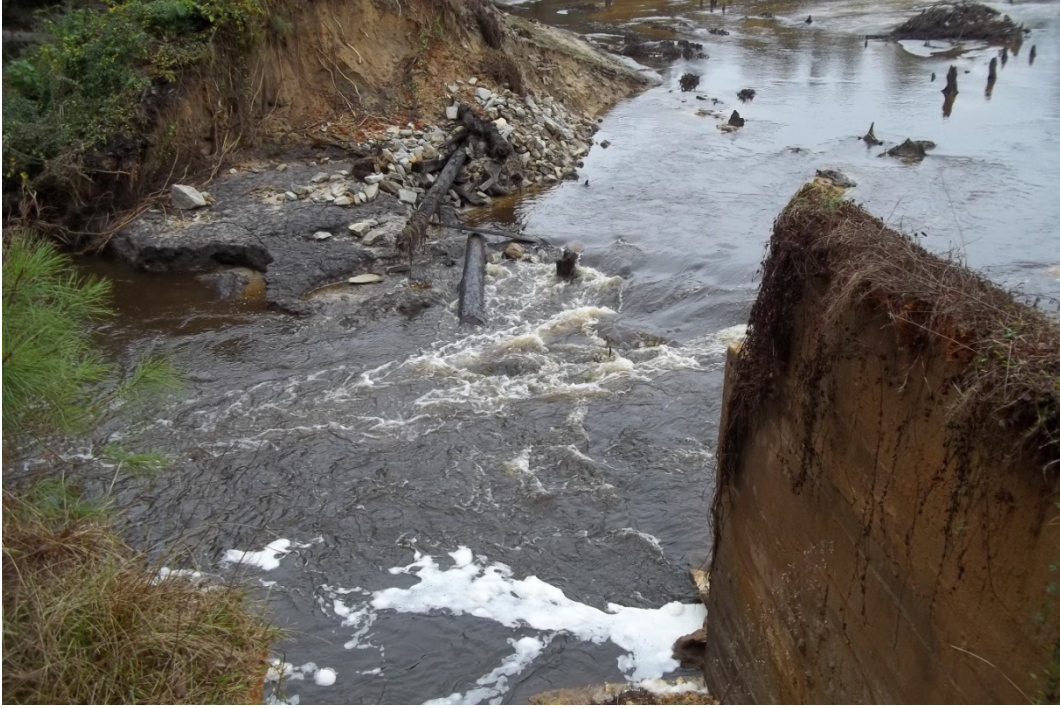
Photo 5: Looking at breach at right abutment.

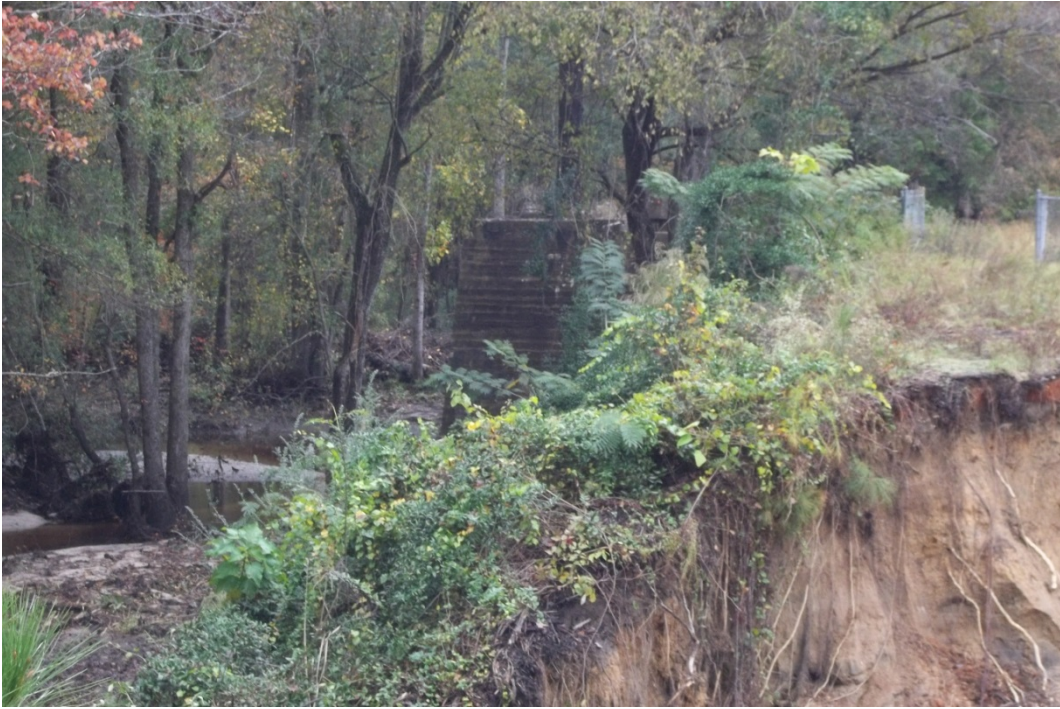
**Service Spillways** – The service spillways for Lexington Old Mill Pond and Gibson’s Pond dams appeared to be intact and operational. The left gated concrete outlet structure at Barr Lake Dam had failed, and the right gated concrete outlet structure could not be observed due to access limitations.

Photo 6: 28-foot concrete gate structure.

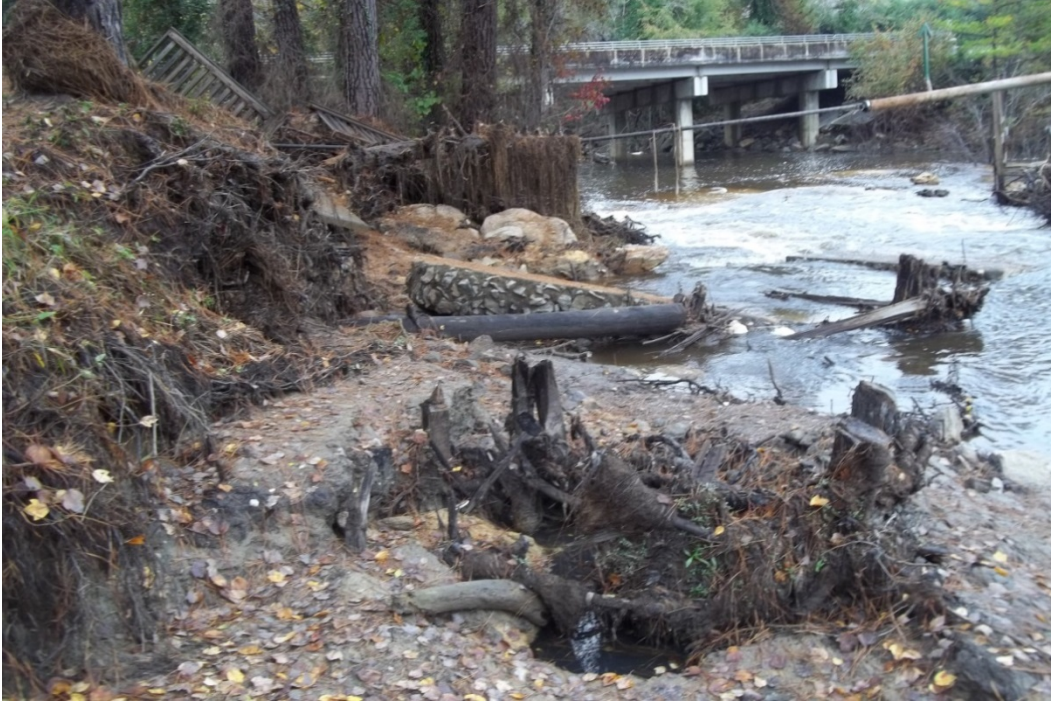
Photo 1: Left abutment looking downstream.

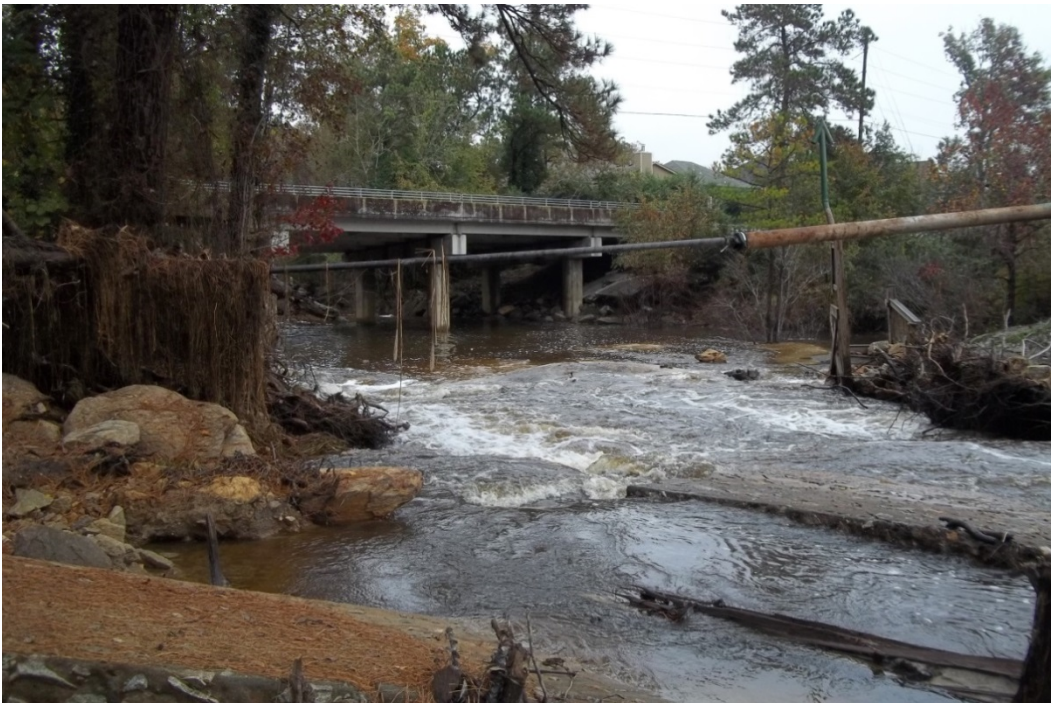
Photo 2: View from approximate dam centerline looking downstream.

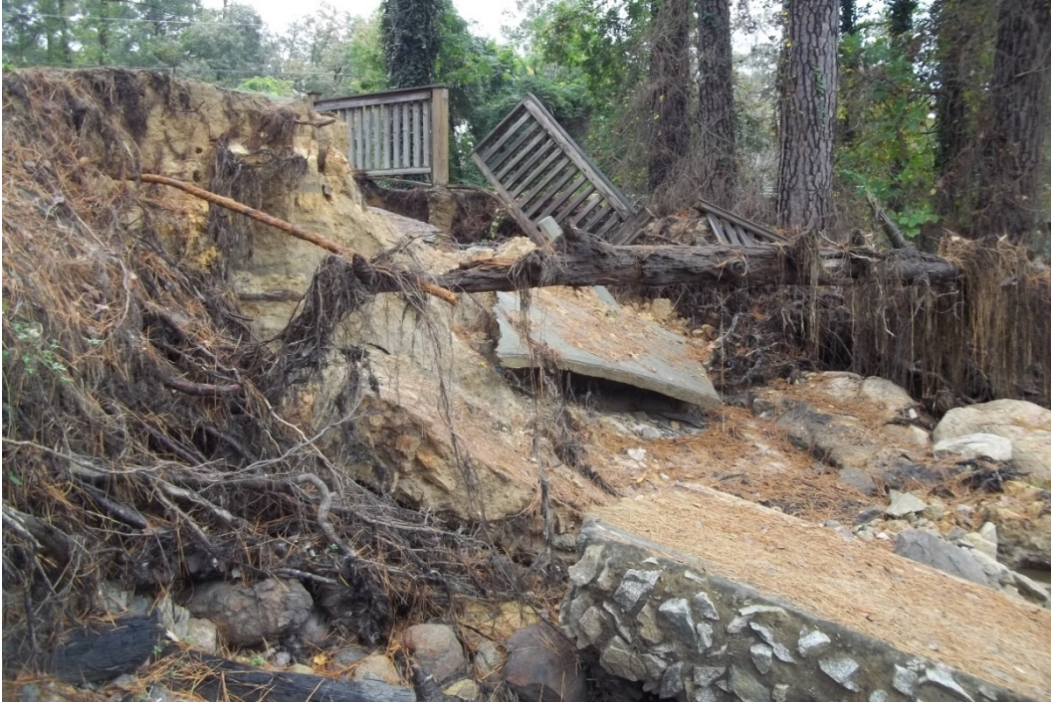
Photo 3: Remnants of wood walkway on left abutment.

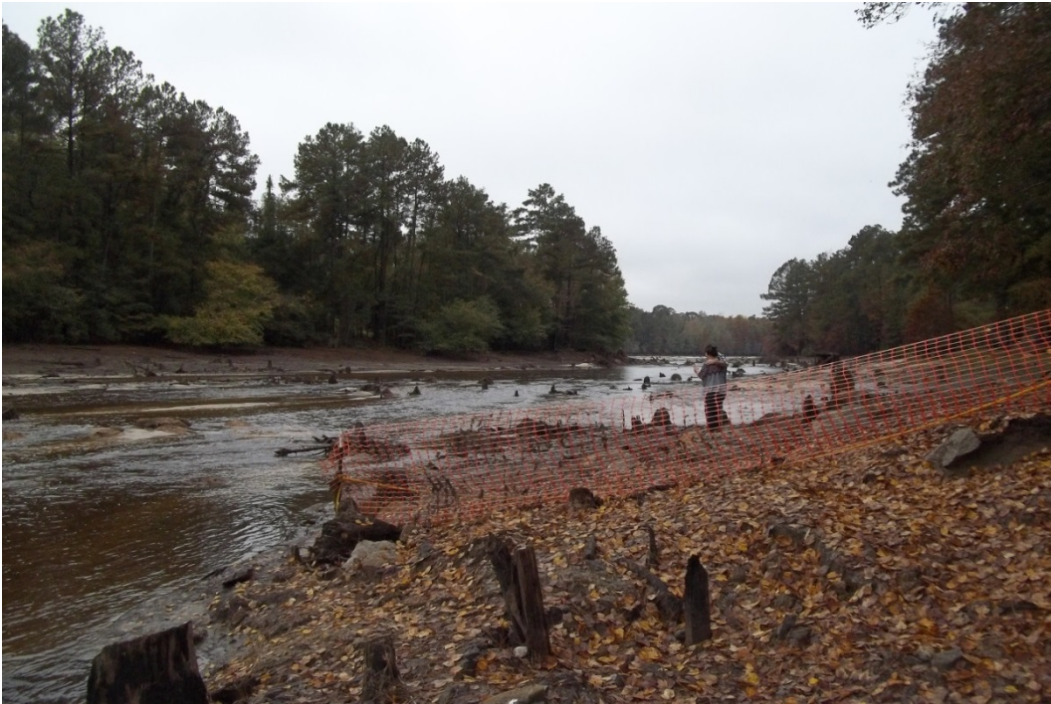
Photo 4: View from left abutment looking upstream.

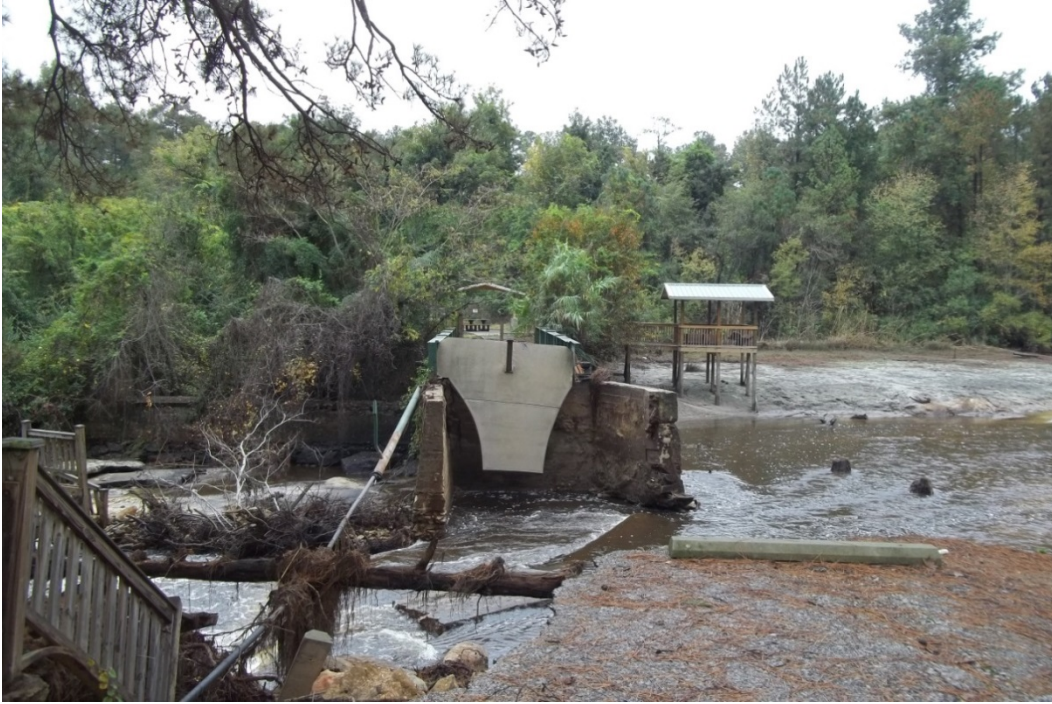
Photo 5: View from left abutment along centerline of dam.

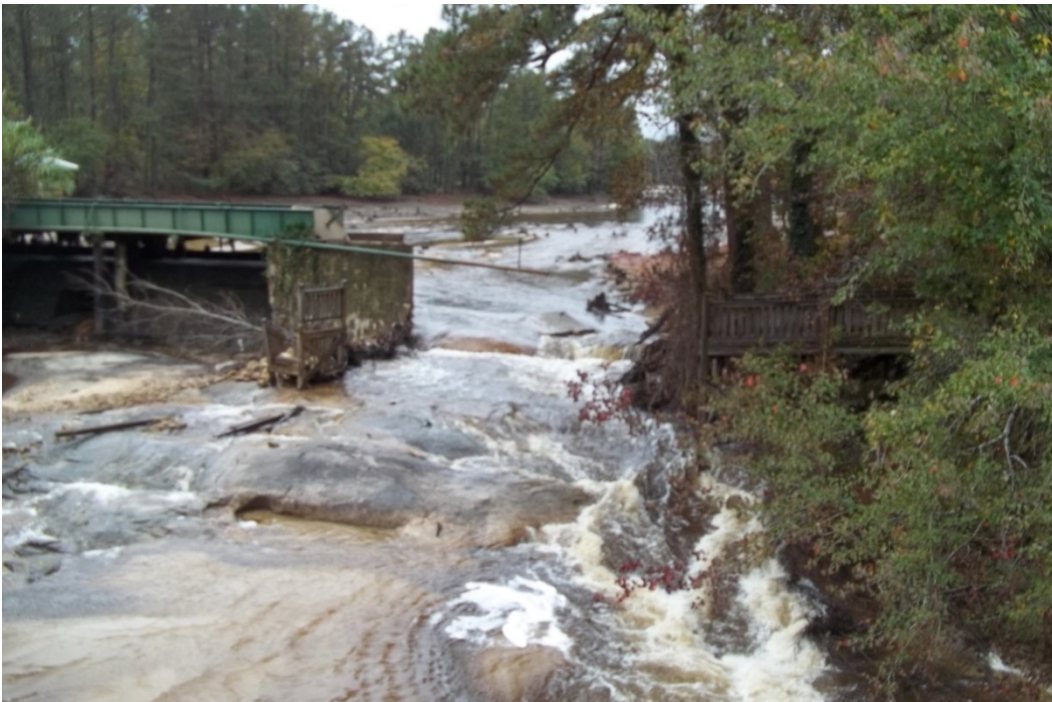
Photo 6: Looking from Gibson Road Bridge at left abutment.

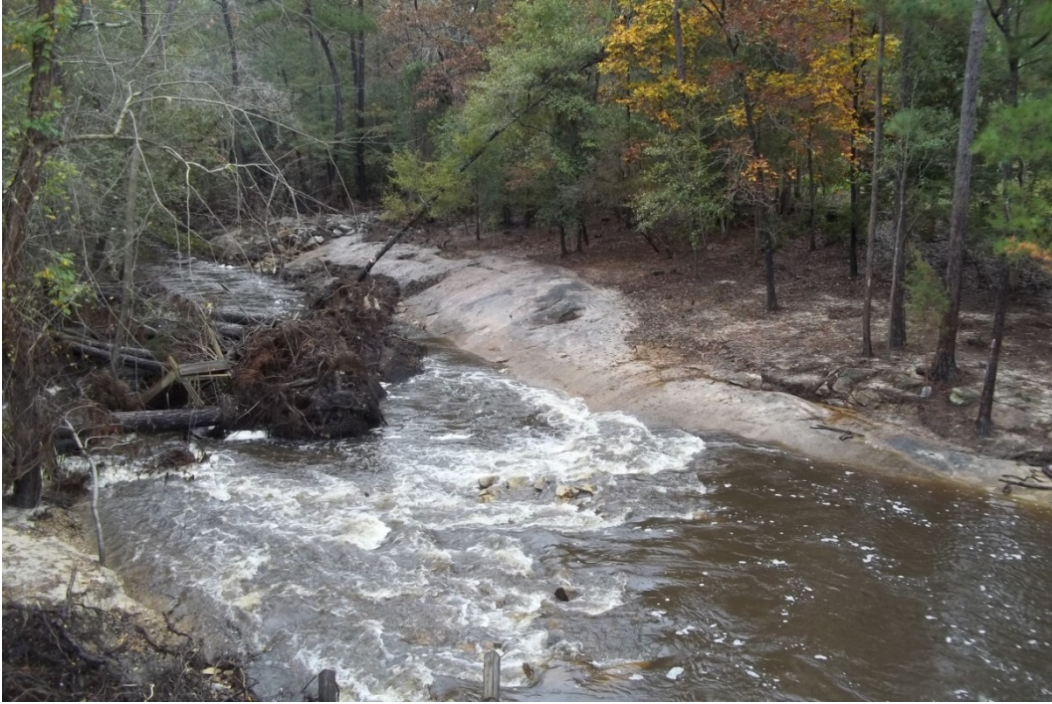
Photo 7: View from Gibson Road Bridge looking downstream.

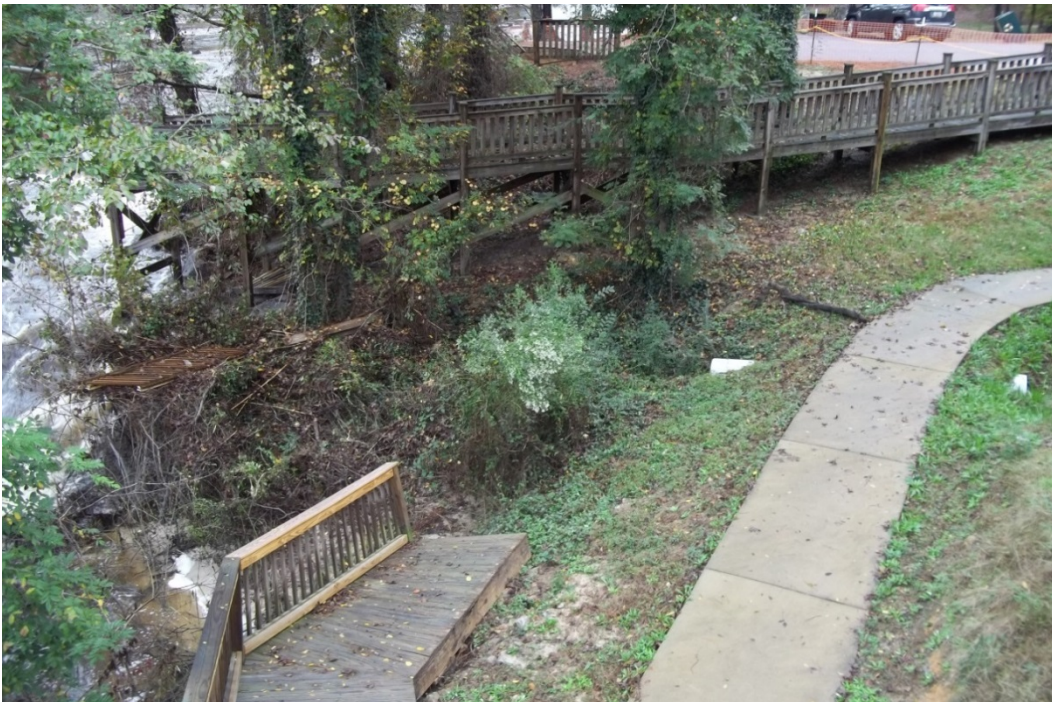
Photo 8: Wooden observation deck piers and walkway on left abutment.

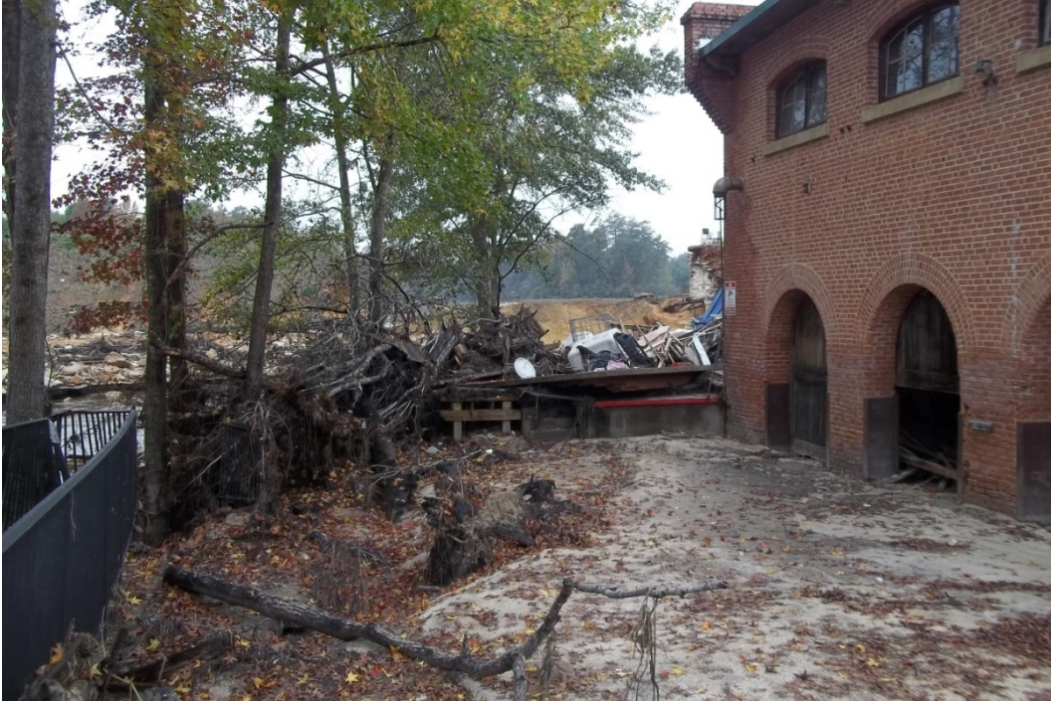
Photo 1: View shows left downstream abutment debris.

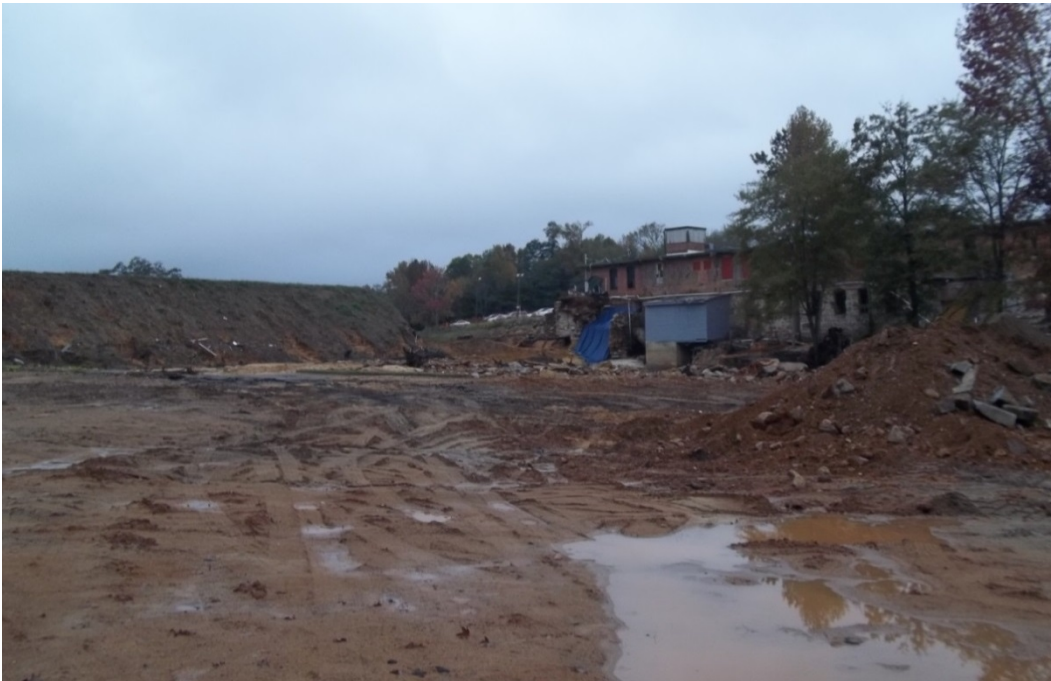
Photo 2: View is looking at downstream face of dam left abutment.

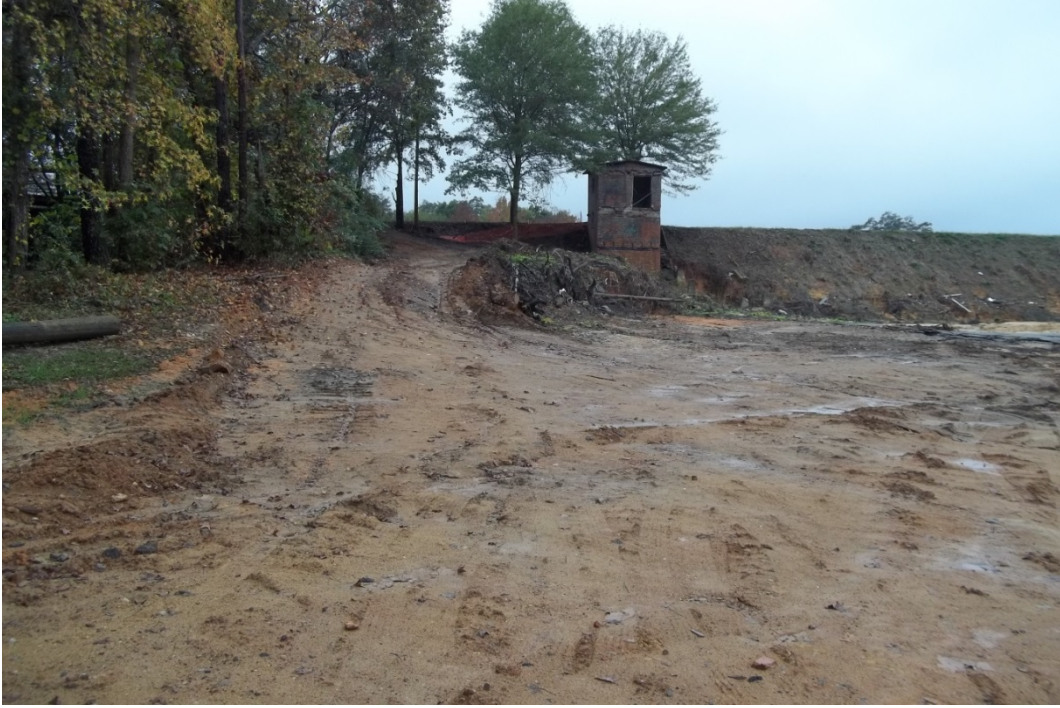
Photo 3: View shows downstream face of right abutment

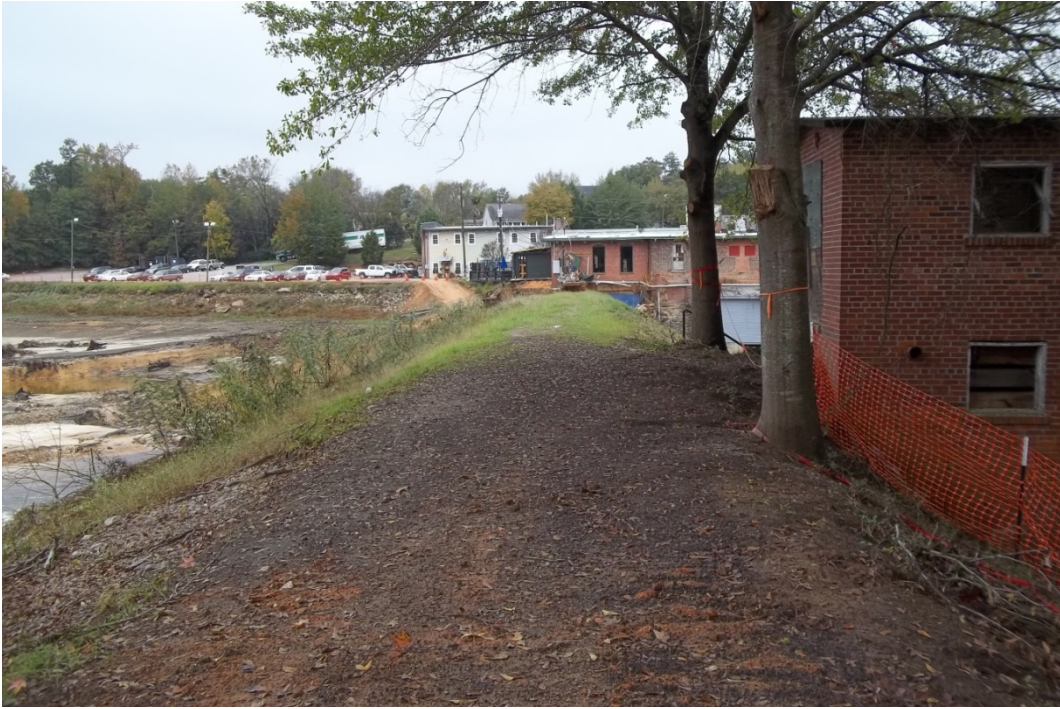
Photo 4: View is from top of dam looking at left abutment.

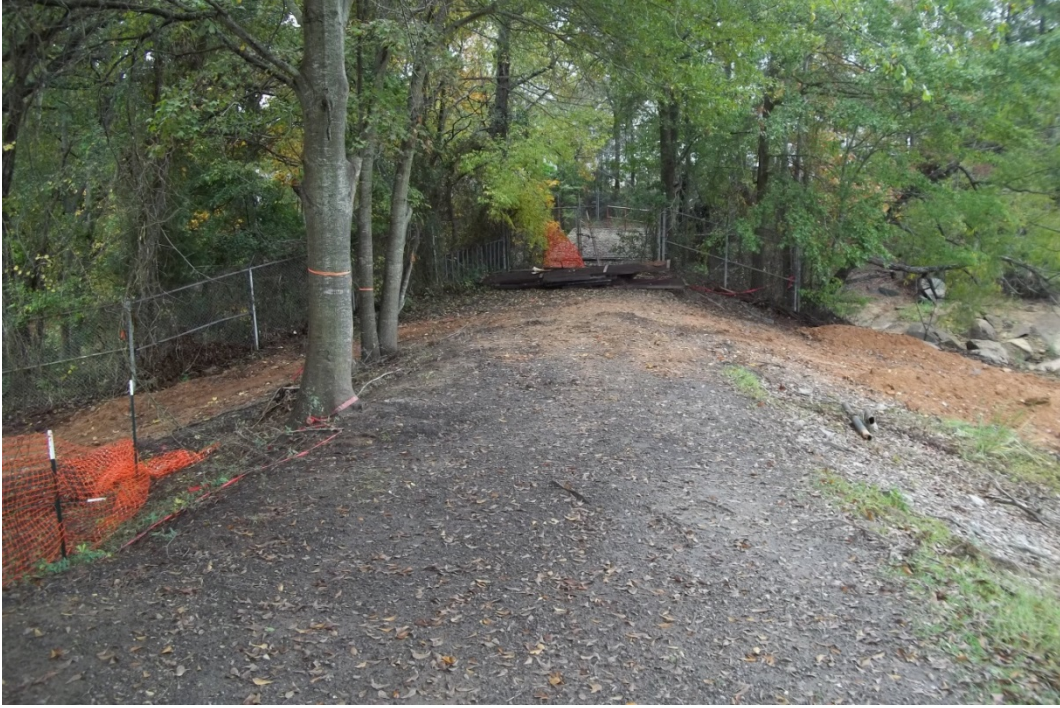
Photo 5: View is from top of dam looking at right abutment.

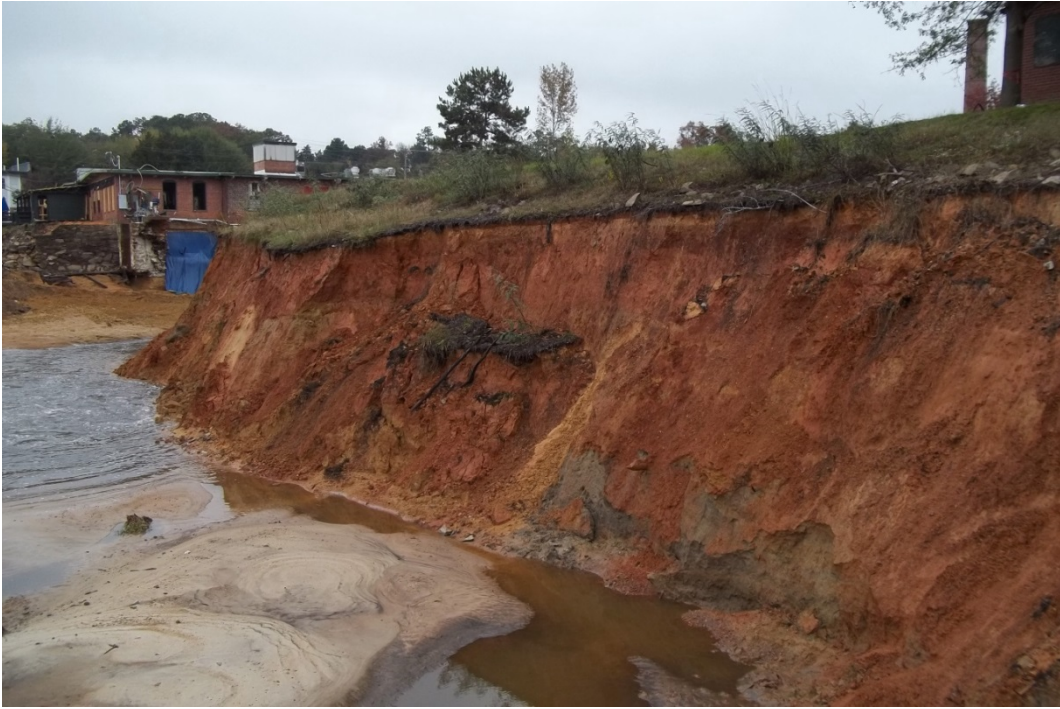
Photo 6: View is looking at upstream face of dam.

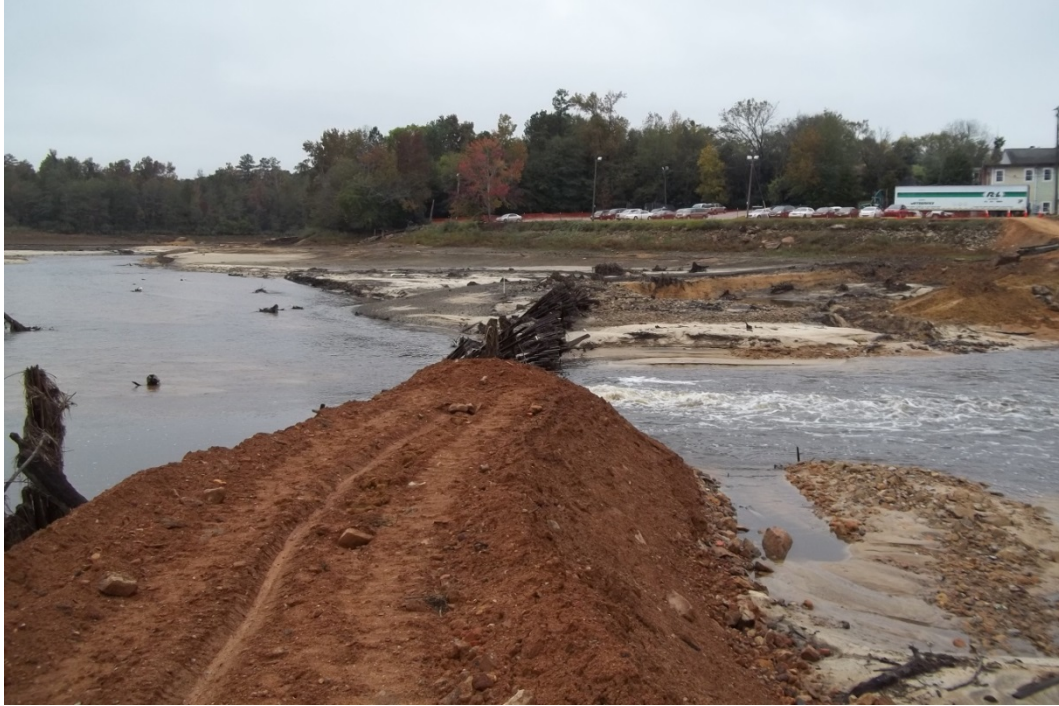
Photo 7: View showing newly placed earthfill and old timber cribbing upstream of the dam breach as viewed from the right abutment.

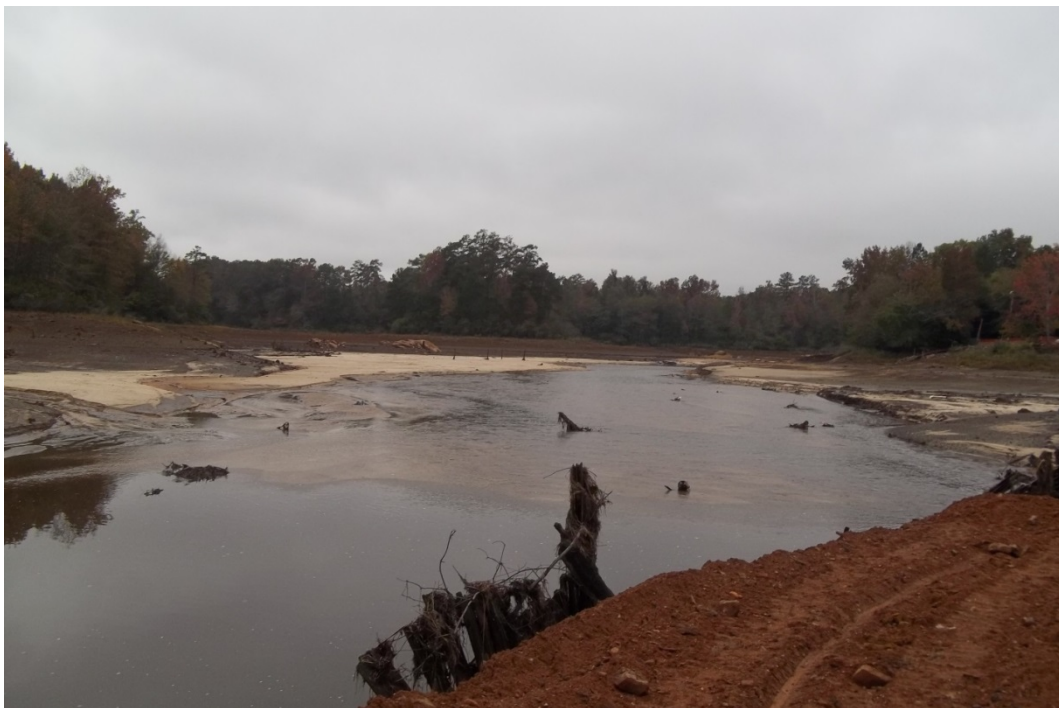
Photo 8: View is looking upstream.

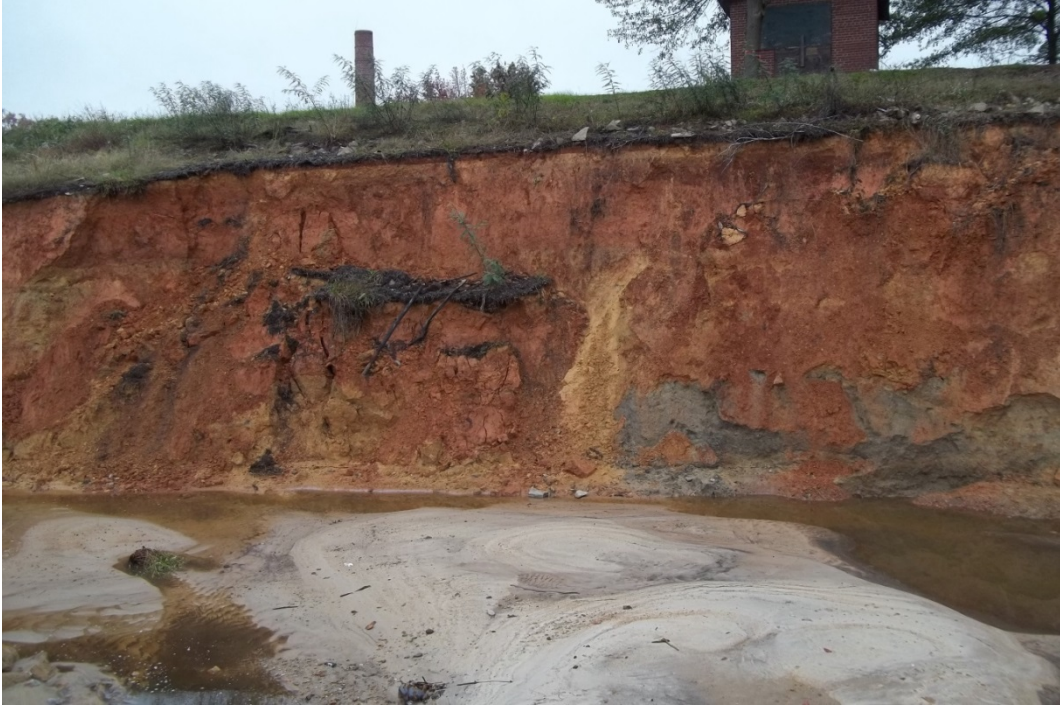
Photo 9: View is looking at upstream face of dam.

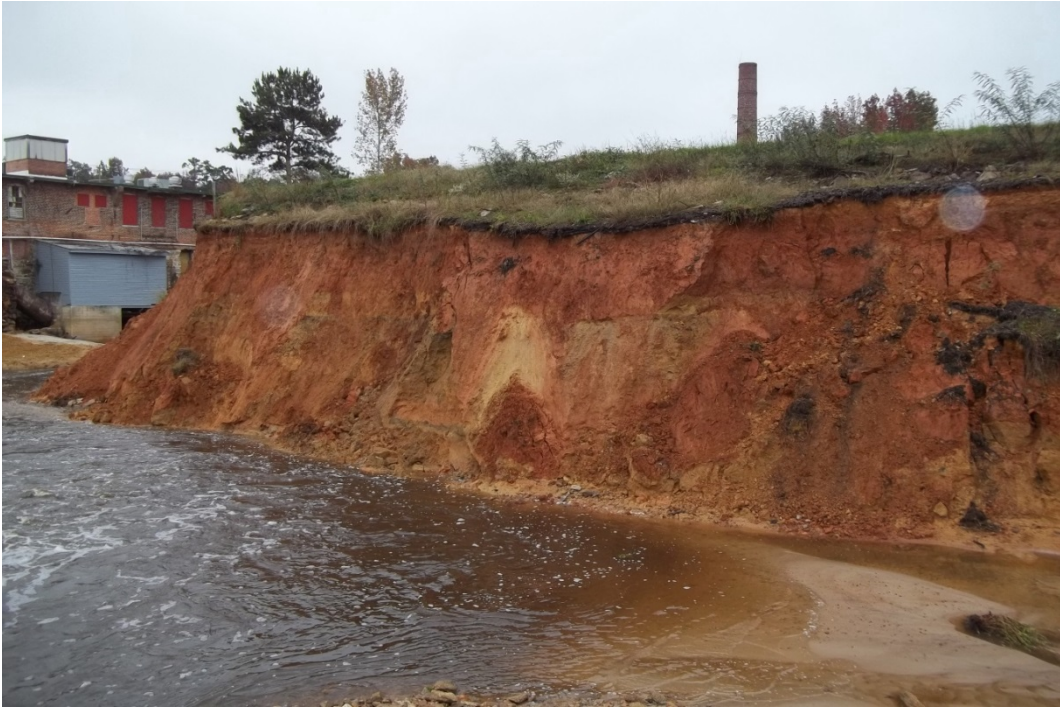
Photo 10: View is looking at upstream face of dam.

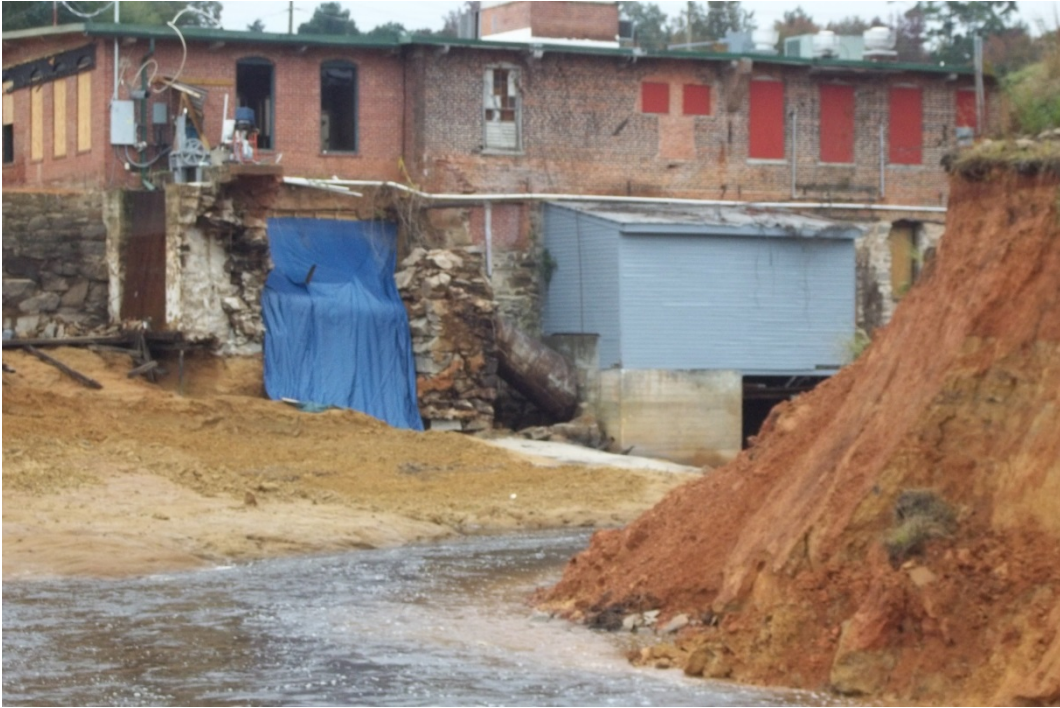
Photo 11: View is looking at penstock pipe.

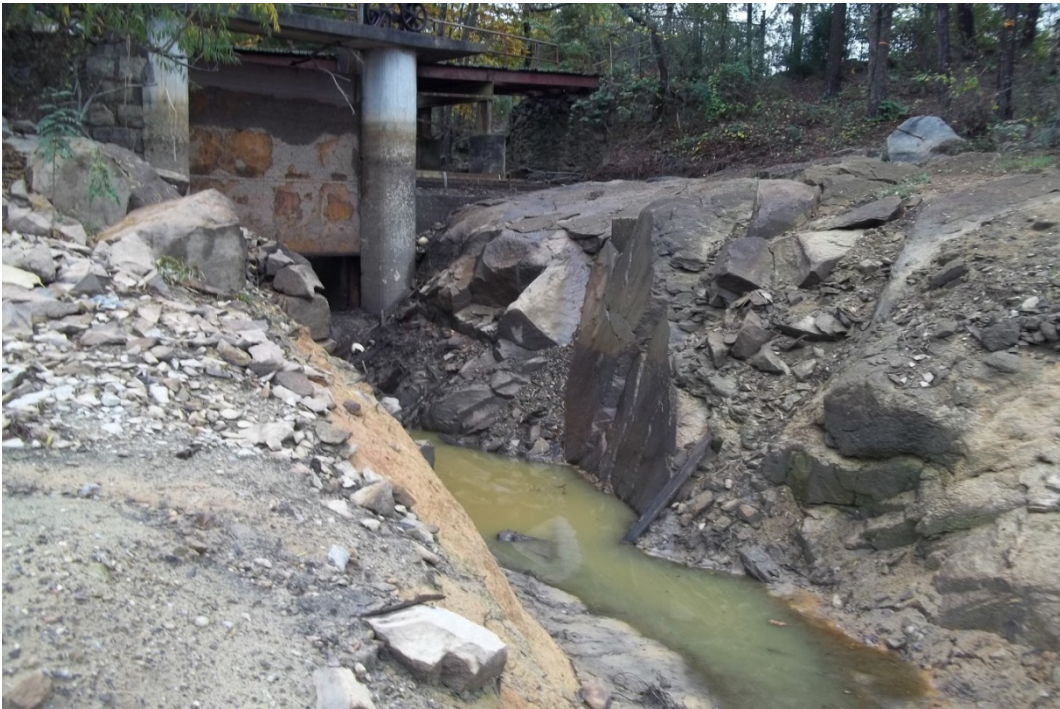
Photo 12: View shows the mill race bypass channel.

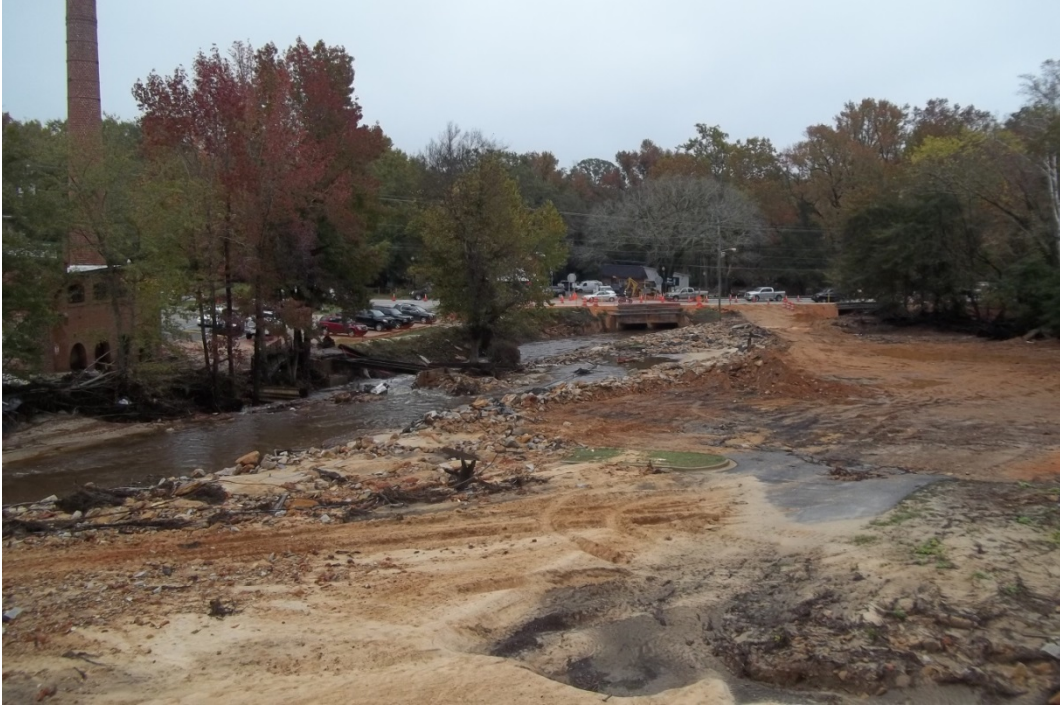
Photo 13: View is from standing on right abutment looking downstream.
