## Twelve Mile Creek Watershed: Assessment of Regulated Dams

April 1, 2016

**PROJECT NAME:** High Level Hydrologic and Hydraulic Overview Model Report for  
Three Regulated Dams on 12 Mile Creek Watershed

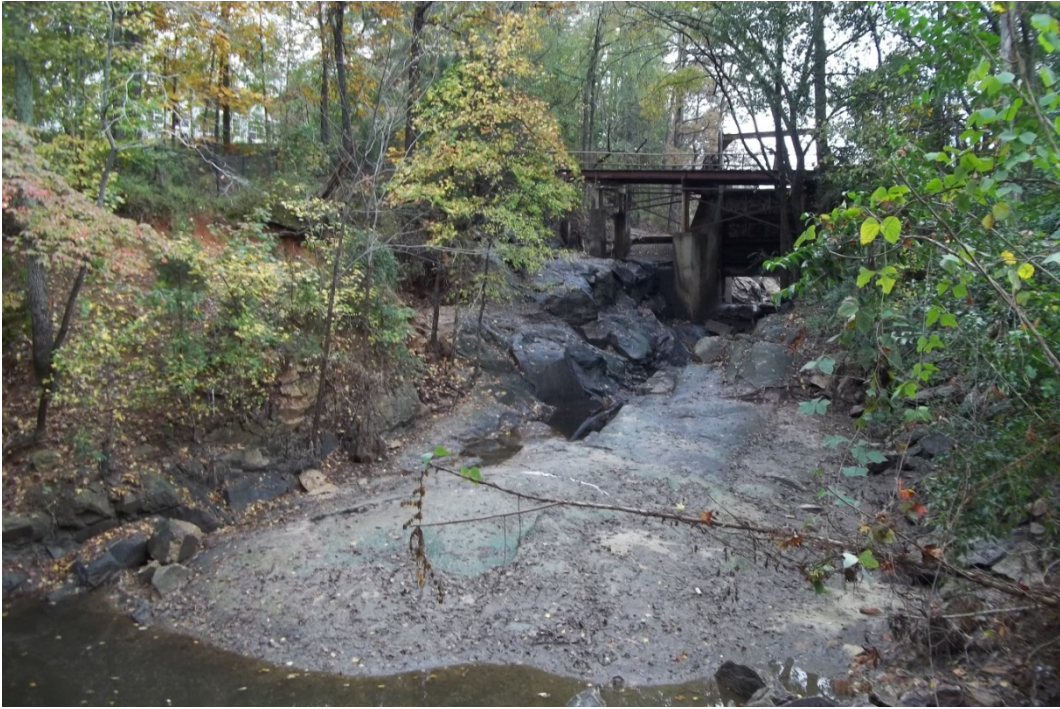
Photo 14: View is looking at downstream face of mill race bypass channel.

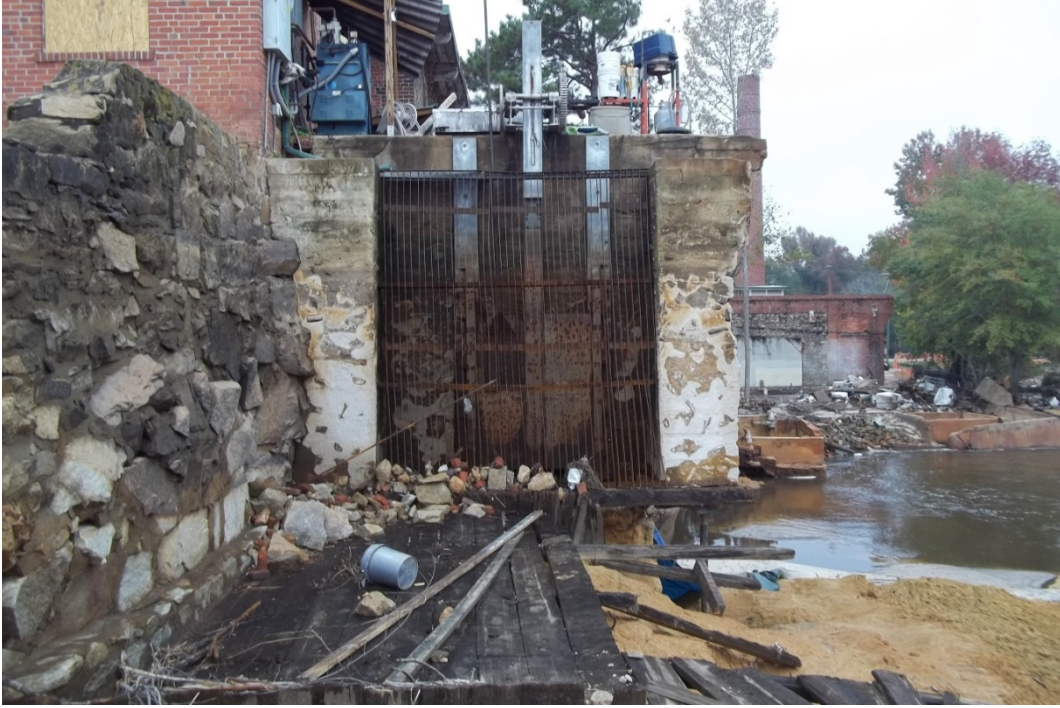
Photo 15: View is at left abutment sluice gate looking downstream.

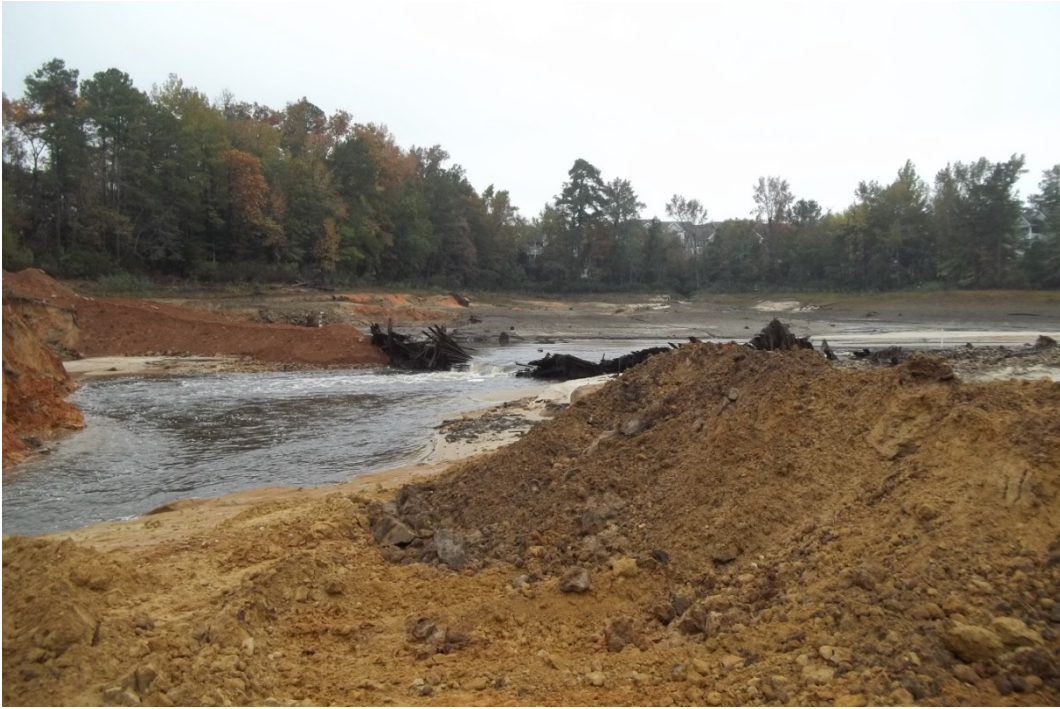
Photo 16: View is looking upstream from left abutment.

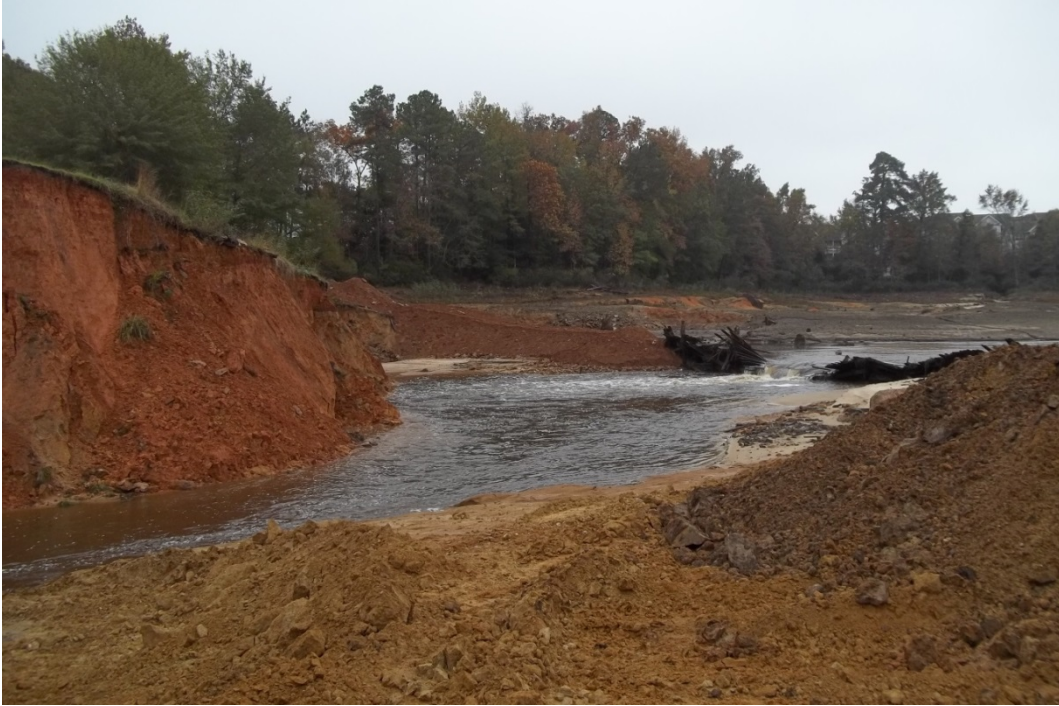
**Lexington Old Mill Pond (D 0958):** The embankment was completely breached, with an opening approximately 150 feet wide exposing the Old Mill Building foundation. Significant base flow discharge is flowing through the breach. At the time of the site visit, there continued to be some active erosion at the toe of the remaining embankment as the stream flow caused eddies. The erosion at the toe appears to result in additional sloughs in the upstream face of the remaining embankment. This dam is considered to be of moderate concern due to the continued active erosion and the undermining of the old mill building foundation.

Photo 17: View is at upstream face of dam breach viewed from left abutment.

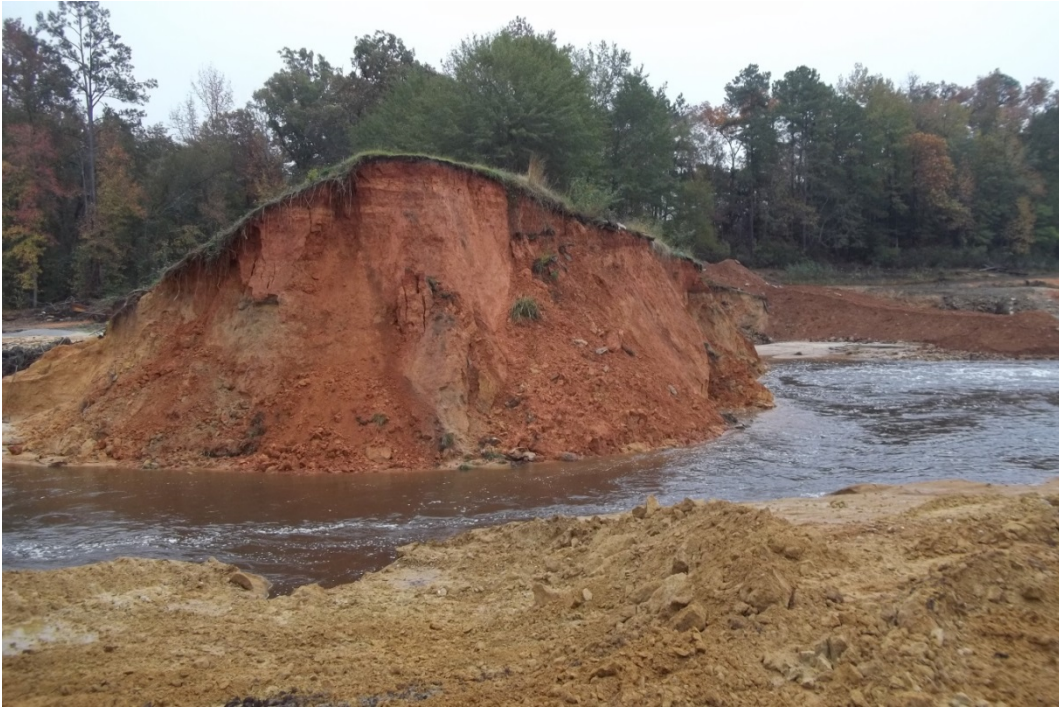
Photo 18: View is looking at dam breach from left abutment.

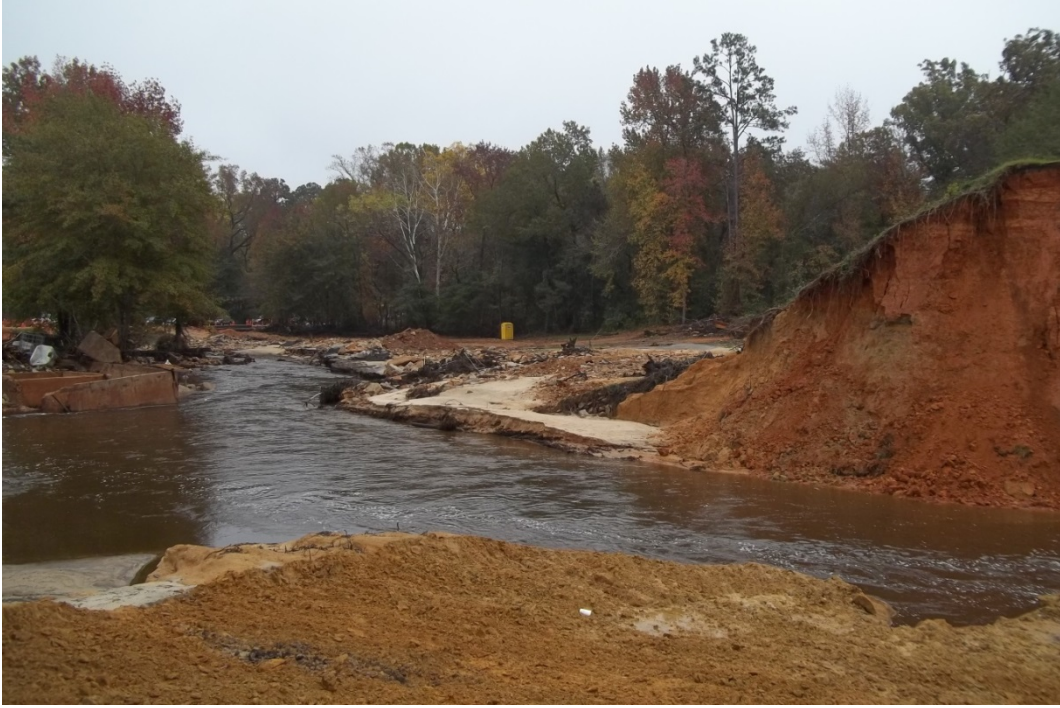
Photo 19: View is looking downstream at dam breach.

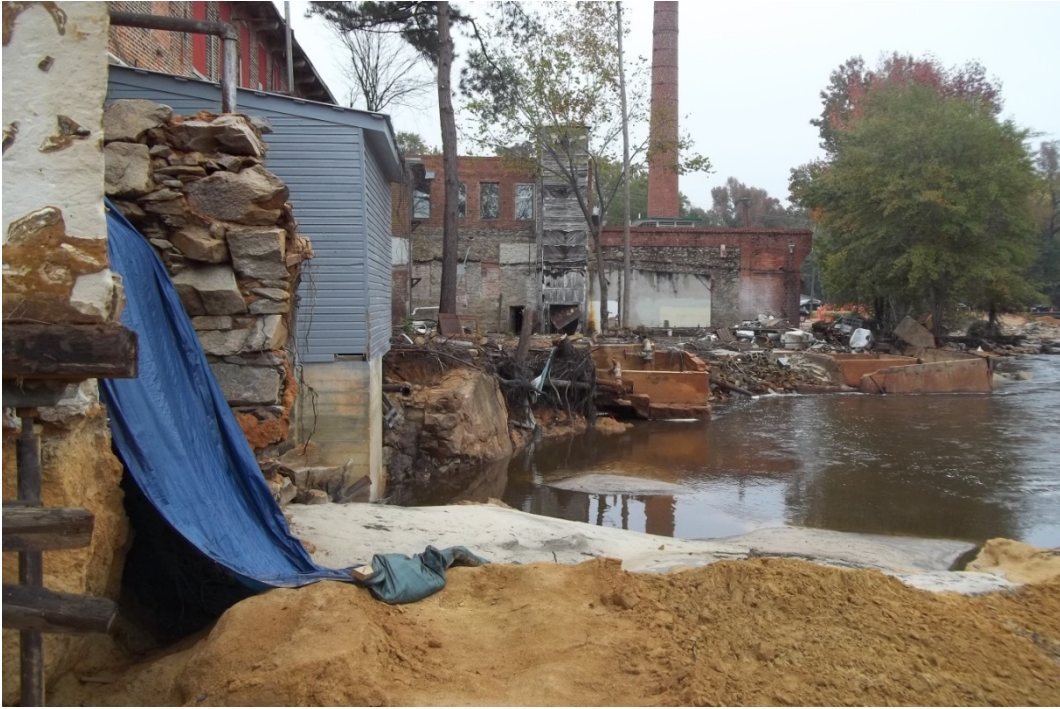
Photo 20: View is looking downstream at dam breach.
