# COVINGTON MILLPOND DAM : D3453

Dams Preliminary Inspection Form

Inspector: Charles Owens

Start Date: 09/28/2018      Completed Date: 10/01/2018

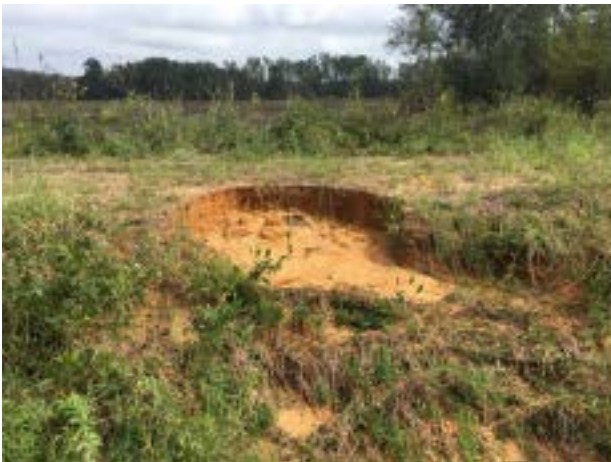
6. Horizontal Alignment	
7. Settlement	
8. Sinkhole	
9. Erosion	Action Required
<p>Several eroded areas were noted on the crest due to overtopping of the dam.</p> <div style="display: flex; align-items: flex-start;">

11. Other:	
12. Embankment: Crest Condition	Needs Maintenance, Needs Permitted Repair(s)
<p><b>Violation Determined: 9/28/2018</b>  <b>DAMMAINTREP</b></p>

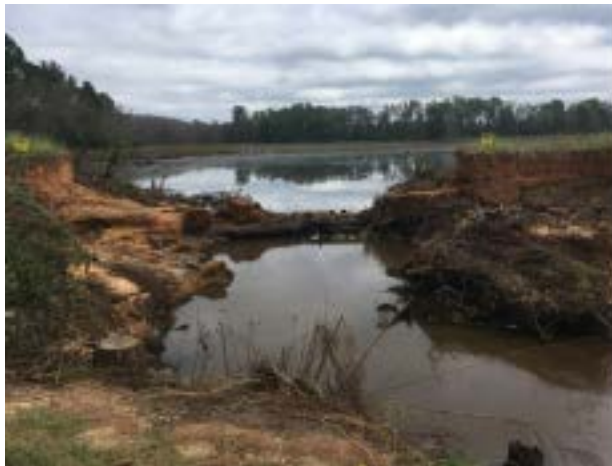
Dam was breached approximately 150 to the right of the primary spillways.

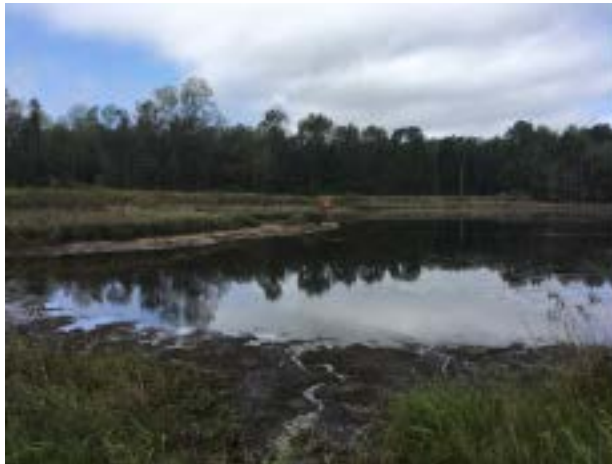
1. Grass Cover	Monitor
2. Deleterious Vegetation	Monitor
3. Trees	No Deficiency
4. Animal Activity	No Deficiency, Monitor
5. Surface Cracking	
6. Subsidence, Sinkhole	
7. Slide, Slough, Scarp	
8. Groins	
9. Erosion	Action Required
Dam was breached approximately 150 to the right of the primary spillways. Note: All Directions given are looking downstream.	
10a. Slope Protection/Armoring Present?	<input type="checkbox"/> Yes <input checked="" type="checkbox"/> No
10b. (If Present:) Slope Protection/Armoring	
11a. Alterations/Repairs Present?	<input type="checkbox"/> Yes <input checked="" type="checkbox"/> No
11b. (If Present:) Alterations/Repairs Condition	
12. Other:

<b>Embankment: Upstream Slope</b>	
13. <i>Embankment: Upstream Slope Condition</i>	Needs Maintenance
<div style="border: 1px solid black; padding: 5px;"> <b>Violation Determined: 9/28/2018</b>  <b>DAMMAINTREP</b> </div>

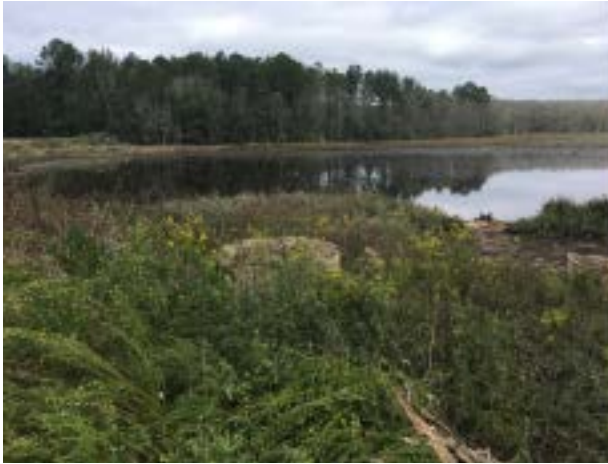
Trees were removed in 2017. The removed trees are located and placed along the right groin of the dam

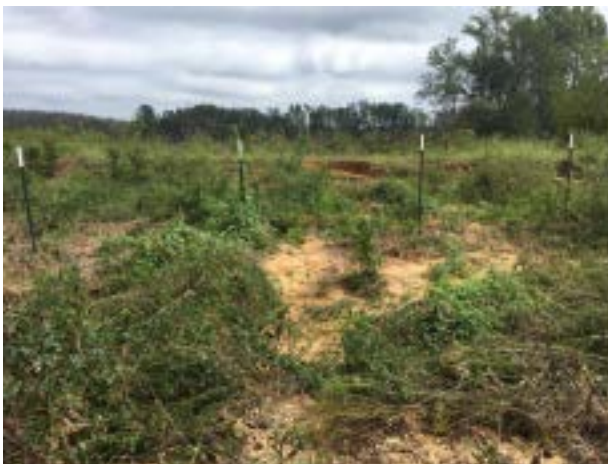
Overtopping and breach of the dam caused substantial erosion to the downstream slope and toe of the dam.

Dam breach occurred approximately 150 feet to the right of the primary spillways. Significant erosion was observed along the downstream slope and toe of the dam. Engage an engineer to develop a repair plan or a plan to decommission the dam if repairs are not going to be conducted.

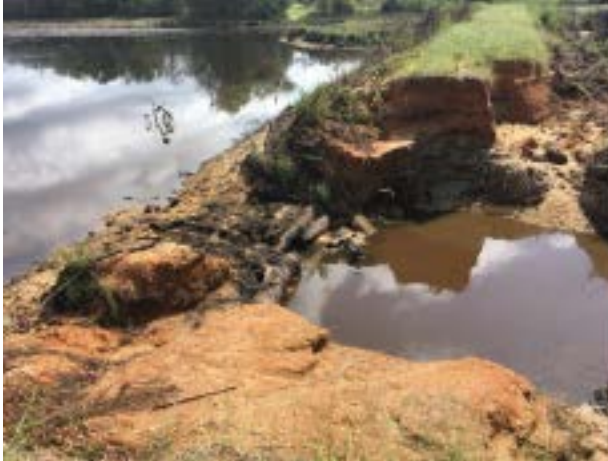
Standing water observed along the toe of the dam from the breach location to the bridge crossing

16. Embankment: Downstream Slope Condition Needs Permitted Repair(s)

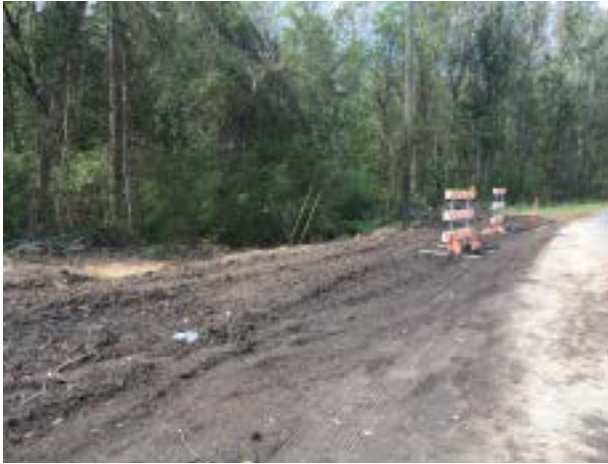
Road shoulder was repaired the week following Hurricane Florence by the local DOT. Road is open and the area beyond the road and bridge is primarily swampland.

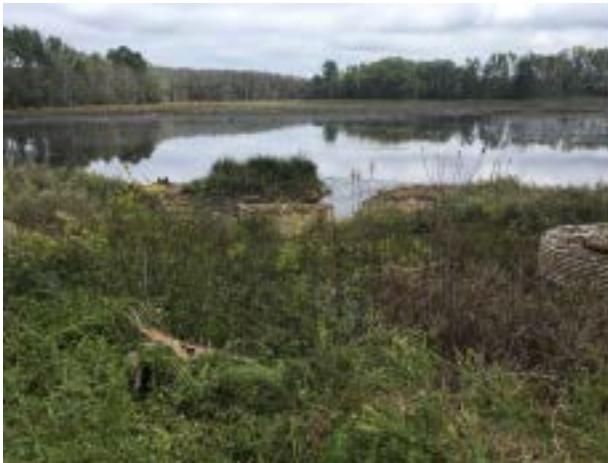
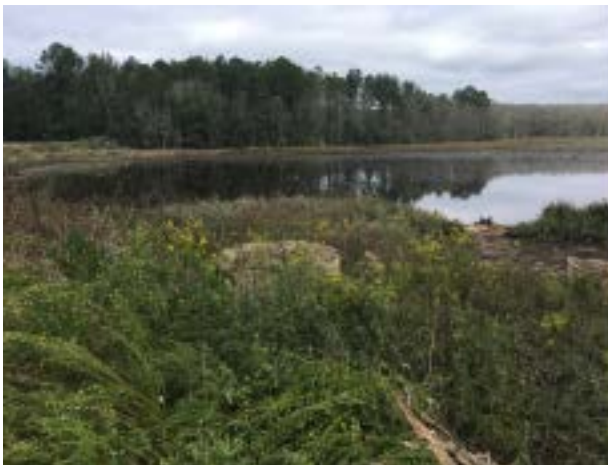
There are two 96" diameter aluminum risers with 60 inch culverts through the dam. One half round 96" riser with control boards is also present. At the time of the inspection, all boards were removed and flow was present only through the half round structure.

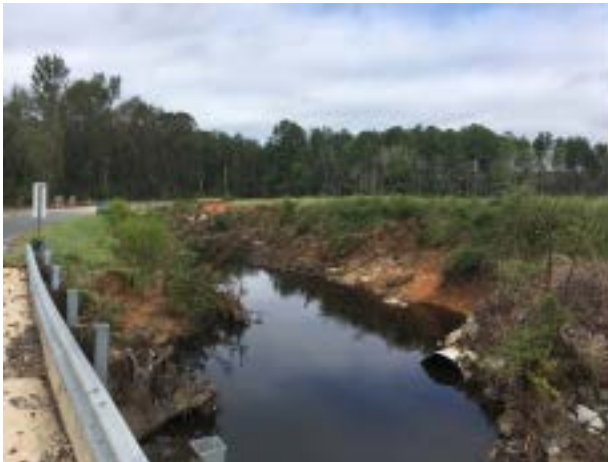
The majority of the outlet pipes were submerged in the plunge pool at the bridge crossing

Eroded areas were observed along the side slopes of the plunge pool
