Preliminary Inspection Report for South Carolina Regulated Dams and Impoundment Structures Regulations R.72-1 through R.72-9

A. Dam Number: D 2085 & Hazard Class 2 B. Name of Dam: Anthony Lake Dam
C. Inspection Date (11/14/2012) & Time: 1330 D. Date of Last Inspection: (07/10/2007)
E. Location-County/City: Taylors / Greenville F. EQC Regional Office: Greenville
G. Inspector's Name: John Cobb
H. Owner's Name: Richard Penoyer
I. Contact Person (if different from above):
J. Dam Owner's or Contact Person's Phone Numbers: Home () Office () Other ()
K. Dam Owner's or Contact Person's mailing address:
Address 1 1013 Camp Creek Rd
Address 2 (optional)
City Taylors State SC Zip Code 29187

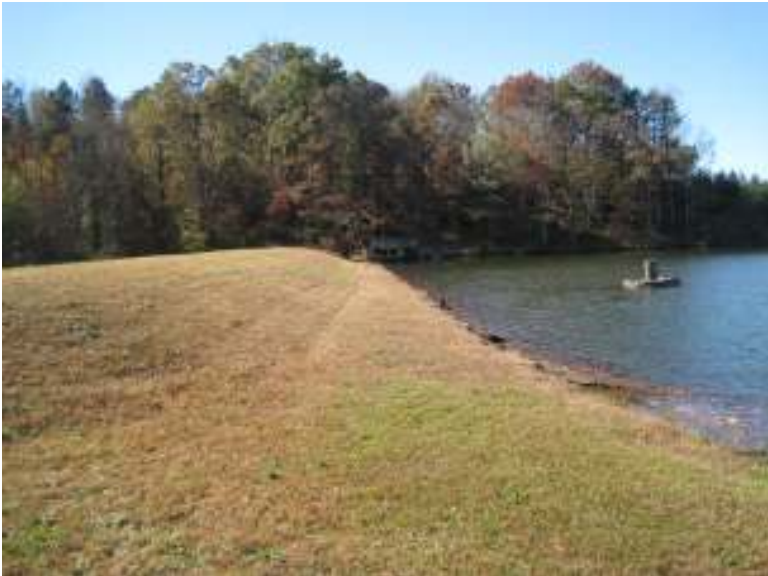
Upstream slope of dam

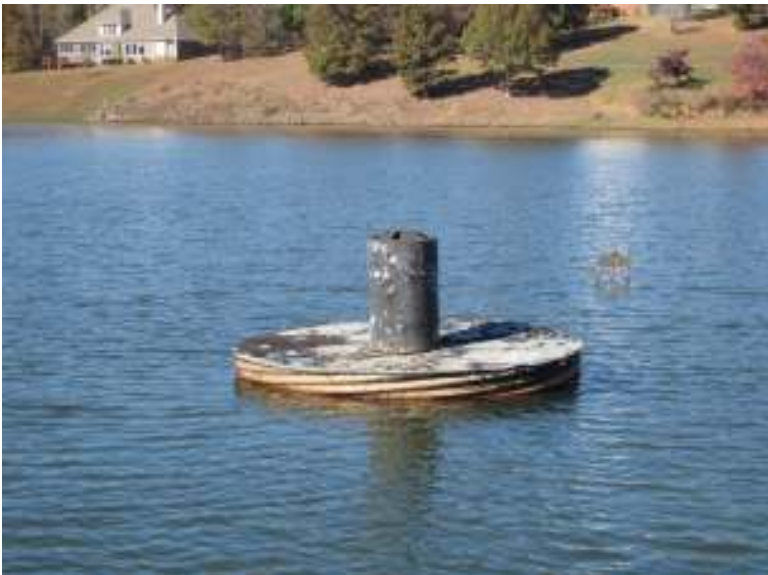
Outlet pipe with trash rack

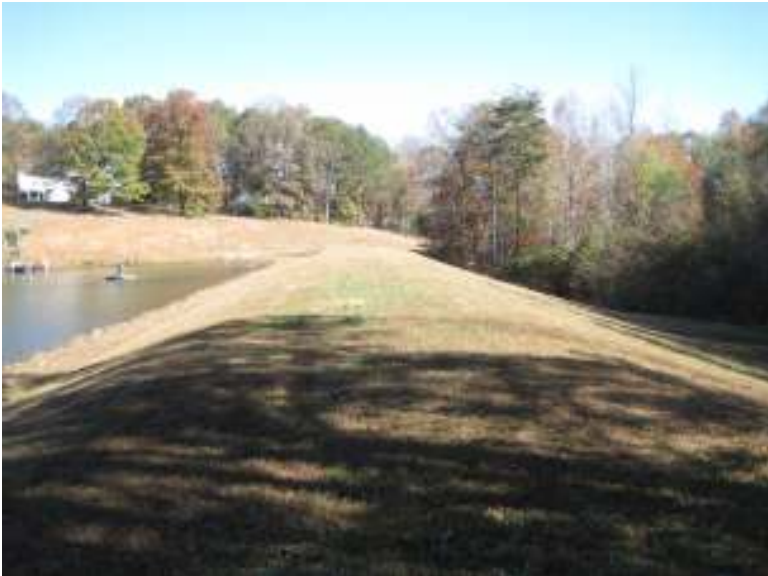
Crest of dam

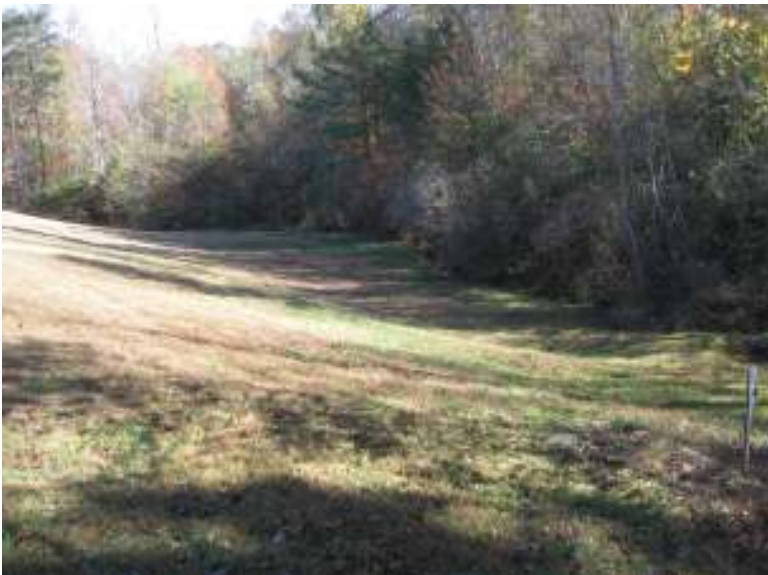
Down stream slope of dam

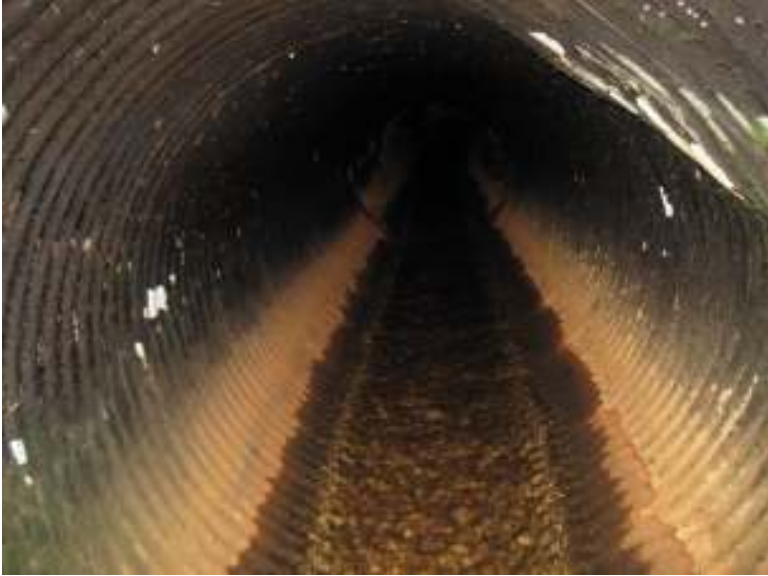
Inside of discharge pipe

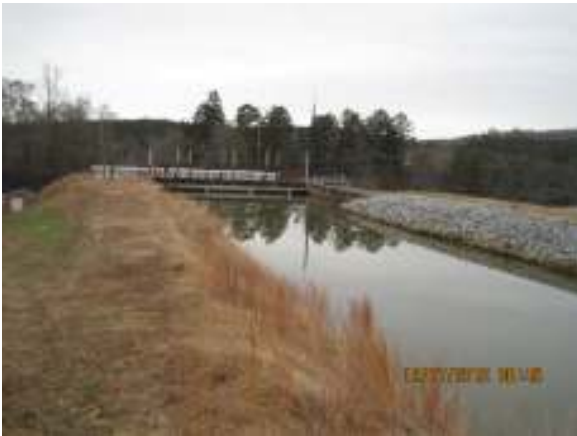
channel leading to power house

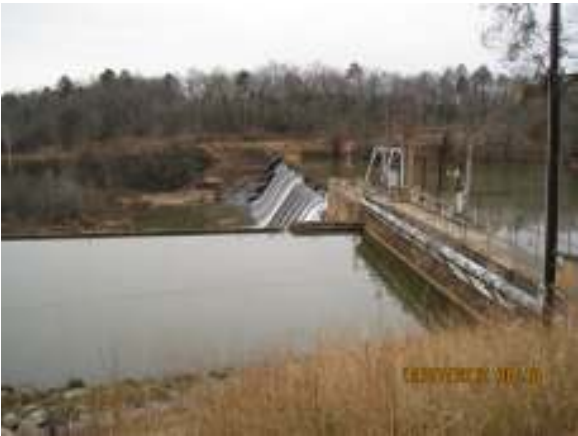
channel leading to power house

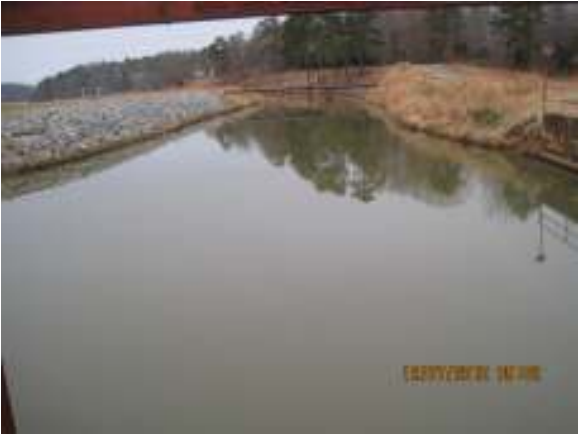
channel leading to power house

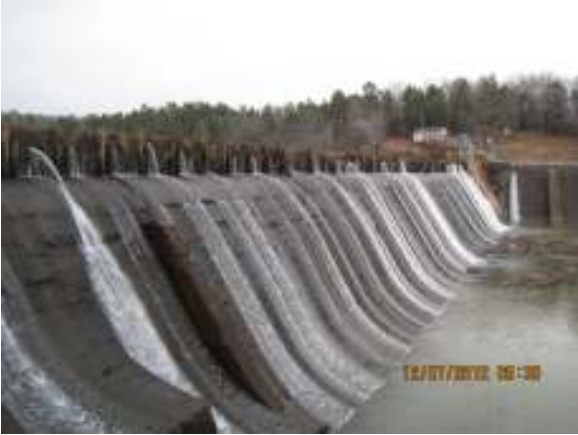
flashboards and downstream slope of dam

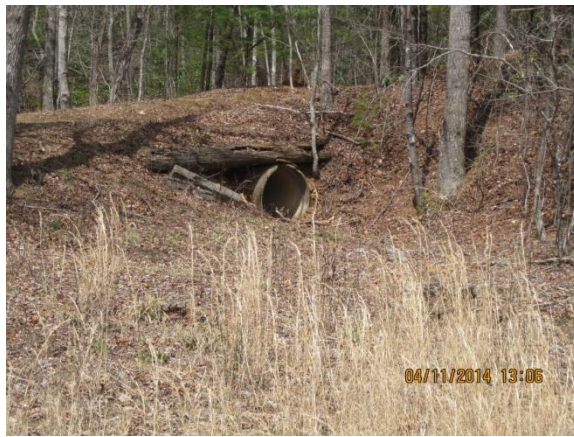
Large concrete pipe for emergency spillway

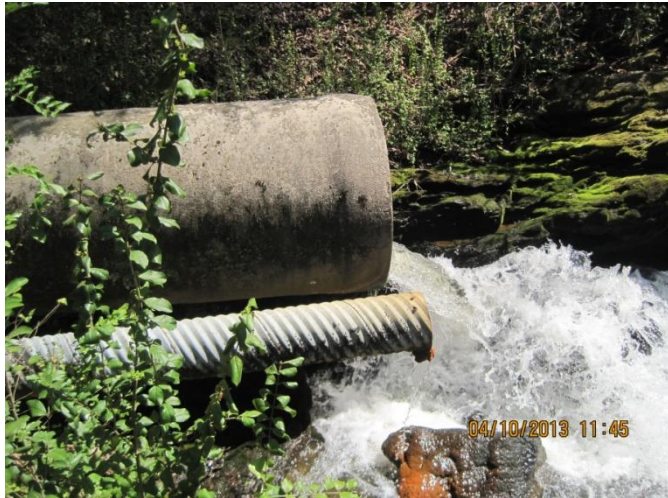
Toe drain and main outlet pipe

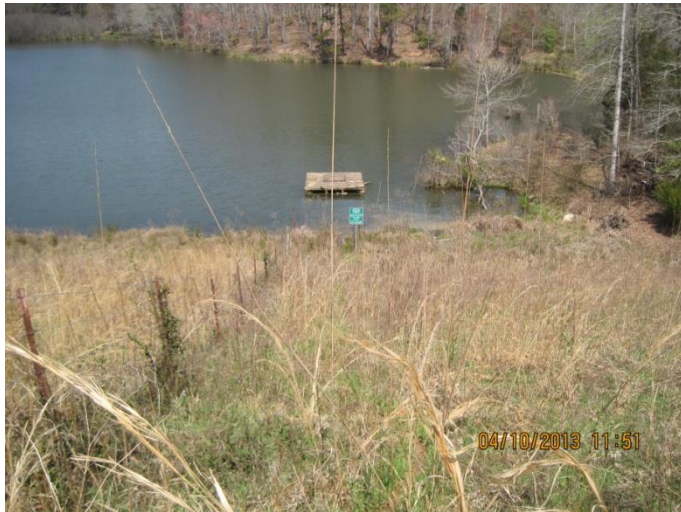
Upstream slope of dam

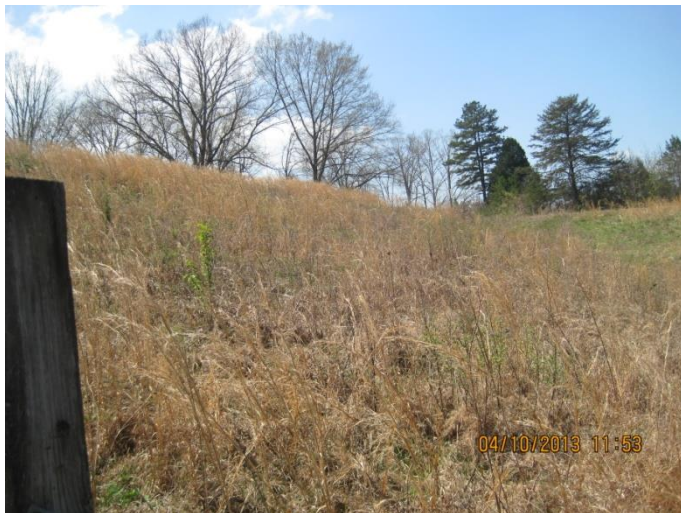
Upstream slope of dam

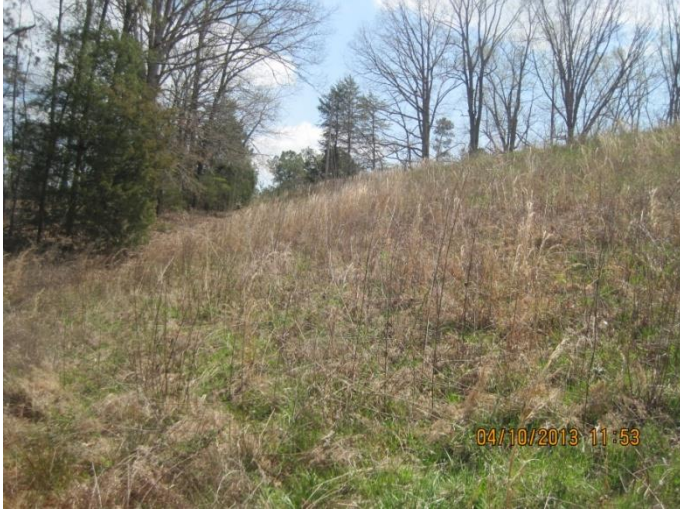
Upstream slope of dam

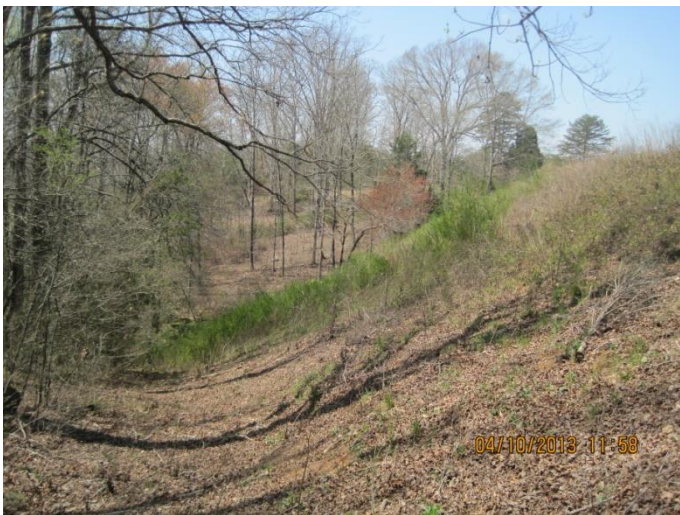
Downstream slope of dam
