## Twelve Mile Creek Watershed: Assessment of Regulated Dams

April 1, 2016

**PROJECT NAME:** High Level Hydrologic and Hydraulic Overview Model Report for  
Three Regulated Dams on 12 Mile Creek Watershed

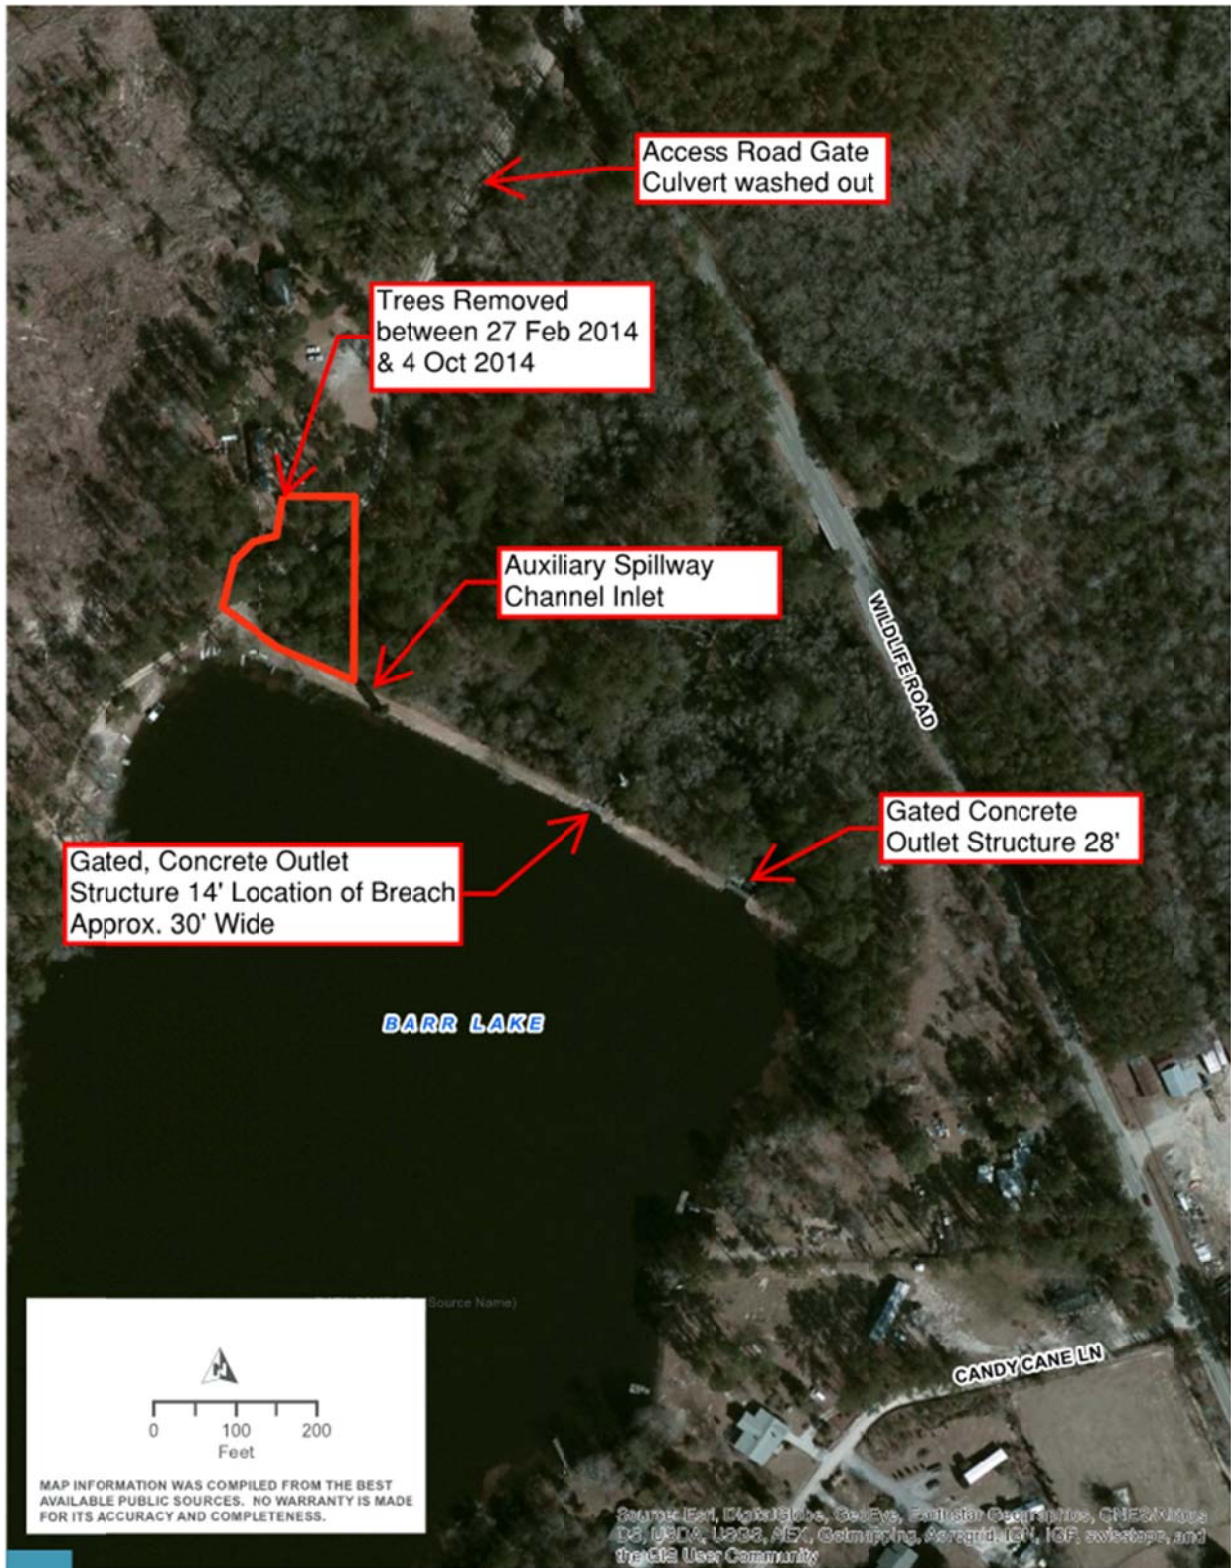
Attachment A: Aerial Photo

The left embankment section of the dam did not appear to be overtopped as no significant erosion, sloughs, or slope failures were observed. The crest is approximately 14 feet wide and vegetated with grass (Photo 1); no areas of significant depressions were observed. The upstream and downstream slopes of the left embankment are vegetated with grass, heavy underbrush, and with mature trees along the toe of the upstream and downstream slope (Photo 1). The downstream slopes of the center and right embankment are heavily vegetated with trees and underbrush (Attachment A: Aerial Photo). The upstream and downstream slopes are generally at 2H:1V, but vary.

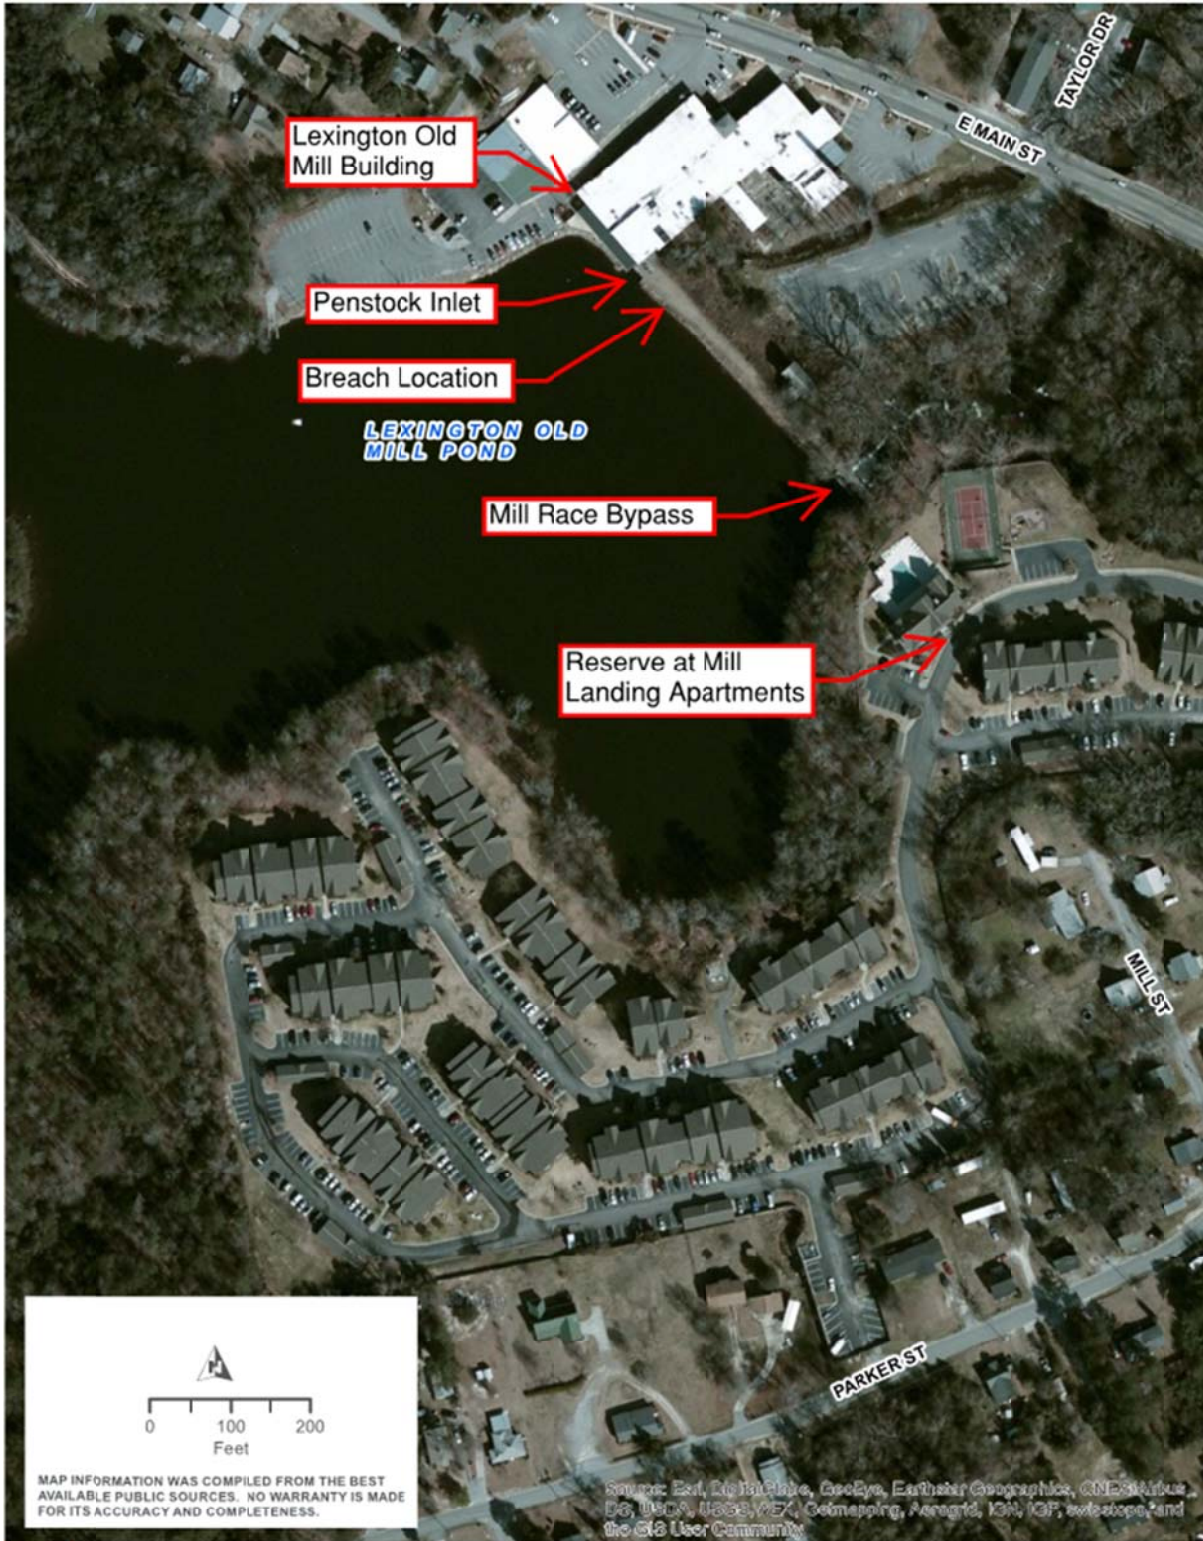
Attachment A: Aerial Photo

There were no indications of overtopping flow with only minor surface erosion apparent; no significant erosion, sloughs, or slope failures observed on the remaining portion of the downstream slope. There were remnants of pier footings from a previously removed building, last visible on GoogleEarth in a 2012 aerial photo. A brick building remains at that location on the downstream slope near the embankment crest (Photos 3 and 4). The crest is approximately 11 feet wide and partially vegetated with grass and two trees on the crest near the building (Photos 4 and 5); no areas of significant depressions were observed. The portion of the upstream slope that has not yet sloughed is about 2.8H:1V. The downstream slope is generally at 1.7H:1V and brush appears to have been recently mowed.
