# COVINGTON MILLPOND DAM : D3453

Dams Preliminary Inspection Form

Inspector: Charles Owens

Start Date: 09/28/2018      Completed Date: 10/01/2018

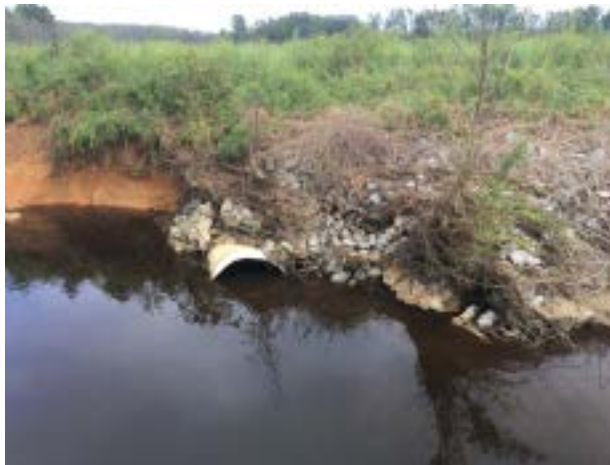
Photo Taken: 9/27/2018 11:36:05 AM  
GPS Latitude: 34.6073583333333  
GPS Longitude: -79.6312638888889  
GPS Altitude: 35.6602821276045 meters  
GPS Azimuth: 11.4051208423068 degrees

No Deficiency

2b. Outlet Structure Type

Pipe
