**Subject: Request for Modification of Product Recovery Activities  
Products (SE) Pipe Line Corporation (PPL)  
Lewis Drive Remediation Site  
Belton, South Carolina  
Site ID #18693, "Kinder Morgan Belton Pipeline Release"**

On behalf of Products (SE) Pipe Line Corporation (PPL), Jacobs has prepared this correspondence to request a modification to the product recovery activities currently conducted at the Lewis Drive Site in Belton, Anderson County, South Carolina (Site ID #18693).

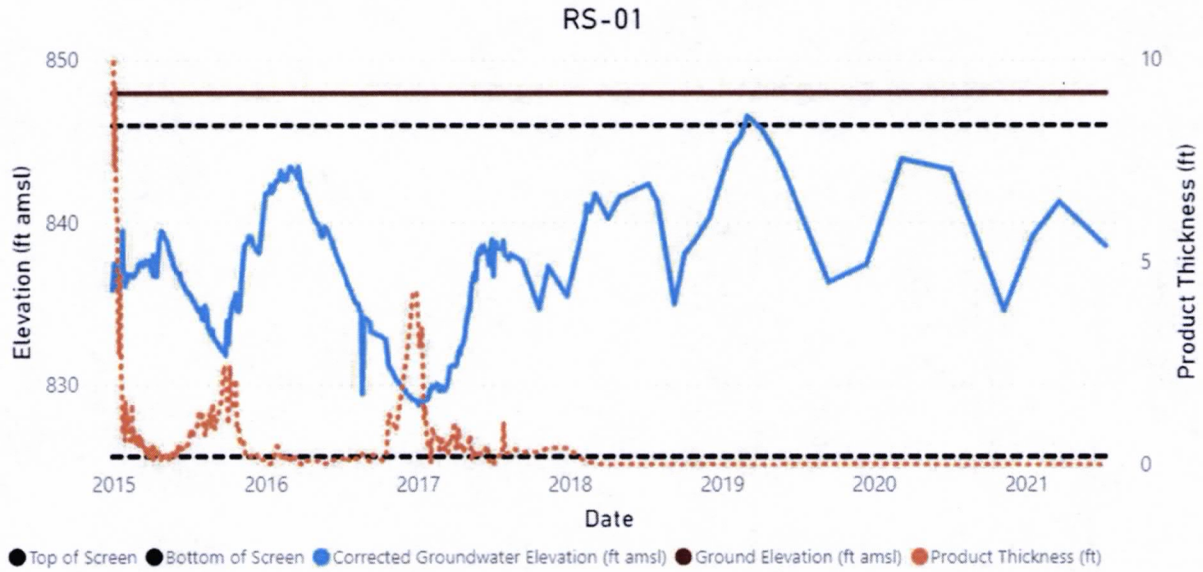
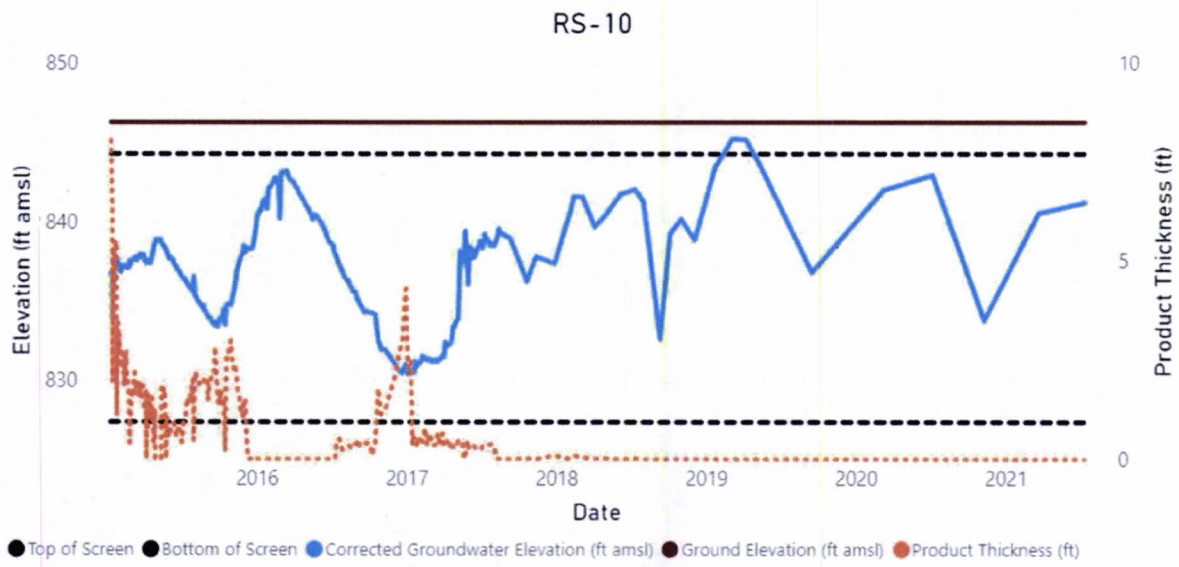
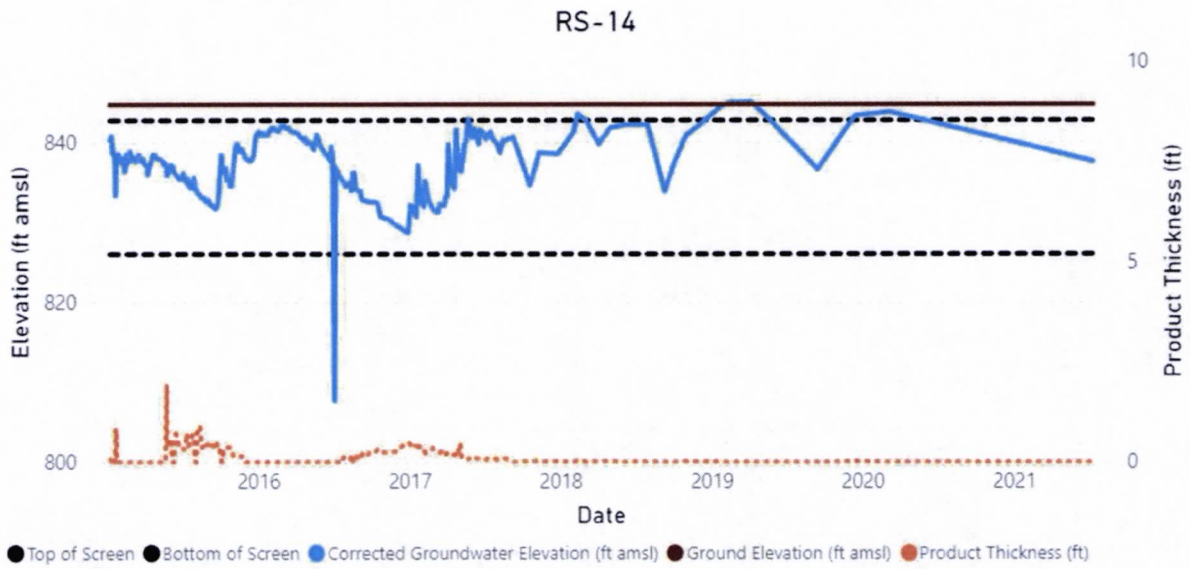
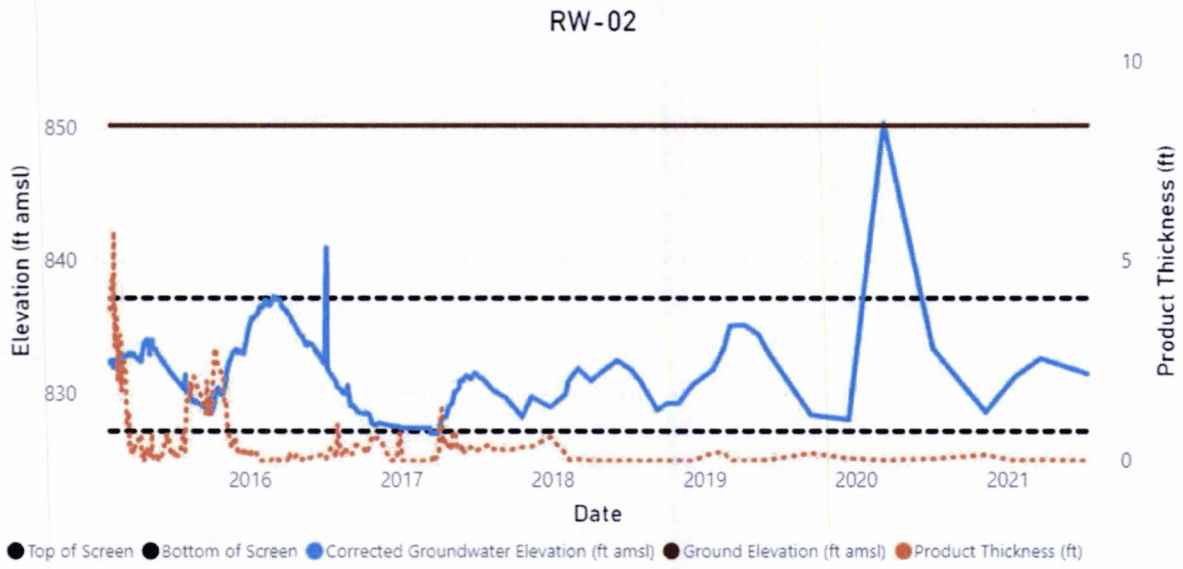
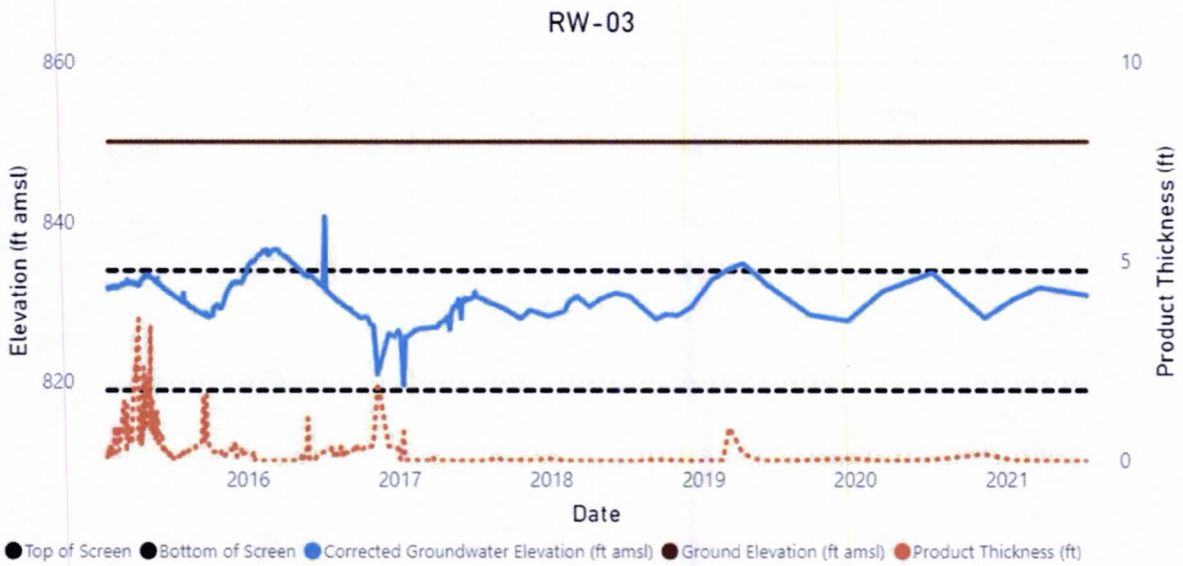
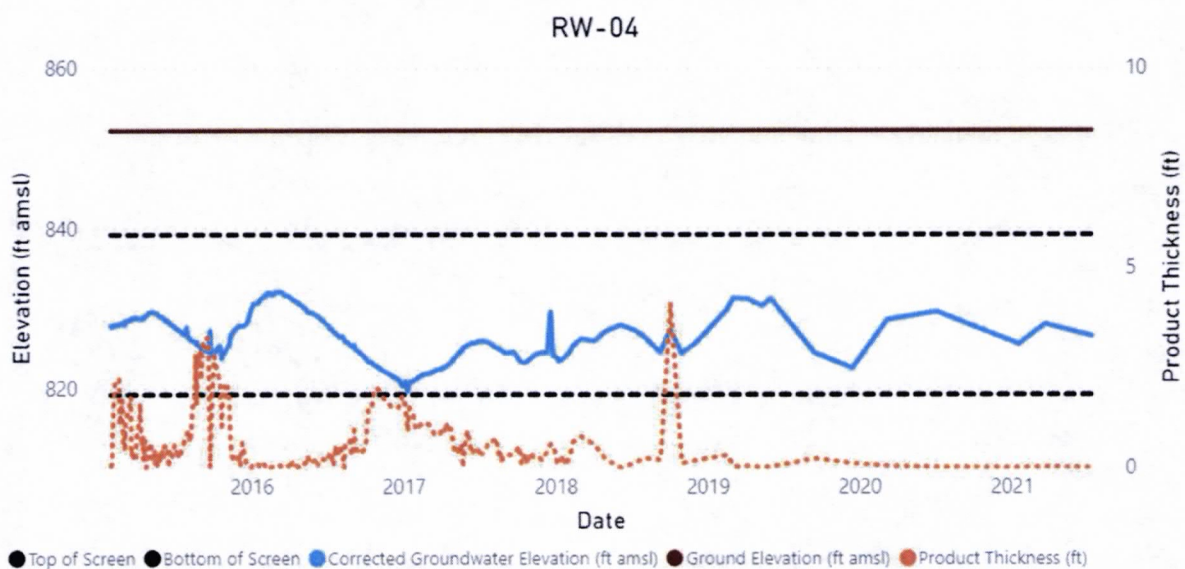
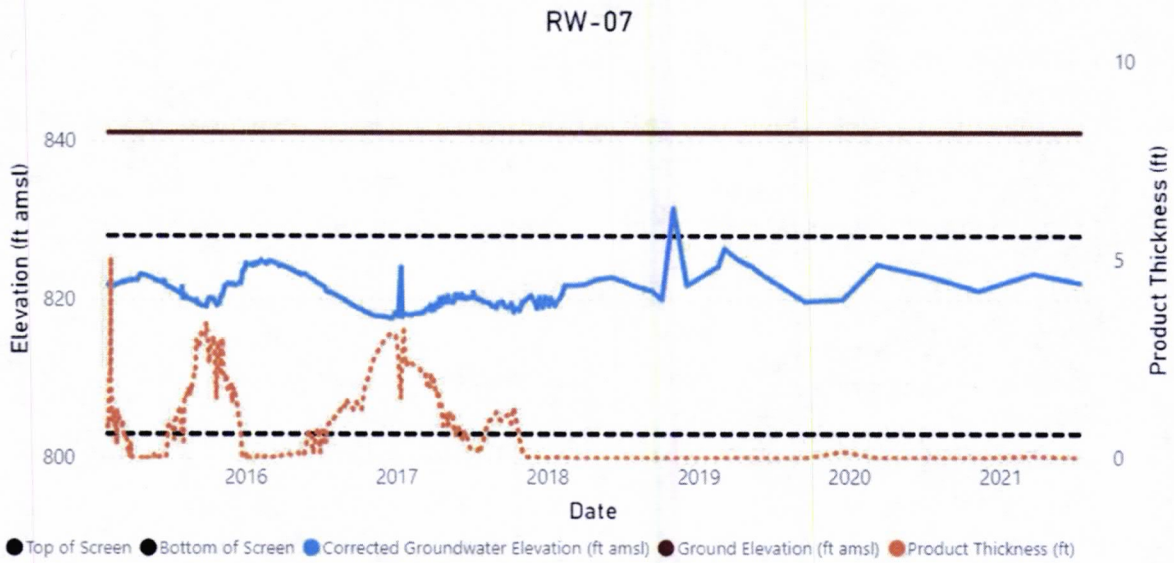
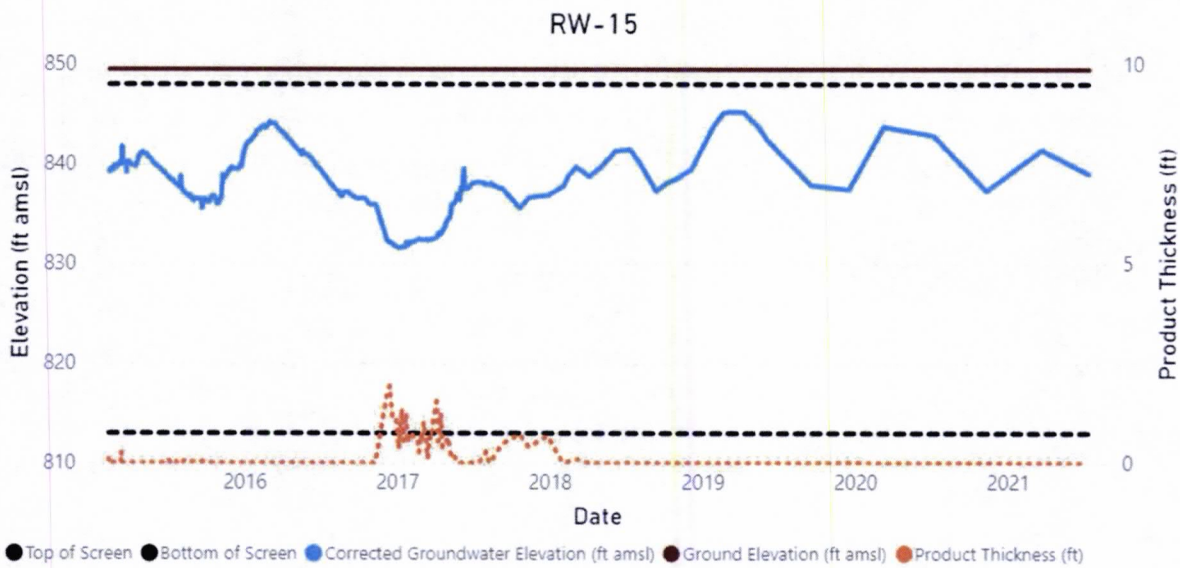
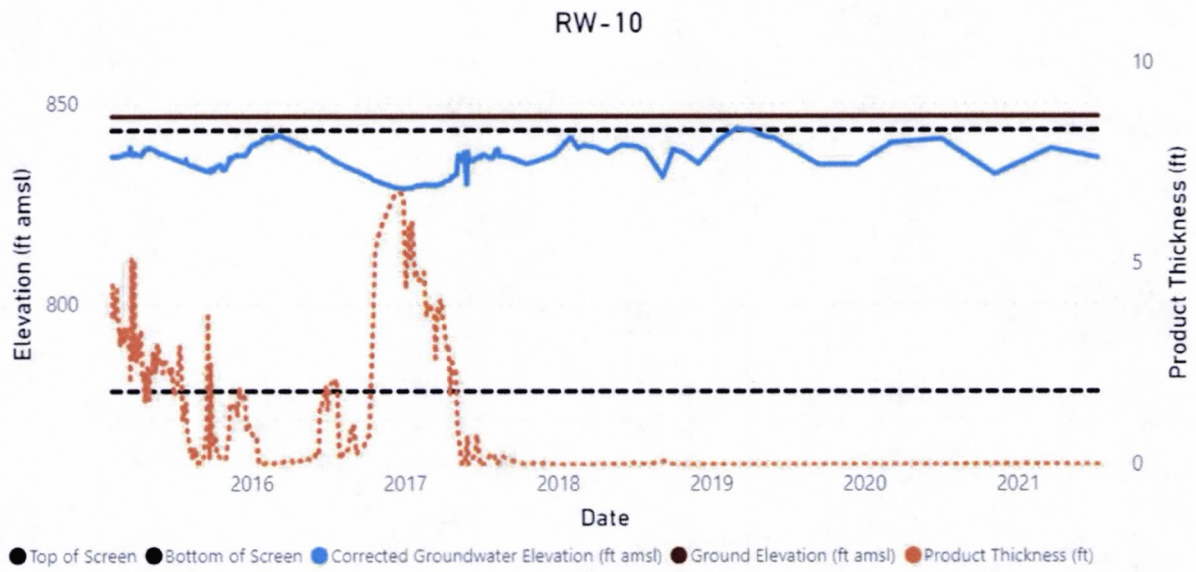
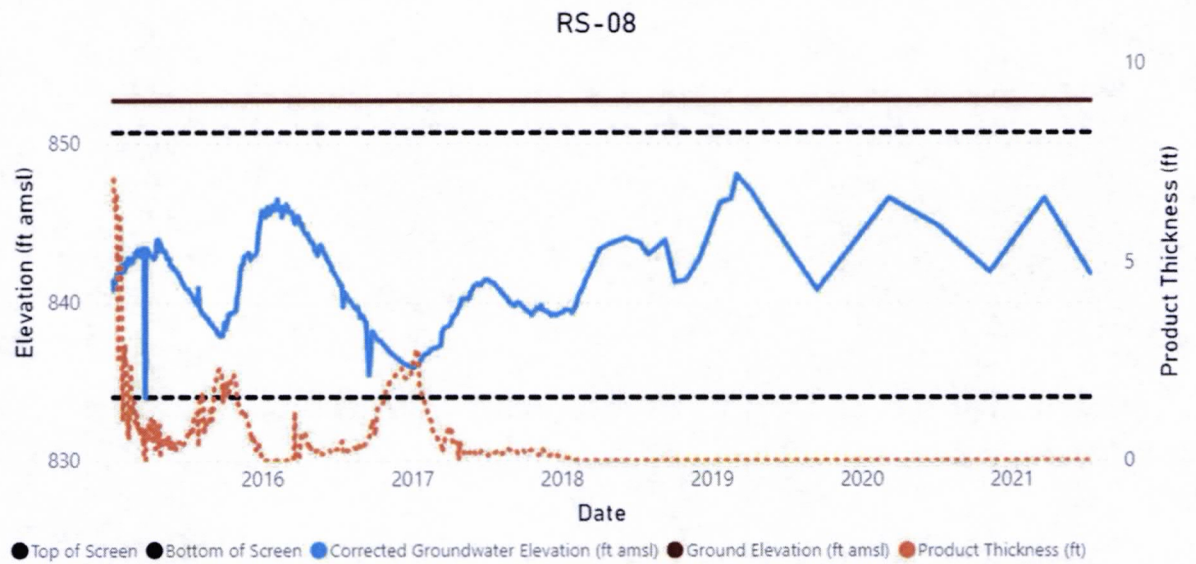
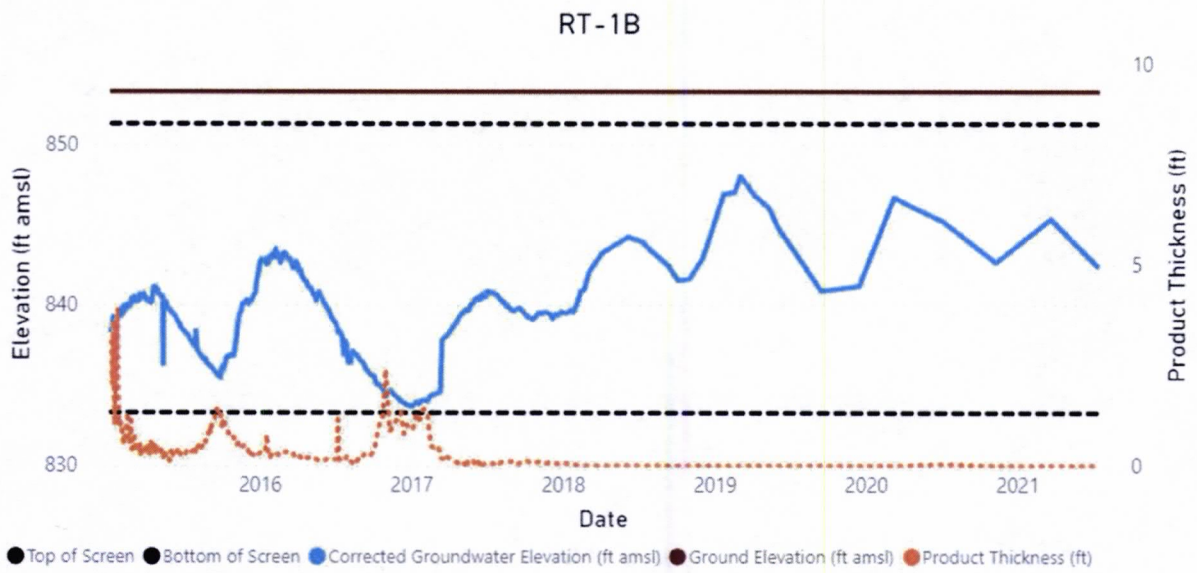
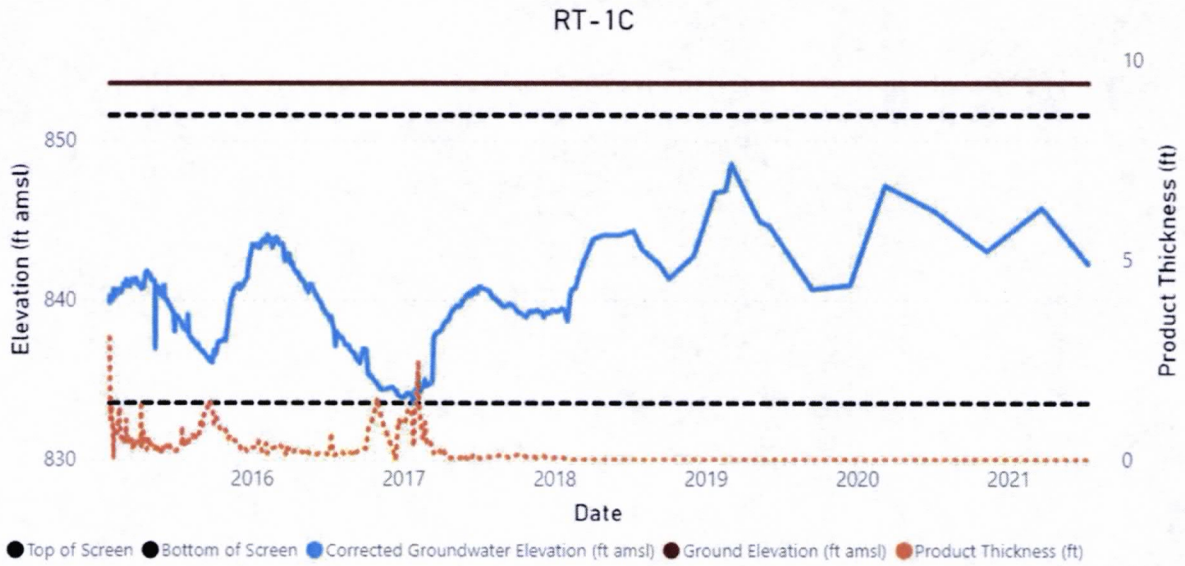
**Attachment A**  
**Product Thickness Trends**

Table 1 – Product Skimmer Recovery Results  
Table 2 – Groundwater Elevation and Product Thickness Data  
Figure 1 – Site Features with Product Recover Features  
Attachment A – Product Thickness Trends
