# WATERSHED WATER QUALITY ASSESSMENT

SALUDA RIVER BASIN

*Technical Report No.004-04*

**South Carolina Department of Health and Environmental Control**

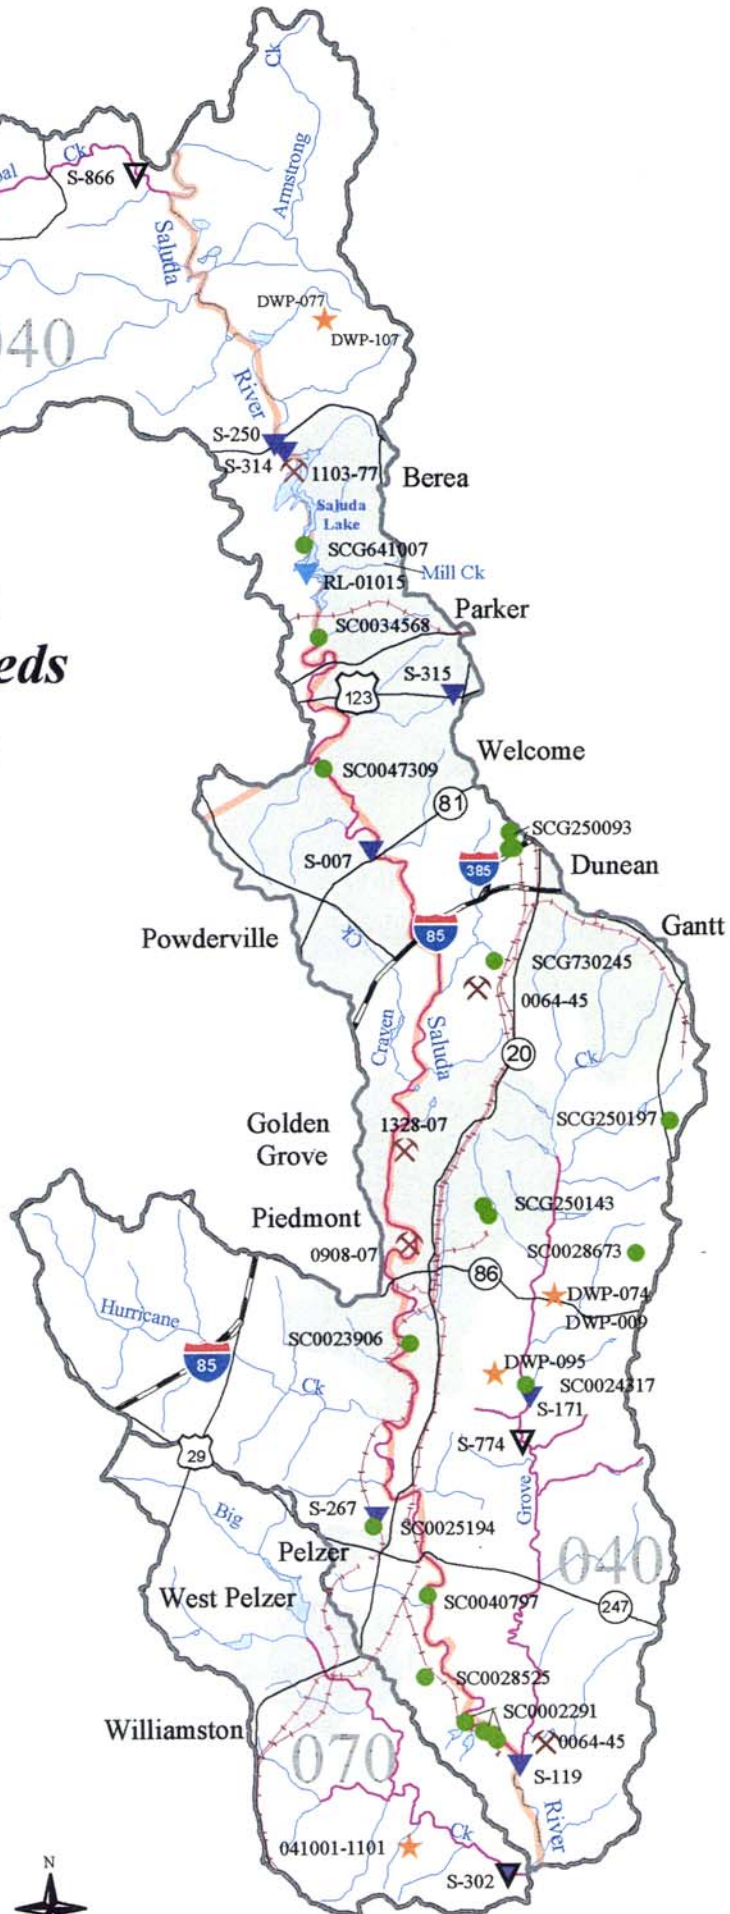
# Saluda River and Big Creek Watersheds (0305109-040 & 070)

- NPDES Permits
- ▽ Biological Sites
- ▼ Water Quality Monitoring Sites
- ▾ Random Monitoring Sites 2001
- ✕ Mines
- ★ Landfills
- ~ Modeled Streams
- ~ Streams
- ~ Highways
- ~ Interstate
- ~ Rail lines
- ~ County lines
- 11-Digit Hydrological Units
- City
- Lakes
