Preliminary Inspection Report for South Carolina Regulated Dams and Impoundment Structures Regulations R.72-1 through R.72-9

A. Dam Number: D 2085 & Hazard Class 2 B. Name of Dam: Anthony Lake Dam
C. Inspection Date (11/14/2012) & Time: 1330 D. Date of Last Inspection: (07/10/2007)
E. Location-County/City: Taylors / Greenville F. EQC Regional Office: Greenville
G. Inspector's Name: John Cobb
H. Owner's Name: Richard Penoyer
I. Contact Person (if different from above):
J. Dam Owner's or Contact Person's Phone Numbers: Home () Office () Other ()
K. Dam Owner's or Contact Person's mailing address:
Address 1 1013 Camp Creek Rd
Address 2 (optional)
City Taylors State SC Zip Code 29187

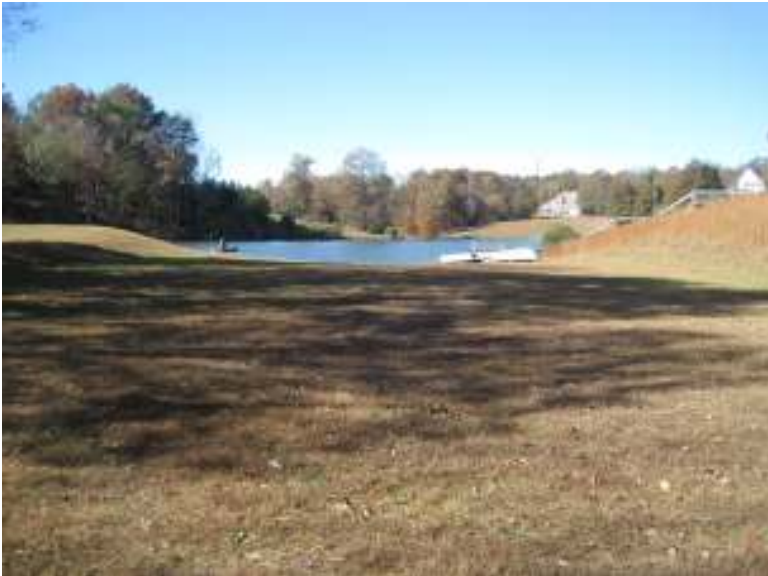
Emergency spillway

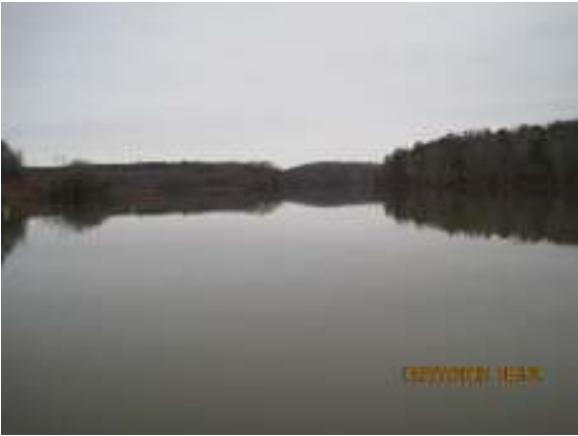
impoundment

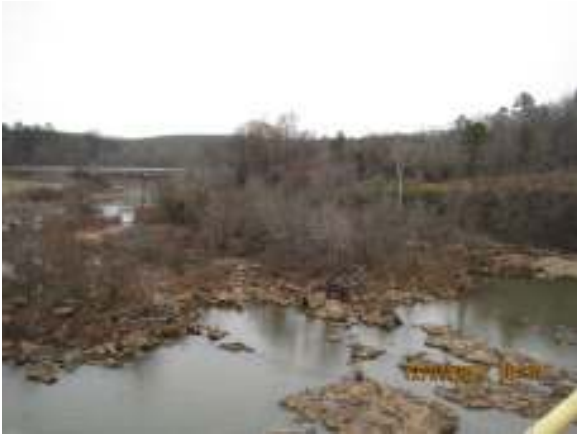
down stream

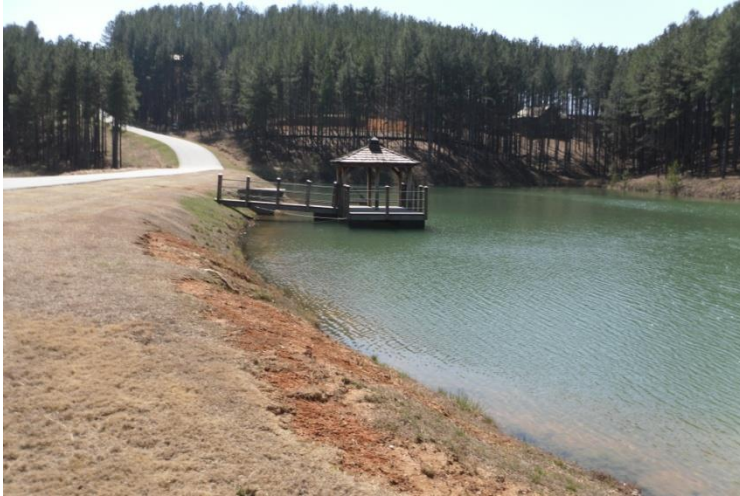
Upstream slope

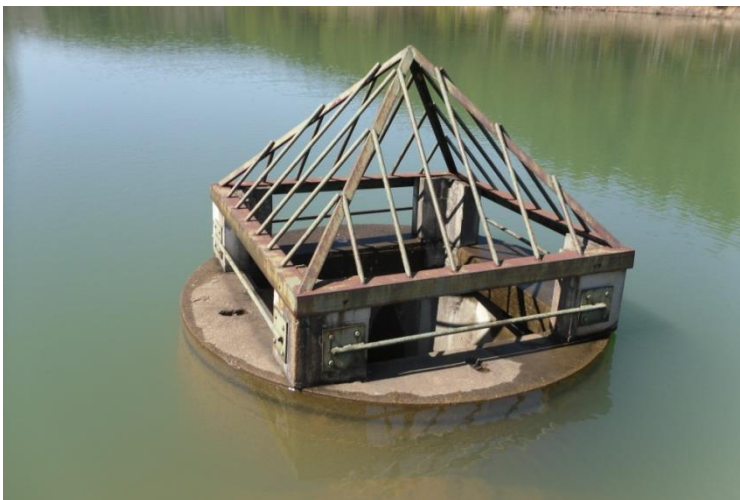
Inlet riser

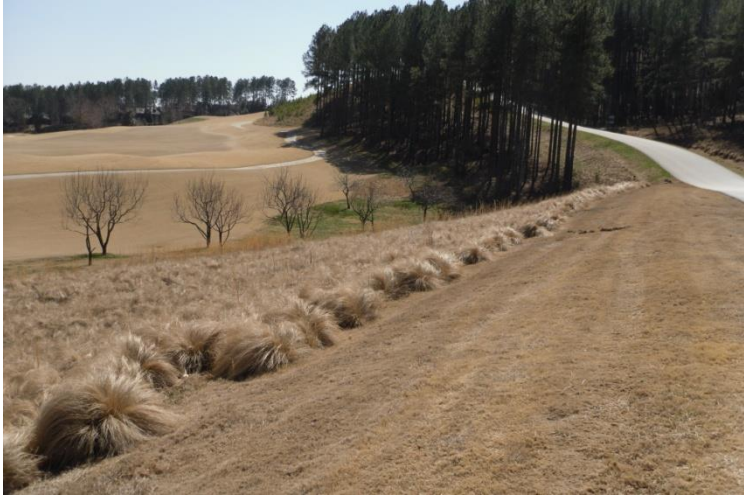
Downstream slope

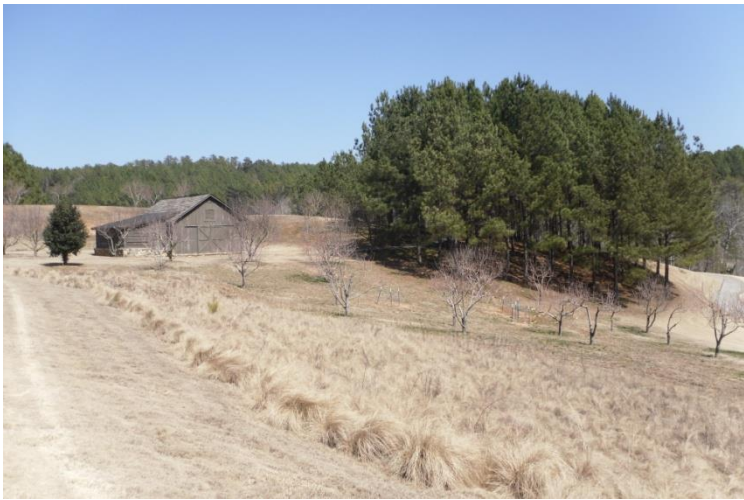
Downstream slope

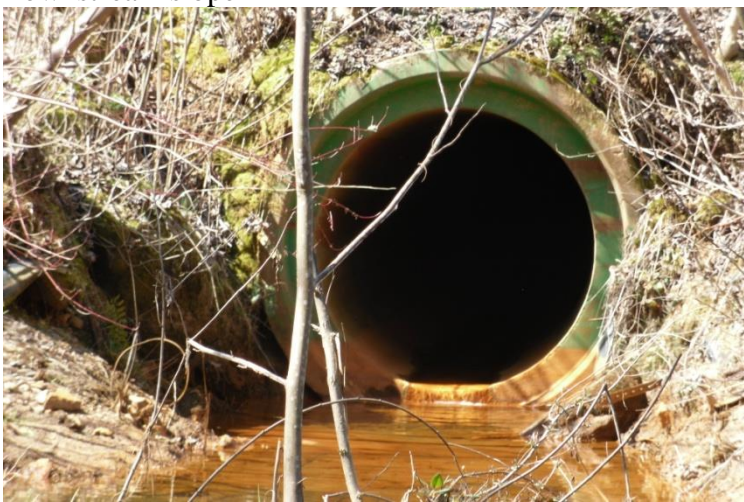
Spillway outlet

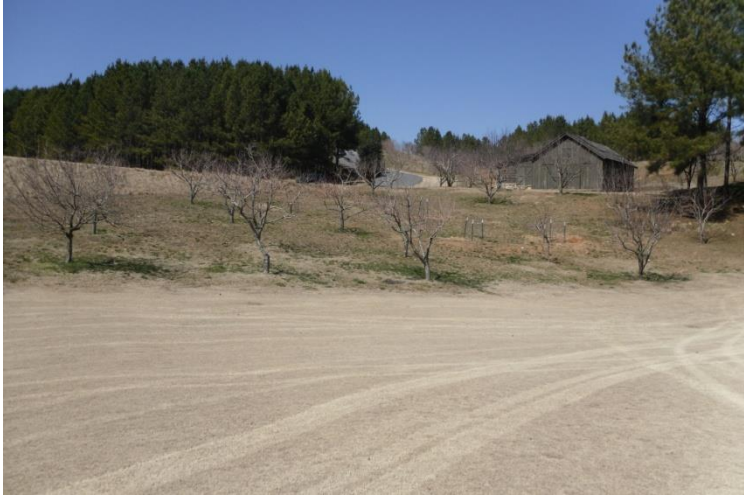
Downstream slope

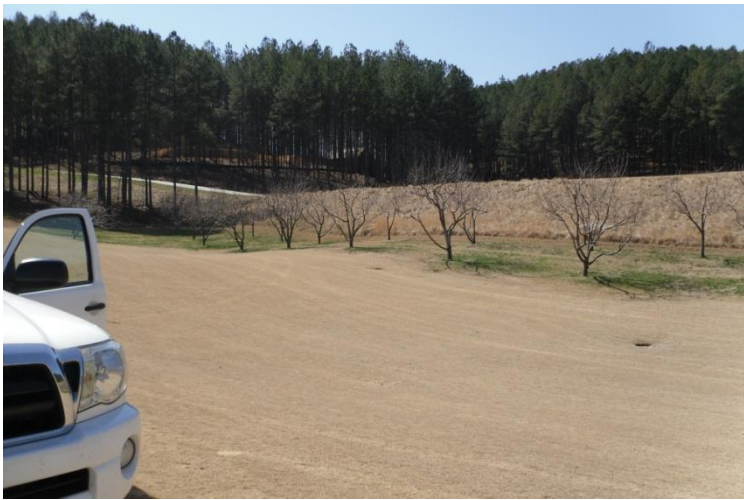
Downstream slope

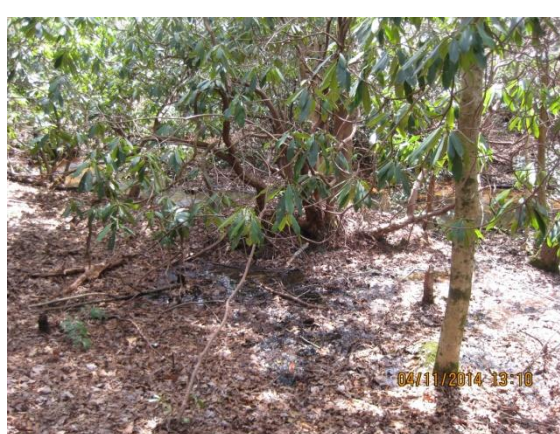
Seepage area

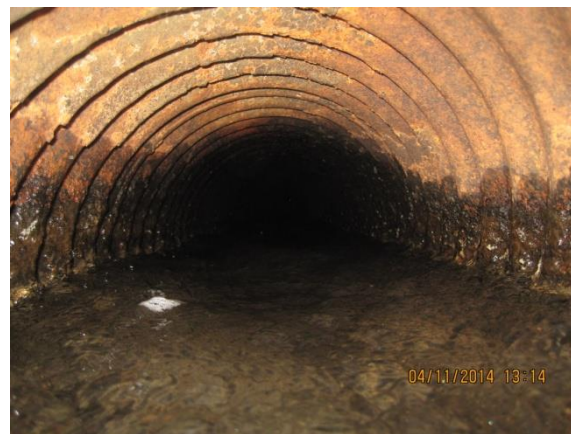
Outlet pipe

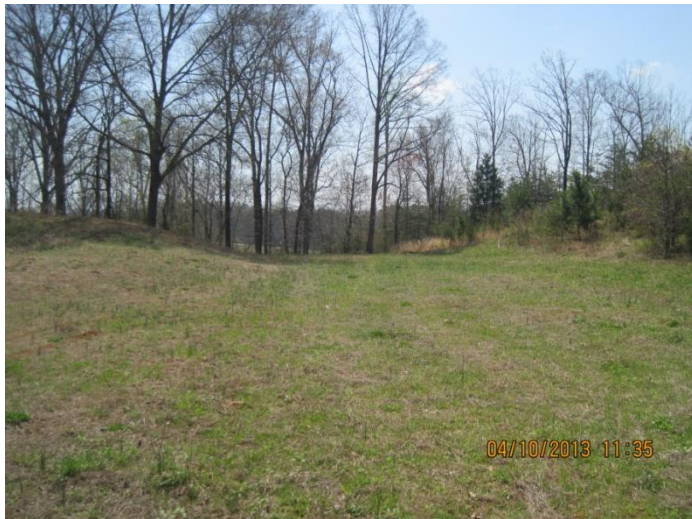
Emergency spillway

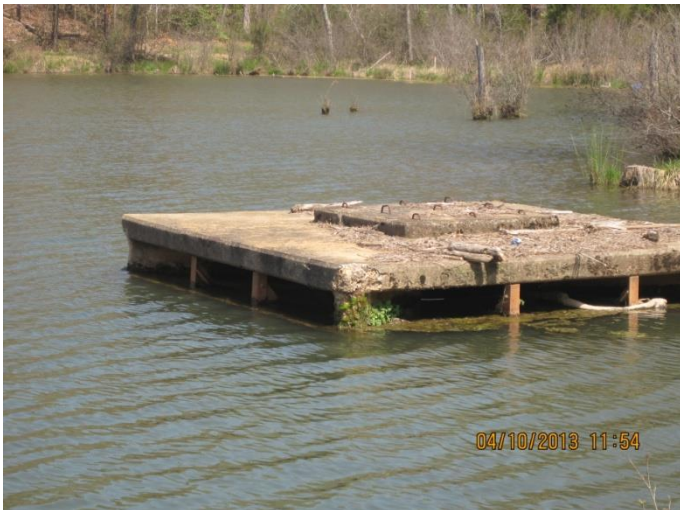
Outlet structure

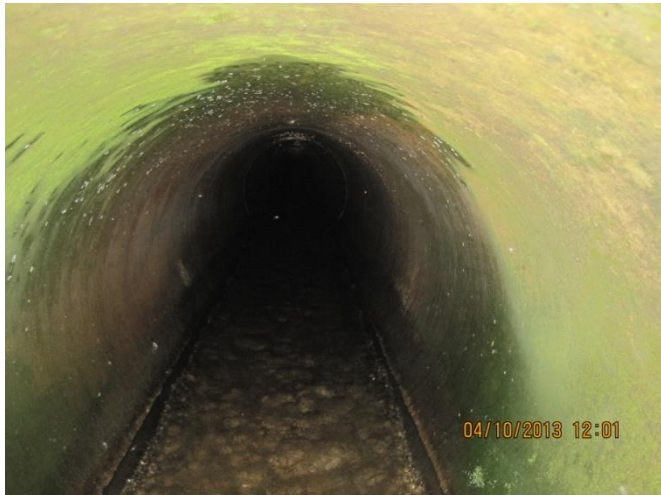
Outlet pipe
